**ACCIDENT**

<b>Aircraft Type and Registration:</b>	Tecnam P2008-JC, G-OLIC	
<b>No &amp; Type of Engines:</b>	1 Rotax 912-S2 piston engine	
<b>Year of Manufacture:</b>	2016 (Serial no: 1059)	
<b>Date &amp; Time (UTC):</b>	9 July 2017 at 1130 hrs	
<b>Location:</b>	Lydd Airport, Kent	
<b>Type of Flight:</b>	Training	
<b>Persons on Board:</b>	Crew - 1	Passengers - None
<b>Injuries:</b>	Crew - None	Passengers - N/A
<b>Nature of Damage:</b>	Nose leg collapsed, propeller destroyed, engine shock-loaded and damage to firewall and underside panels	
<b>Commander's Licence:</b>	Student	
<b>Commander's Age:</b>	40 years	
<b>Commander's Flying Experience:</b>	56 hours (of which 6 were on type) Last 90 days - 10 hours Last 28 days - 6 hours	
<b>Information Source:</b>	Aircraft Accident Report Form submitted by the pilot

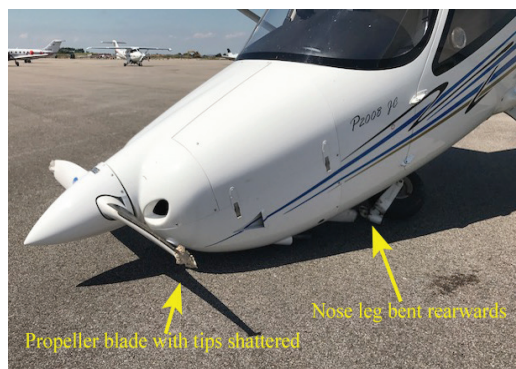
**Figure 2**

The student pilot was undertaking a solo cross-country flight to Lydd Airport where, accompanied by his instructor, he had landed a few days previously. Runway 21 was in use and the reported wind was from 110° at 8 kts so there was a crosswind from the left and a slight tailwind. The pilot believed he approached at the correct airspeed but, when he flared, the aircraft ballooned and then sank. Although he tried to reduce the descent rate by adding power, the aircraft bounced and when it contacted the runway a second time, the nose leg collapsed rearwards, the propeller blade tips shattered and the engine stopped before the aircraft came to a halt on the runway (Figures 1 and 2).

**G-OLIC pictured after the accident**
