## Inspection and testing of failed tow wire rope from tug *ALP Forward*

### FINAL REPORT

TTI Reference number TTI-IMLR-2016-5284

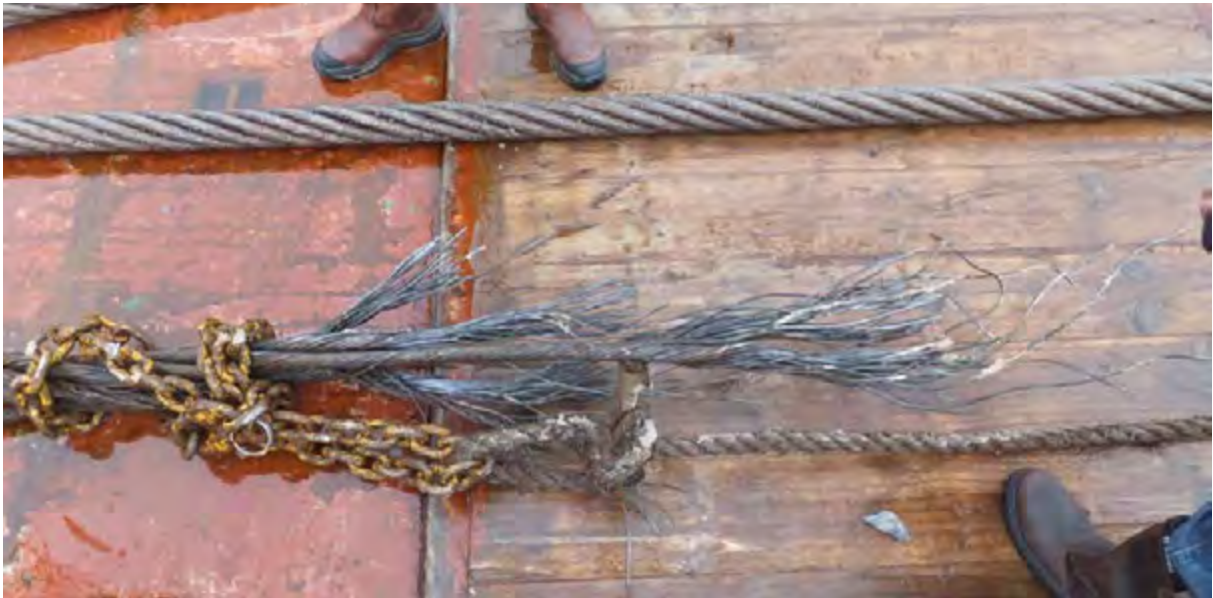
**Figure 3.3:** View on failure of 77 mm wire rope (*tug side*) (Photograph supplied by **MAIB**).

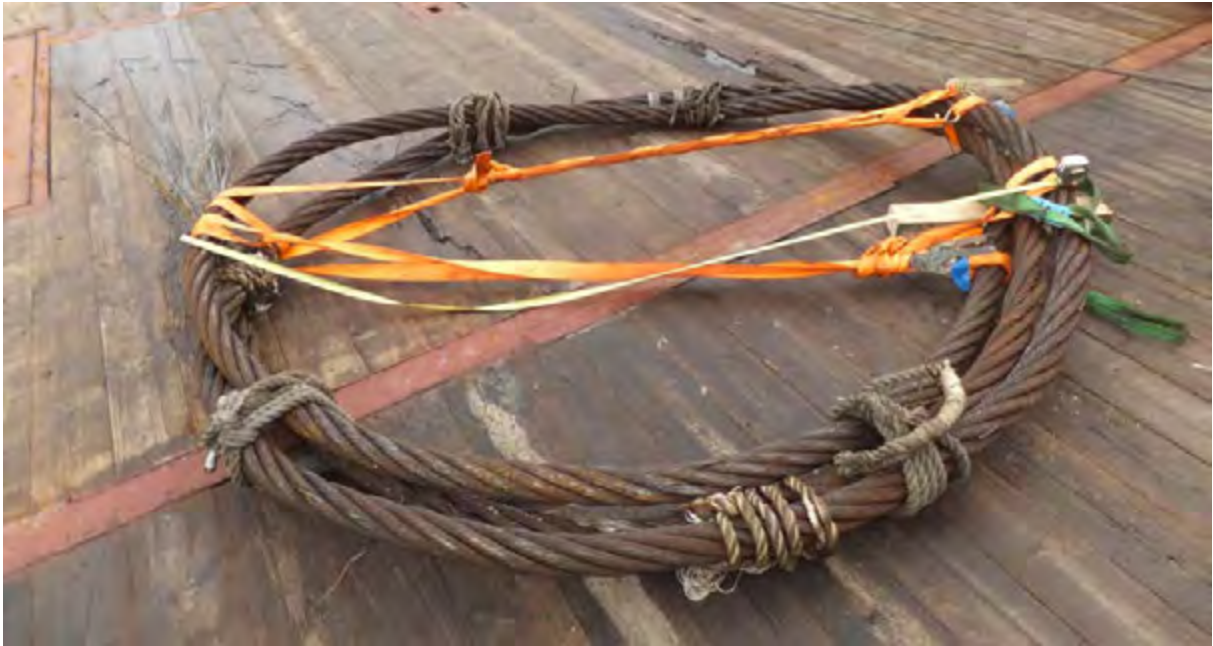
**Figure 3.4:** *Tug side* sample taken for inspection: 20 m from the failure towards the tug *ALP Forward* (Photograph supplied by **MAIB**).

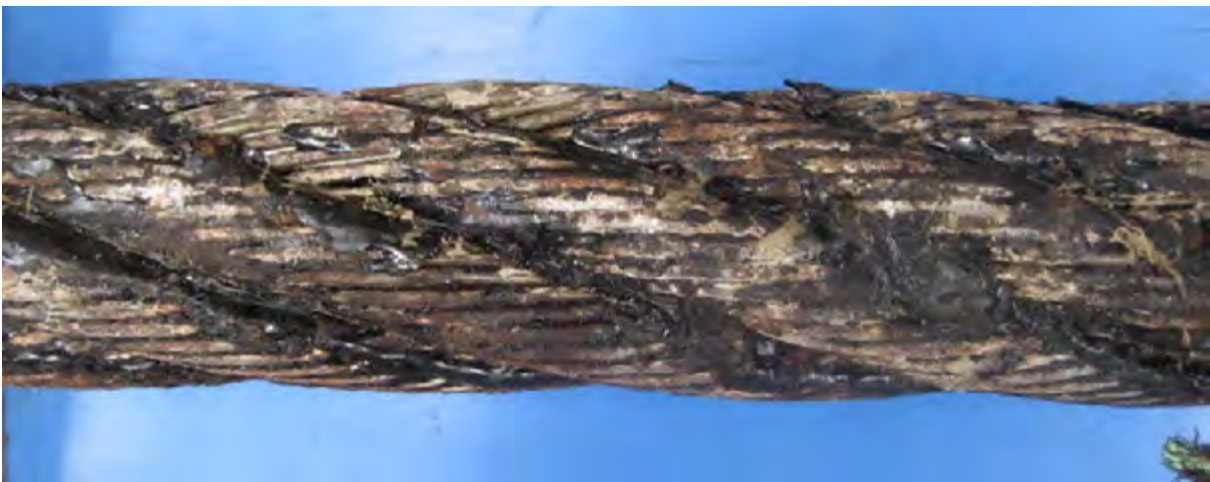
Figure 5.1 shows the general condition of the drum sample as received. Generally the sample was well lubricated particularly in the outer strand valleys. Where present the lubricant was glossy and black in appearance, and as new. There were also some grey deposits of what were thought to be mud or silt. It is not known at what stage these were deposited on the wire rope. Superficial corrosion was noted on the surface of the wires.

**Figure 5.1:** General condition of the drum sample as received.

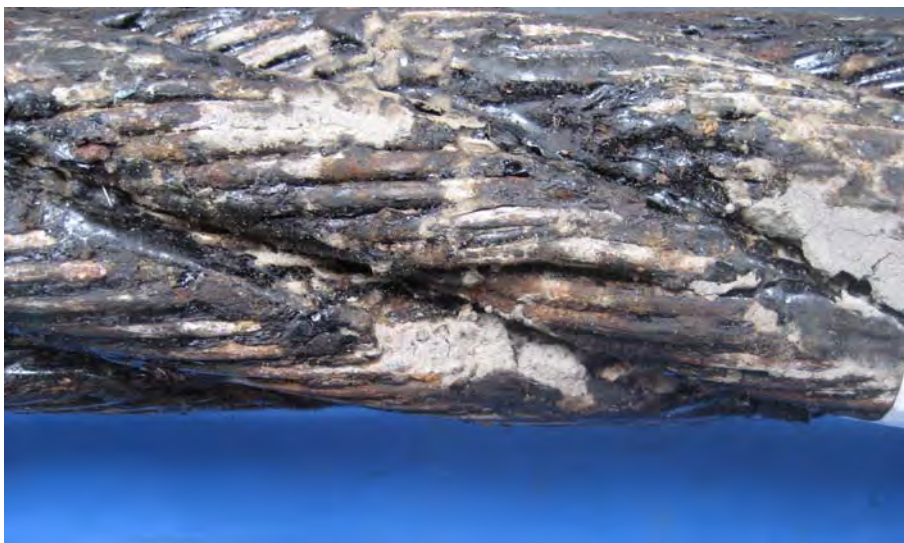
Mid-length along the sample was found an area of crushing damage on one of the strands. Whilst not ideal, it is thought that this damage would not adversely affect the breaking strength of the sample as the damage should 'pull out' under the high loads.

**Figure 5.2:** Area of crushing damage found on the drum sample (mid-length).

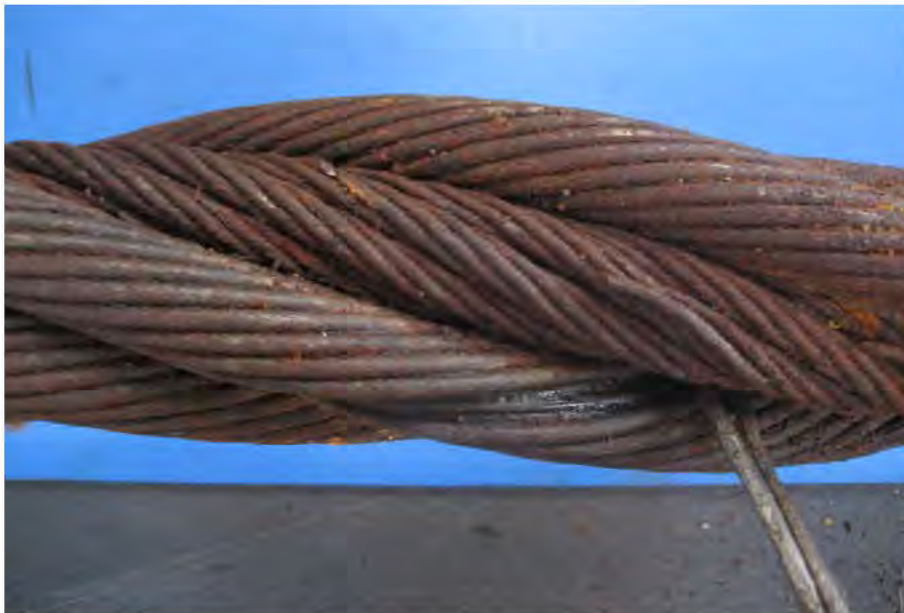
Where exposed, the IWRC appeared to be in poor condition. Multiple wire breaks were observed, the core was dry and lacking in lubrication and corrosion had begun (Figure 5.4).

Figure 5.4: IWRC displaced from the centre of the wire rope at 12.5 m from cut end on tug side sample.

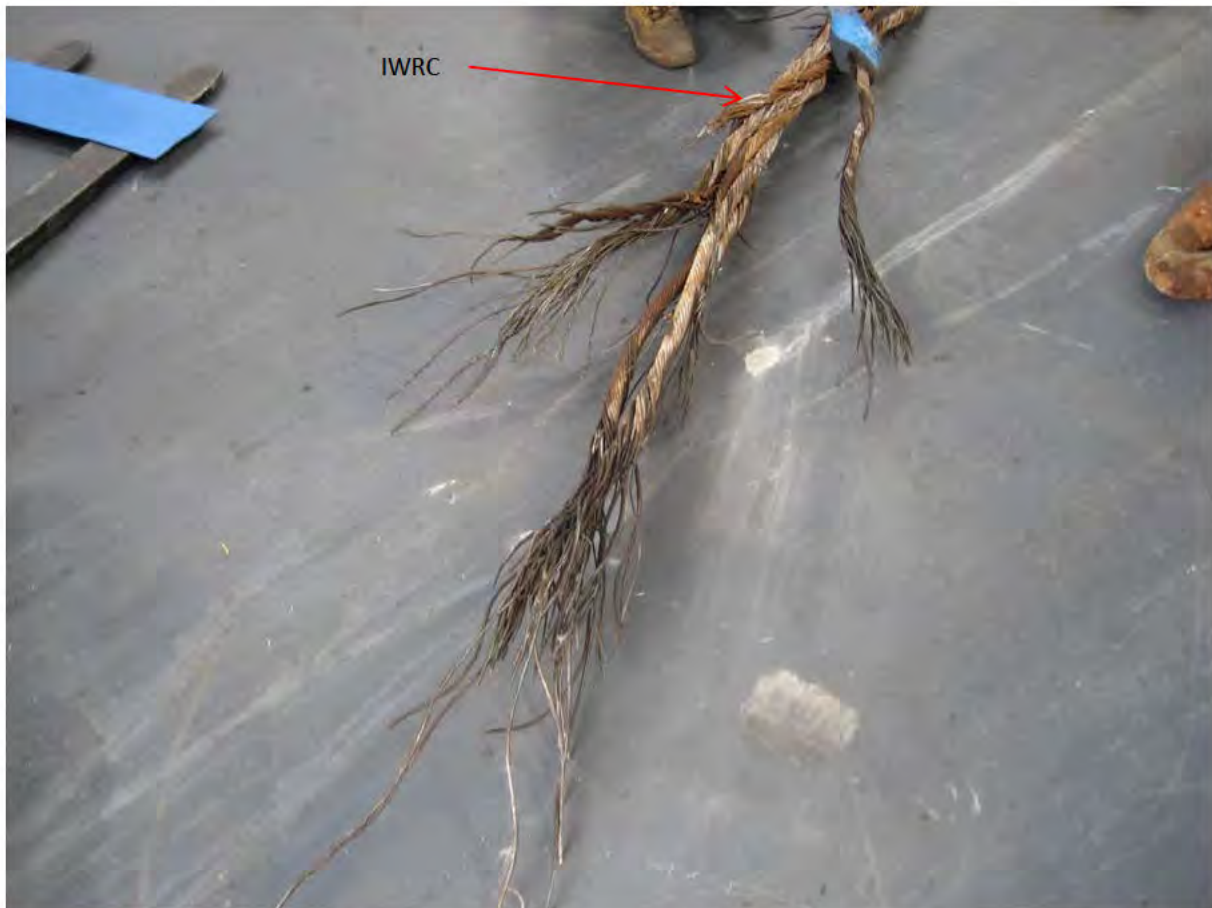
Finally, Figure 5.6 shows the failed end of the tug side sample. The IWRC failed at approximately 18 m from the cut end, and the remaining five strands at distance 18.5 m, 18.7 m (2 off) and 19.2 m (2 off). A more detailed analysis of the failure will be reported in Section 11.

**Figure 5.6:** Failure of IWRC and five strands over a distance 18.0 - 19.2 m from the cut end on tug side sample.

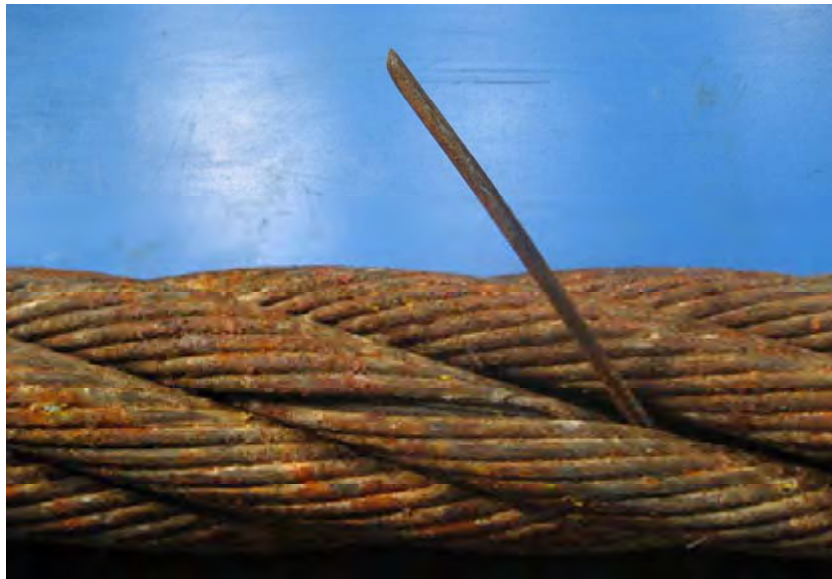
It is immediately noted that the lubricant between the strands is missing, the protective galvanising seems low or lost, and the wires (the outside of the wire rope) are covered in what appears to be superficial corrosion. Wire breaks were noted distributed along the 10 m length, both along and around the wire rope circumference. In all 40 visible breaks were counted (there may well have been more), all of which initiated at the inter-strand contact region of the wire rope and appeared to be shear type in nature. Beyond 10 m from the cut end there were many more wire breaks.

**Figure 5.7:** Outer strand wire break (valley) measured at 1.4 m from cut end on tug side sample.

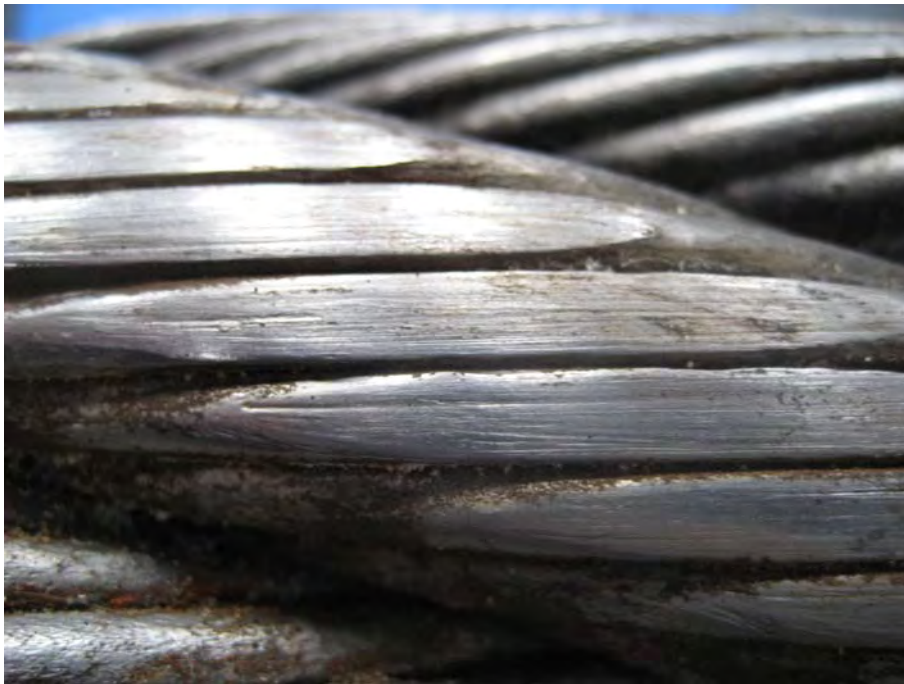
The lack of corrosion on the surface of the abrasion suggests that it is very recent. It must be considered possible that this damage (the abrasion) was caused to the wire rope after the failure of the tow. Given the position of the main failure along the wire rope the failed end of the wire rope would have dragged along the seabed for some distance ( $\approx 3$  miles) as the rig drifted. The nature of the seabed is not known, however small pieces of stone were found between strands in positions along the length of the sample (see for example, Figure 5.12).

**Figure 5.11:** Significant abrasion on the surface of the outer wires 2.0 m from cut end of rig side sample.

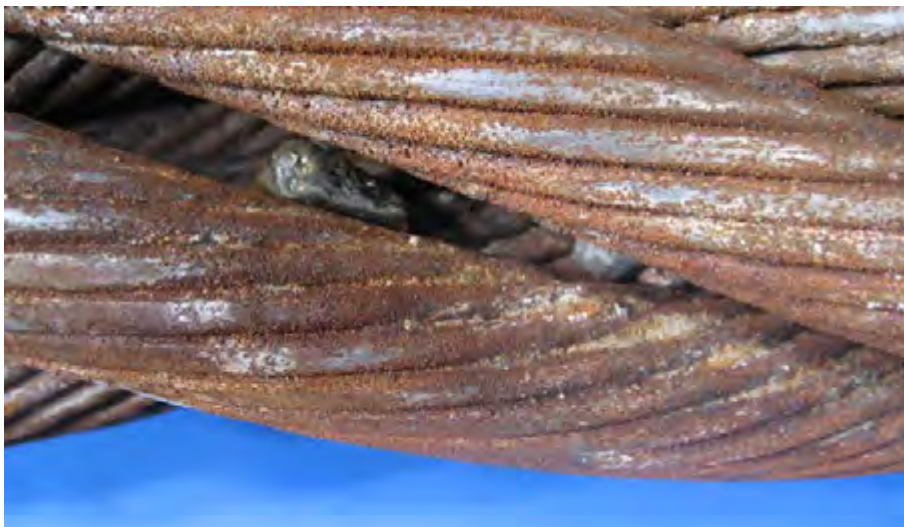
**Figure 5.12:** Small pieces of stone noted trapped in the wire rope at 5.6 m from cut end of rig sample.

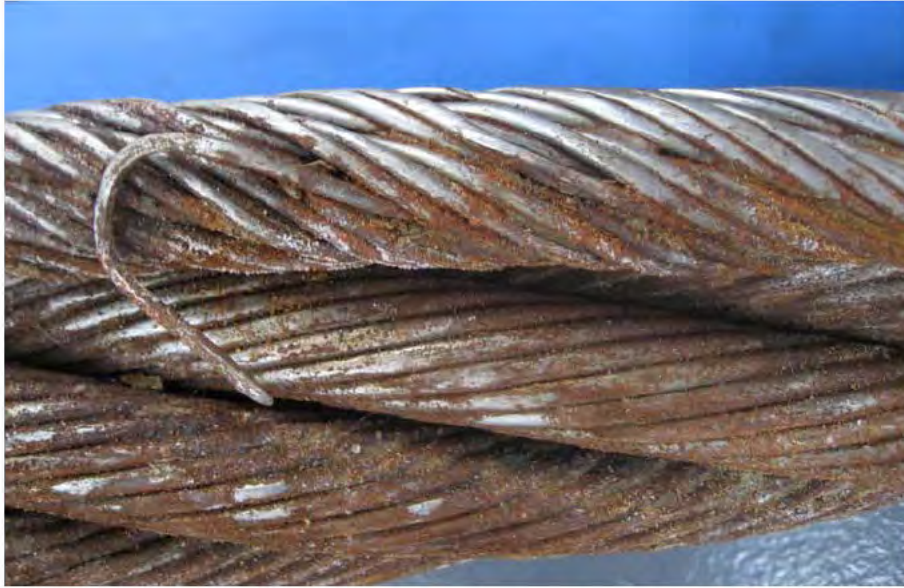
The suggestion that the abrasion damage occurred post to failure is supported by the condition of the IWRC which had displaced from the centre of the wire rope construction at 5.7 m from the cut end (Figure 5.13).

**Figure 5.13:** Abrasion (and wire breaks) noted on the displaced IWRC at 7.2 m from cut end of rig sample.

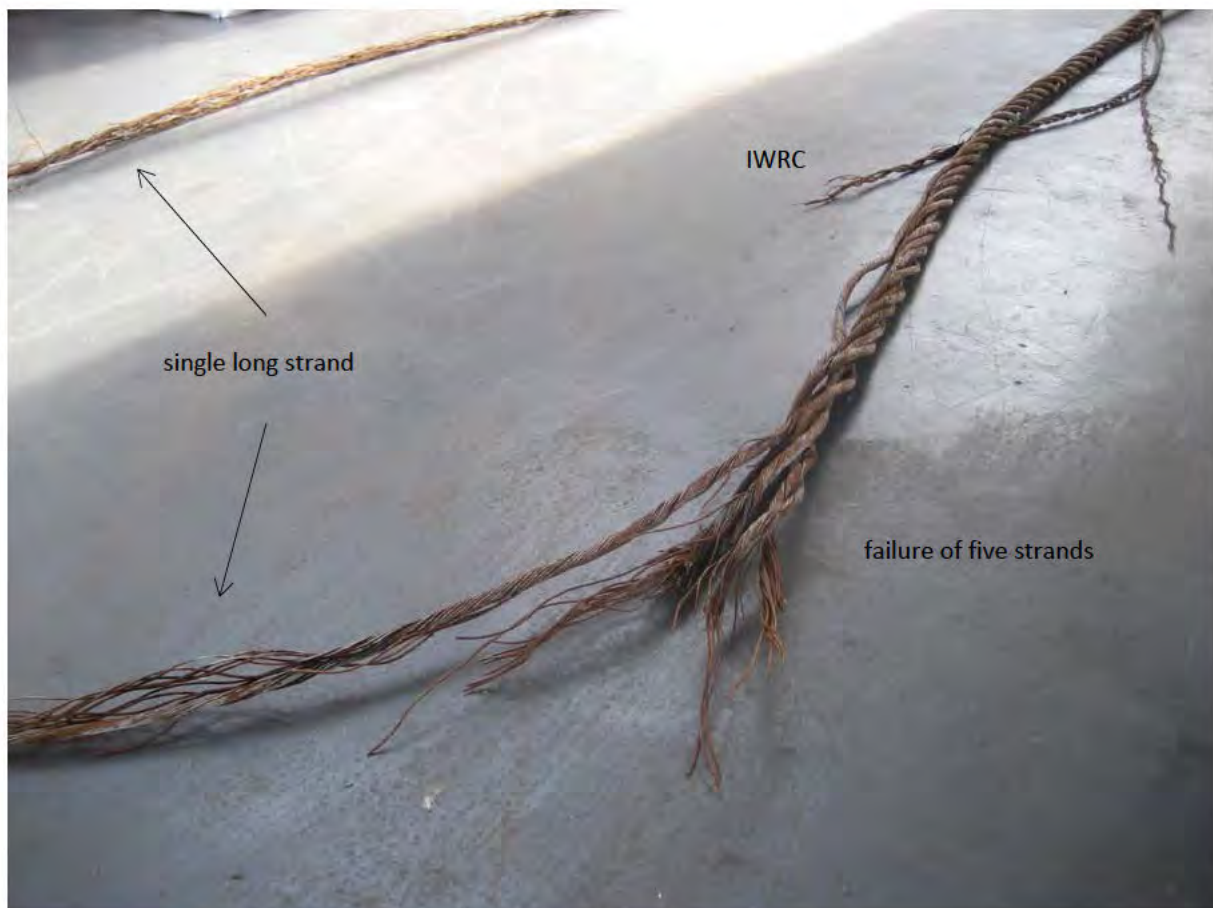
Figure 5.14 shows the failed end of the sample. The end of the IWRC was measured as 12.1 m from the cut end. It is therefore quite possible that a short section is missing. This is not surprising given the condition of the core noted in other positions along the wire rope which showed numerous wire breaks.

**Figure 5.14:** General view on main wire rope failure (rig sample).

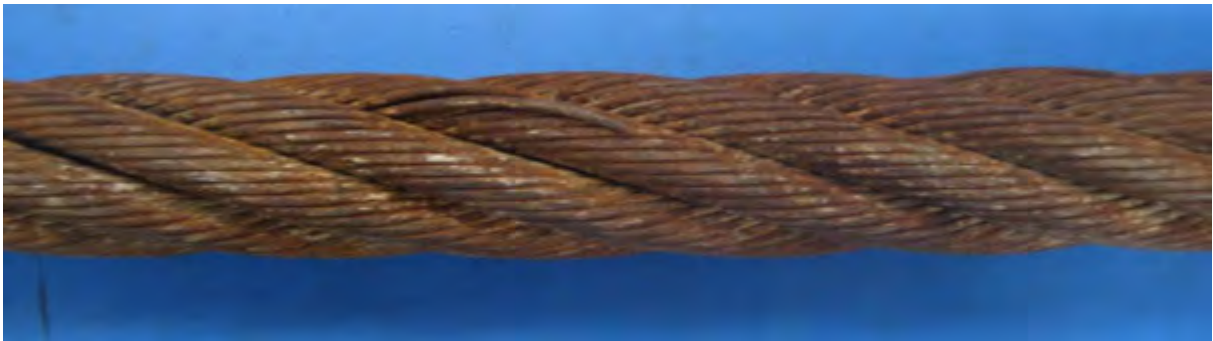
Figure 8.1 shows the general condition of the bridle sample as received. In general terms the sample appeared to be in the same condition as that of the tug side sample (compare with Figures 5.7 - 5.9):

- the lubricant on and between strands was missing;
- the protective galvanising seems low or totally lost, and the surface of the wire rope is at the point of onset of corrosion.

**Figure 8.1:** General condition of the bridle sample as received (7.1 m).

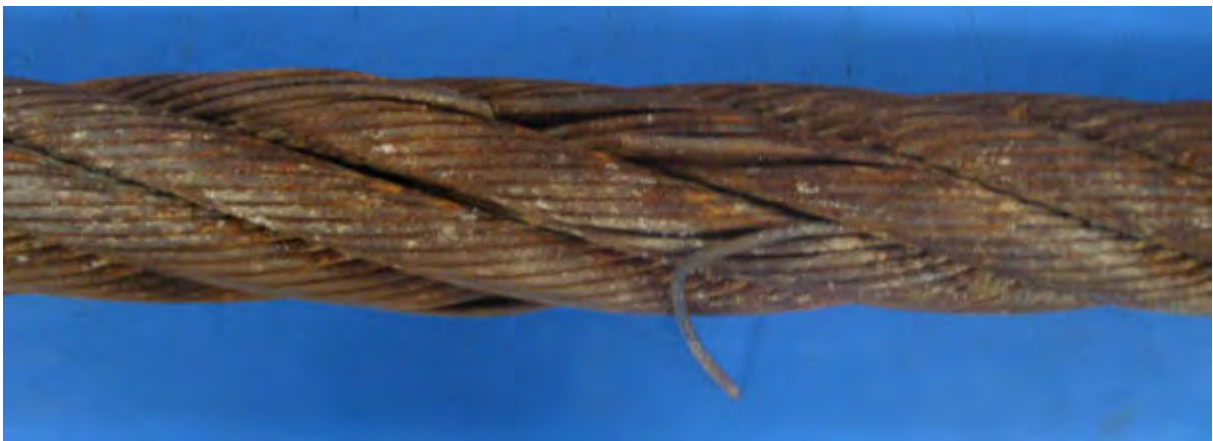
Wire breaks were observed along the sample (40 were counted over the 20 m length). Two groups of wire breaks were observed at 15.2 m (eight), Figure 8.2, and at least six at 16.5 m, Figure 8.3. (All distances measured from the front of the socket face.) In all eighteen wire breaks were counted over a  $30d^1$  length (2.31 m).

**Figure 8.2:** Group of at least eight wire breaks noted at 15.2 m on the bridle sample.

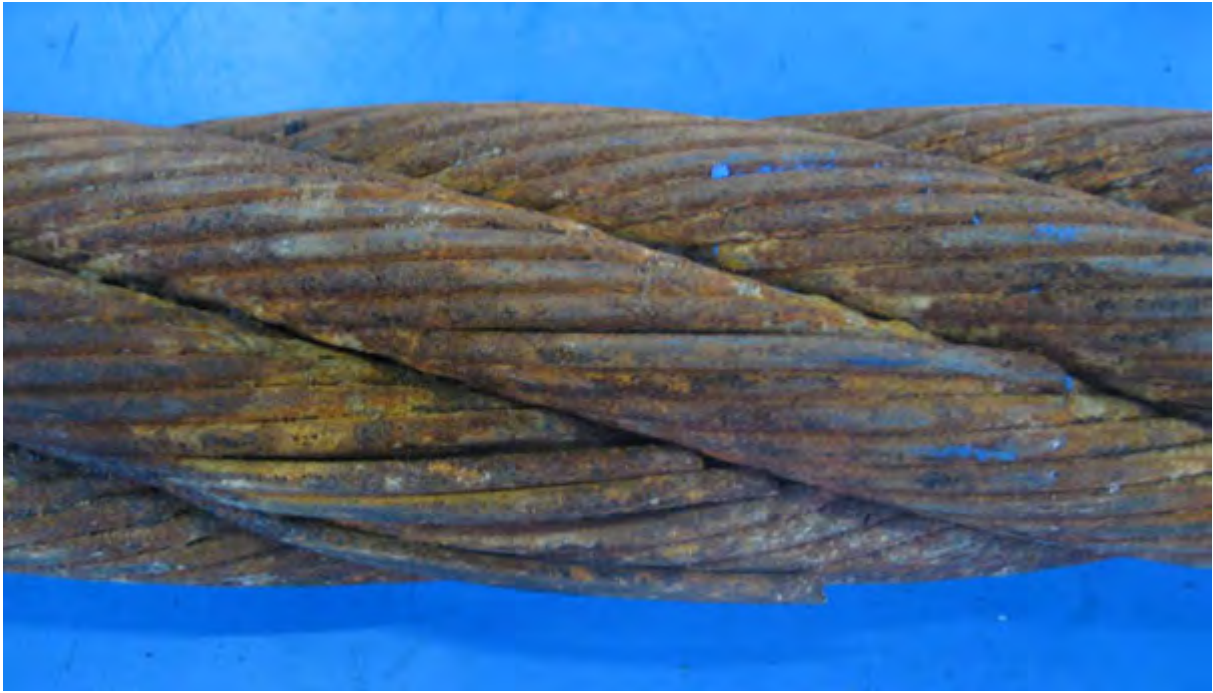
**Figure 8.3:** Group of at least six wire breaks noted at 16.5 m on the bridle sample (the blue paint is from the shipping container).

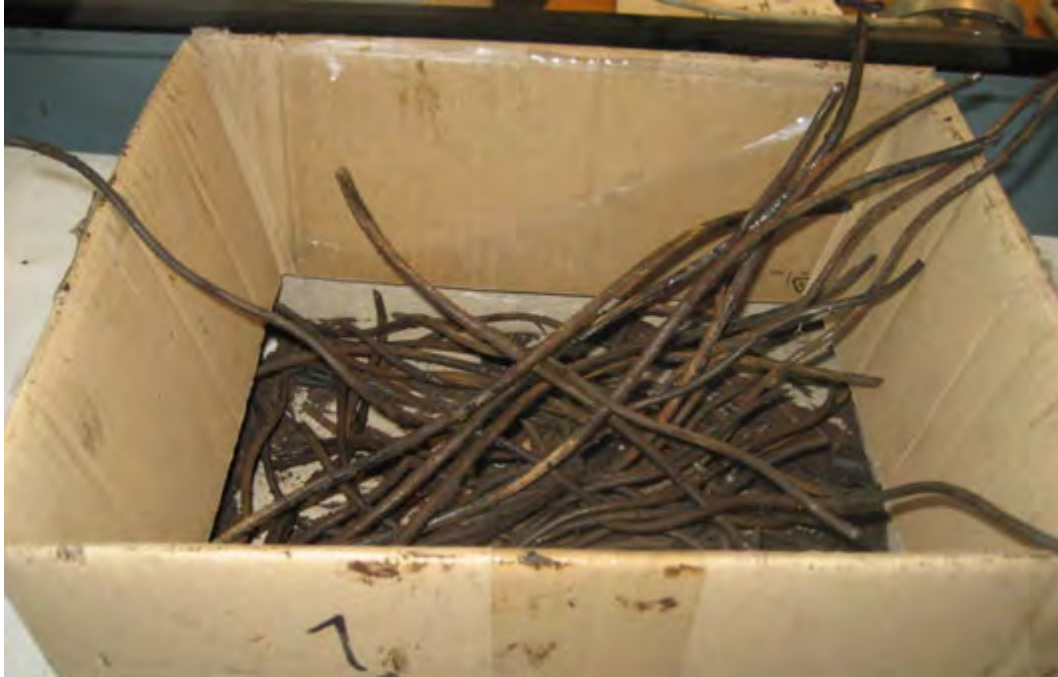
Figure 9.6 shows the broken wires which fell out of the tug side sample when it was terminated for testing. The wires are largely from the IWRC, which as the initial inspection had shown was in fairly poor condition. In addition to the IWRC wires there were also some outer strand outer layer wire breaks. The tug side sample failed mid-length (Figure 9.7).

**Figure 9.6:** Tug side sample - broken wires found in preparation of sample terminations. (Mostly IWRC wires, but also some outer strand outer wires).

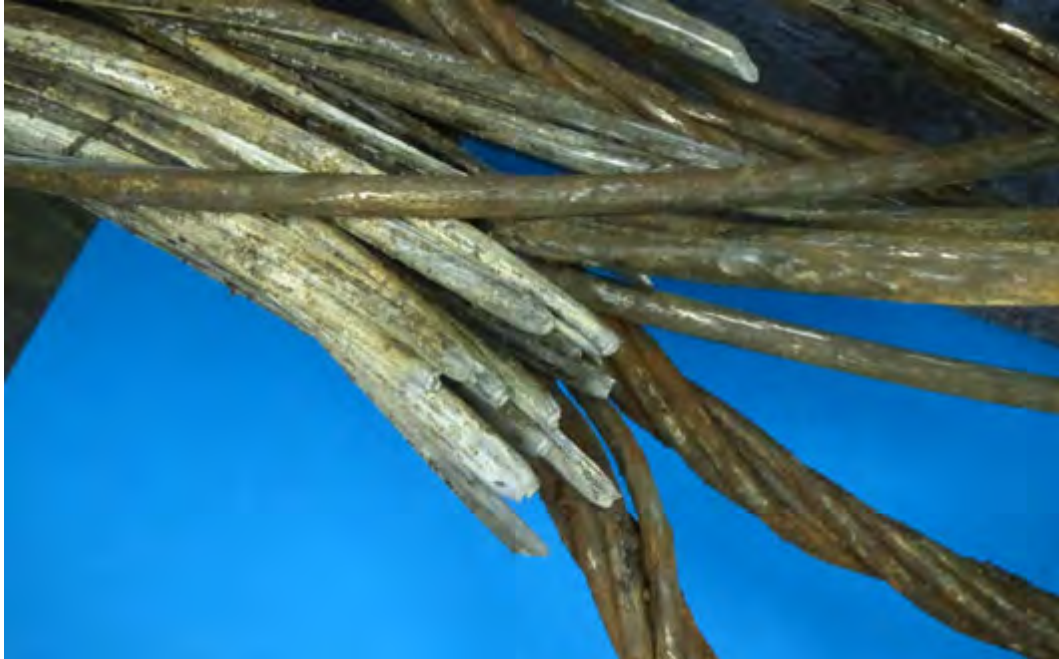
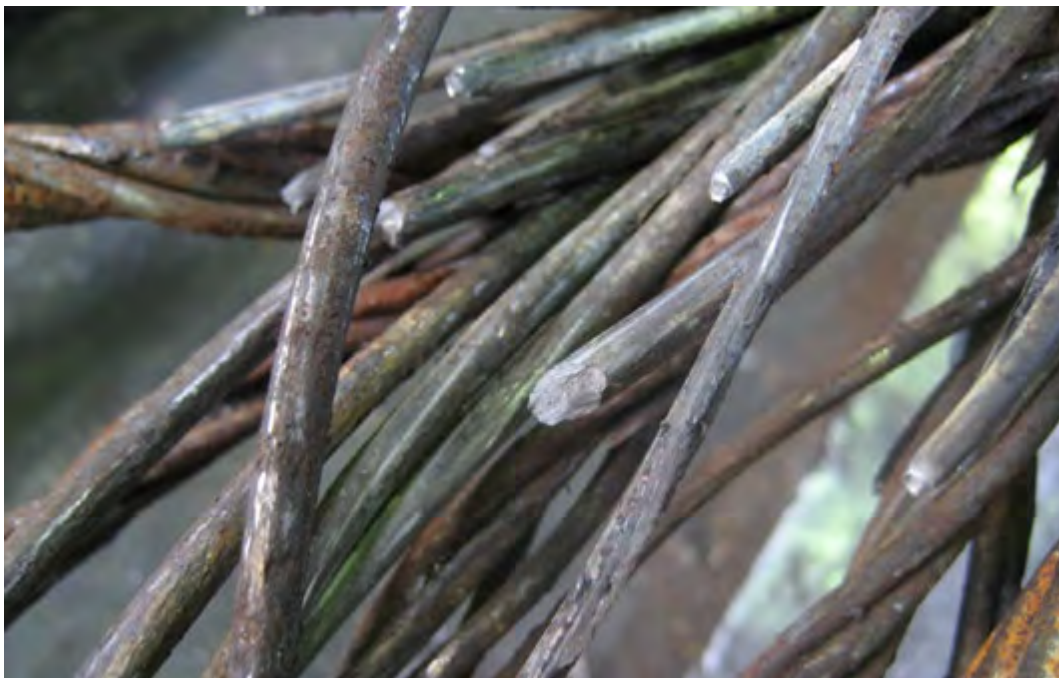
Figures 9.8 and 9.9 show views on the groups of wire failures after testing of the tug side sample. The inner layers of the main strands may be readily identified by their paler colour. It can be seen that these wires failed with tensile cup and cone type failures. There were also some shear failures (e.g. centre of Figure 9.9).

**Figure 9.8:** Tug side sample after testing, detailed view on wire failures.

**Figure 9.9:** Tug side sample after testing, detailed view on wire failures.

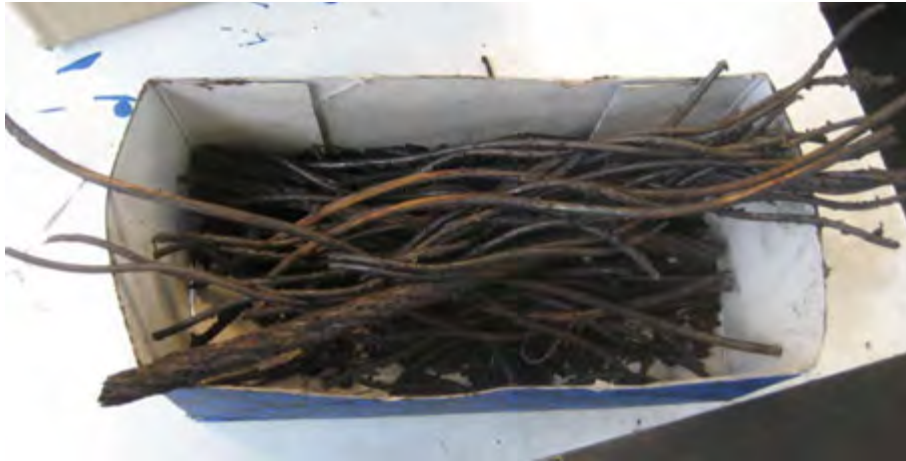
As with the tug side sample, the core of the IWRC was found to be mostly in pieces when the sample was prepared for testing (Figure 9.10). Additionally, there were also breaks in some outer strand outer wires. As with the other samples, the bridle sample failed clear of the terminations (Figure 9.11).

**Figure 9.10:** Broken wires found in preparation of Bridle sample terminations - mostly IWRC wires.

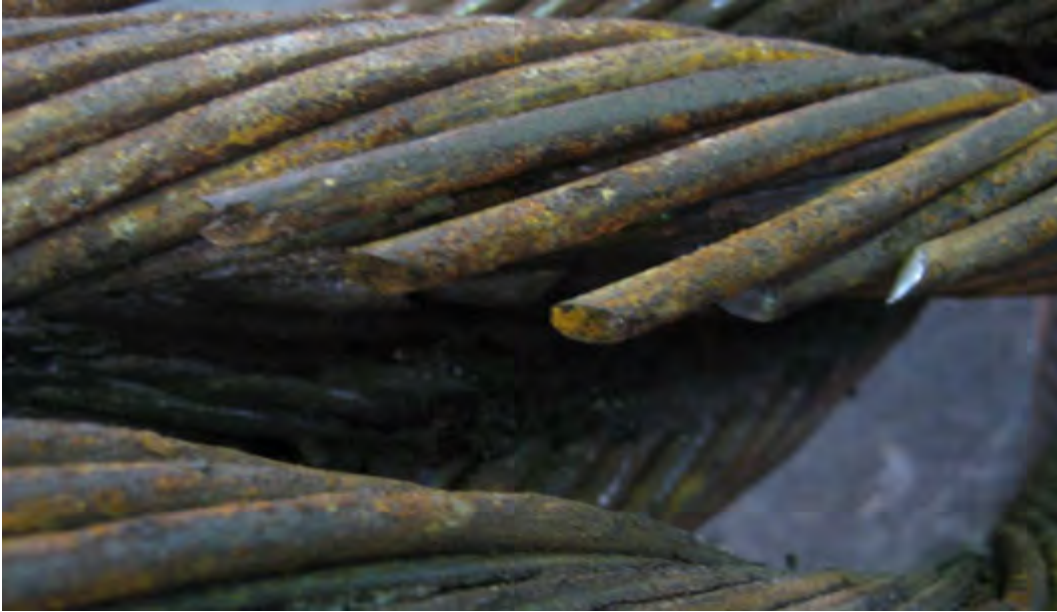
Figure 9.12 shows a group of shear wire breaks on one of the outer strands after testing. This view is interesting as it shows clearly that there were three existing wire breaks in the sample (corroded fracture surfaces), and two wires which were broken in the breaking load test (fresh ends).

**Figure 9.12:** Bridle sample after testing, detailed view on wire failures (old - rusty ends, new - shiny).

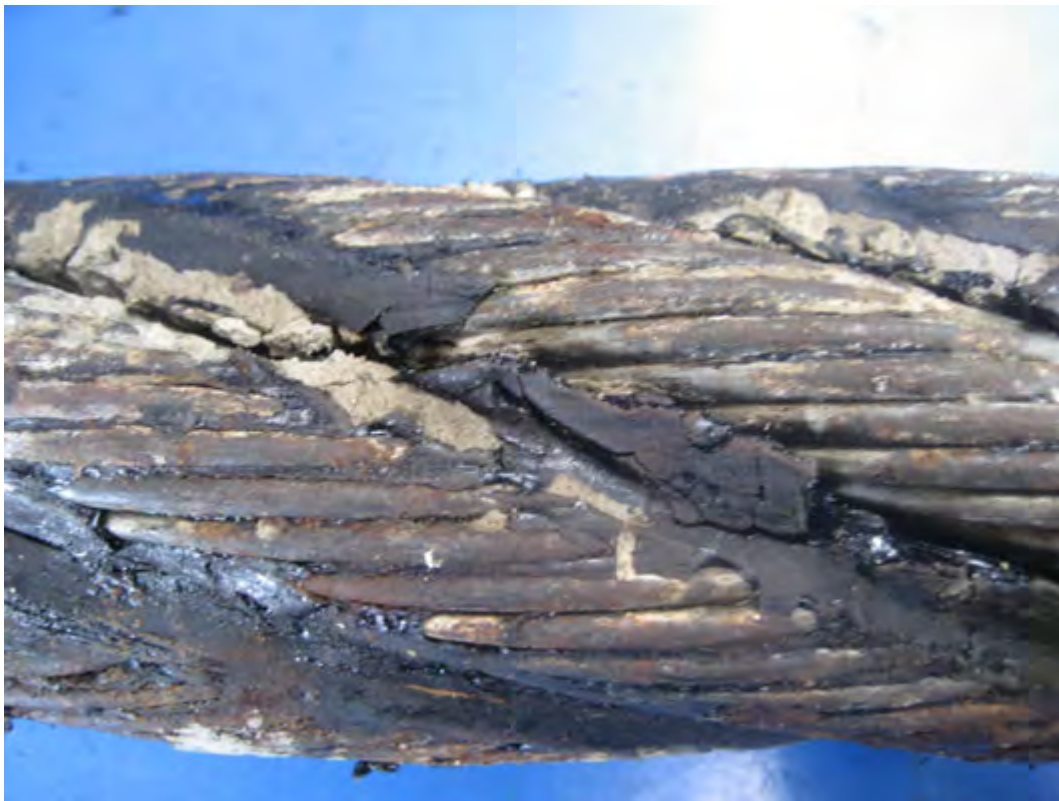
**Figure 10.2:** Detailed view on the drum sample showing an area of corrosion. Note also the 'mud deposits' and the good level of lubricant in the valleys.

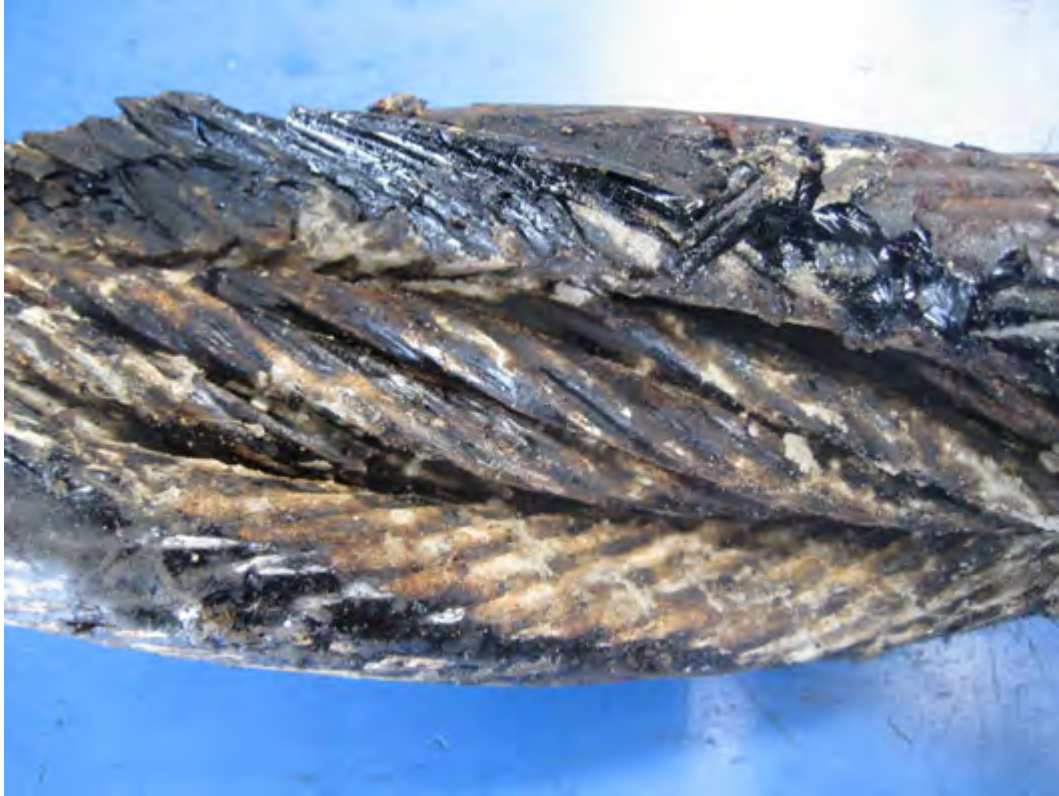
Figure 10.3 shows the sample with two outer strands removed to reveal the IWRC. It may be seen that the lubricant level on the IWRC is very low, and what lubricant there is, is dry.

**Figure 10.3:** Drum sample with two outer strands removed to show the condition of the IWRC - the lubricant level is very low. Note also the light corrosion on the outer strand (top right) and the glassy bitumous lubricant in the valley positions (of the outer strands).

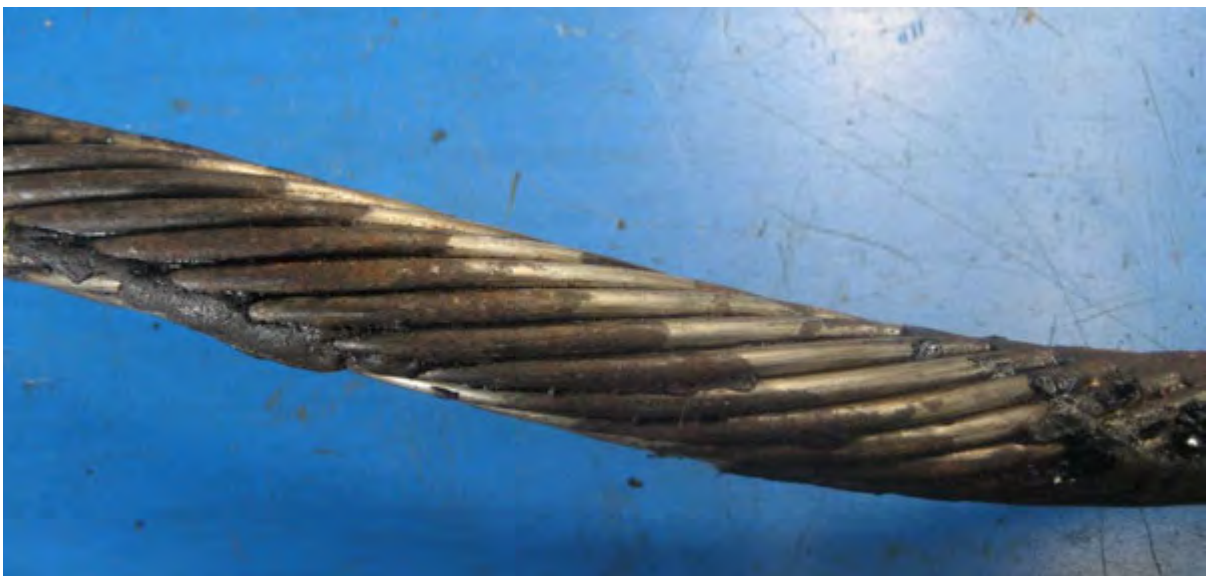
Figure 10.4 shows an outer strand after removal from the wire rope sample and partially cleaned. Sections of lubricant have been left in place to highlight the difference in residual galvanising levels between the section of strand normally on the outside of the wire rope, and that facing towards the IWRC.

**Figure 10.4:** Drum sample outer strand partially cleaned to show the difference in residual galvanising levels for sections on the inside and outside of the wire rope.

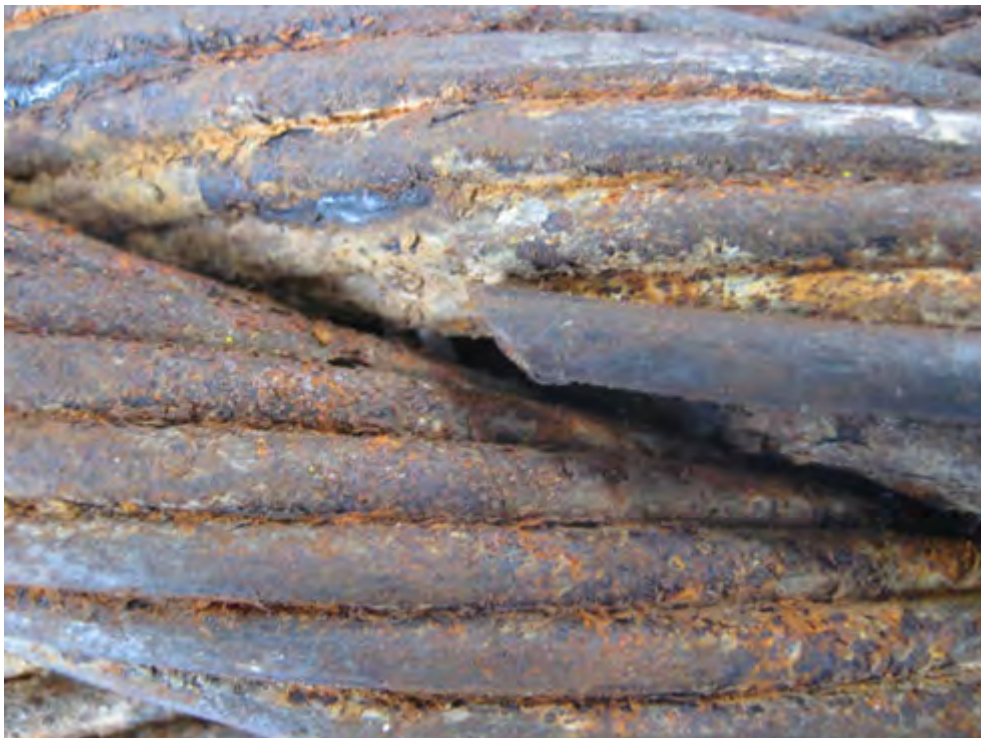
**Figure 10.16:** Detailed view on single wire break noted in valley position on tug side sample.

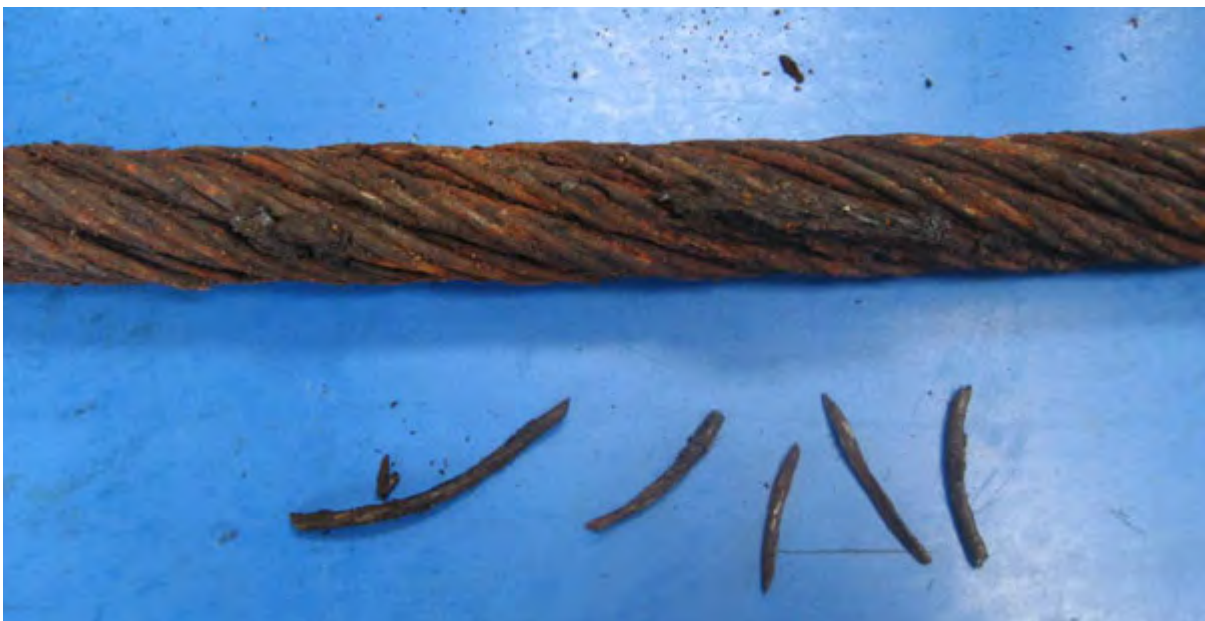
**Figure 10.18:** Tug side sample, general condition of IWRC. Five wires dropped out of the construction as the outer strands were removed. Some areas of good level, good nature lubricant, but on the whole the lubricant level was low and dry.

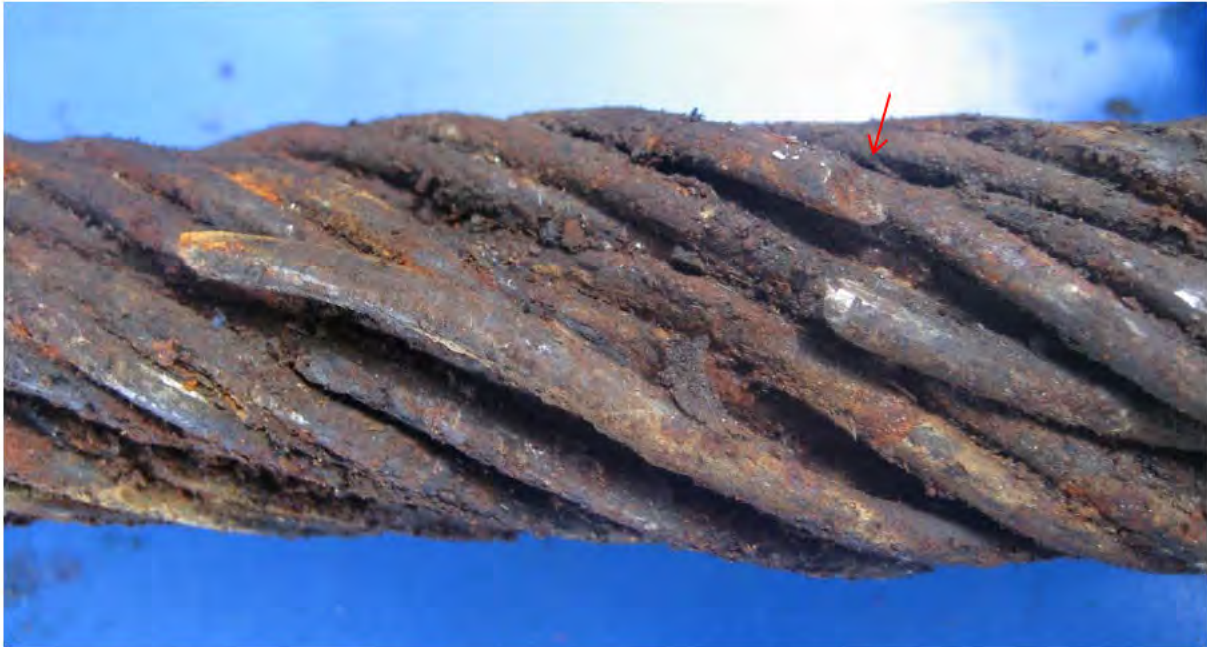
**Figure 10.19:** Wire breaks found in tug side sample IWRC outer strands (existing wire break arrowed).

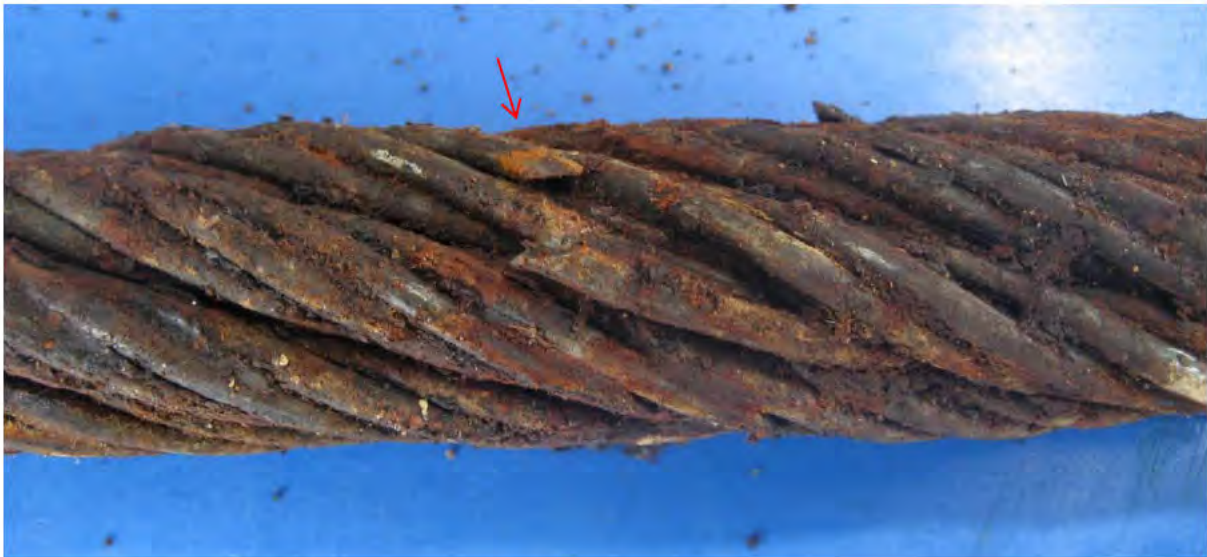
**Figure 10.20:** Wire breaks found in tug side sample IWRC outer strands (recent wire break arrowed).

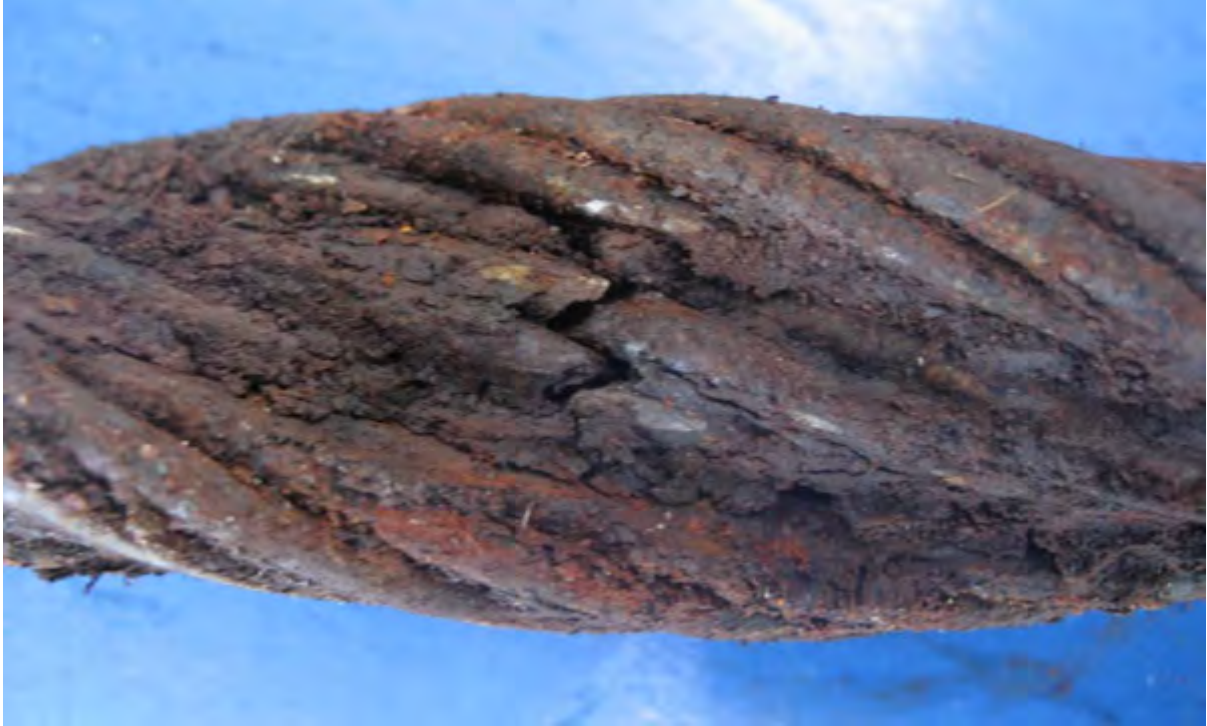
**Figure 10.21:** Tug side sample, IWRC with two strands removed to show core. Core strand broken through. Good level of lubricant.

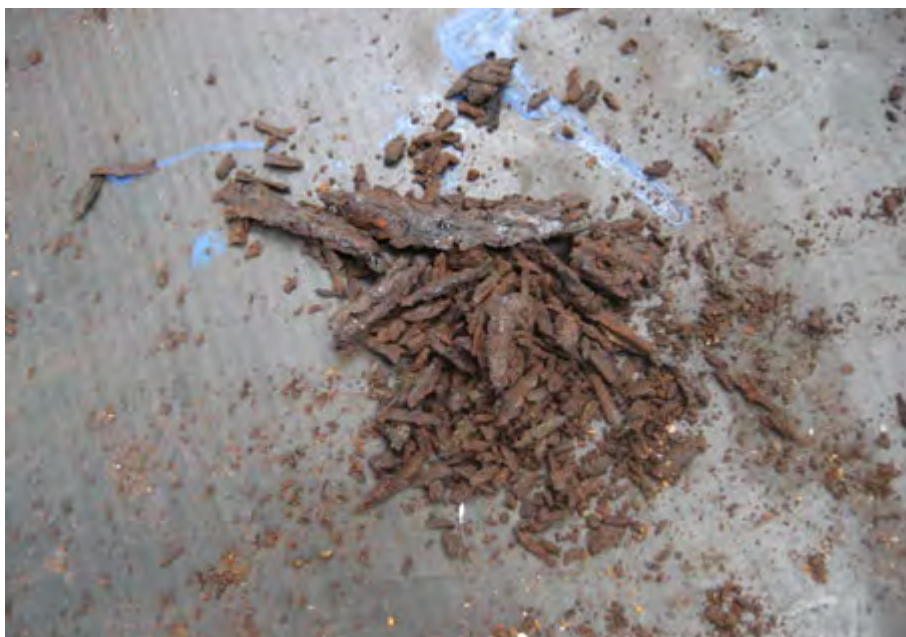
**Figure 10.22:** Tug side sample, dry lubricant which dropped out of the wire rope.

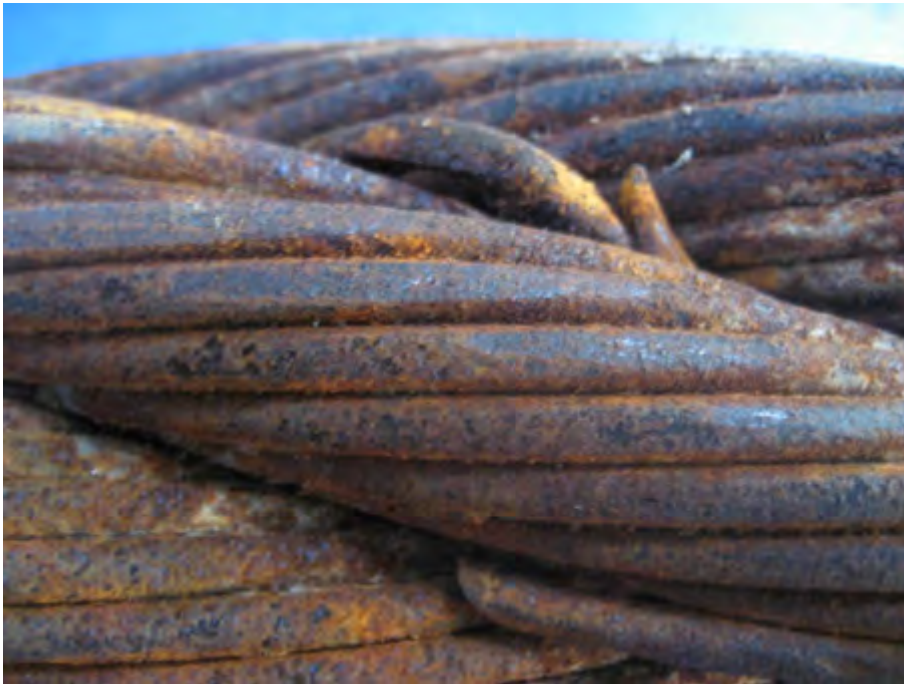
**Figure 10.31:** Detailed view on bridle sample - note no visible galvanising and a uniform covering of corrosion causing roughening of the surface of the wires.

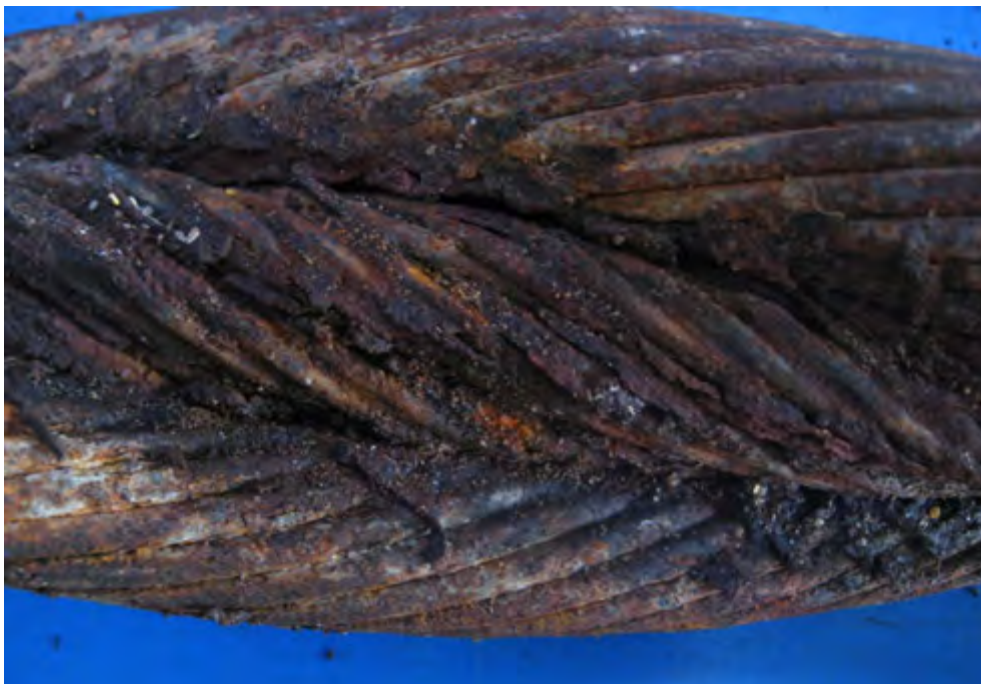
**Figure 10.33:** Bridle sample with two outer strands removed - area of low lubrication on IWRC.
