## Inspection and testing of failed tow wire rope from tug *ALP Forward*

### FINAL REPORT

TTI Reference number TTI-IMLR-2016-5284

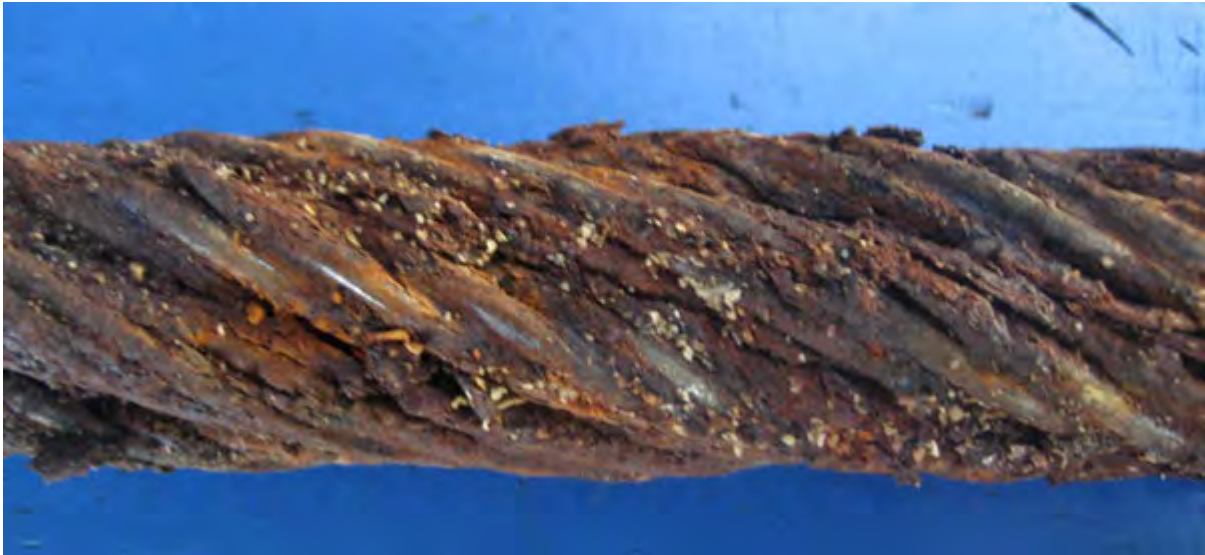
**Figure 10.34:** Bridle sample IWRC. Note the lubricant level is reasonable if a little dry and denatured, also the grains of sand.

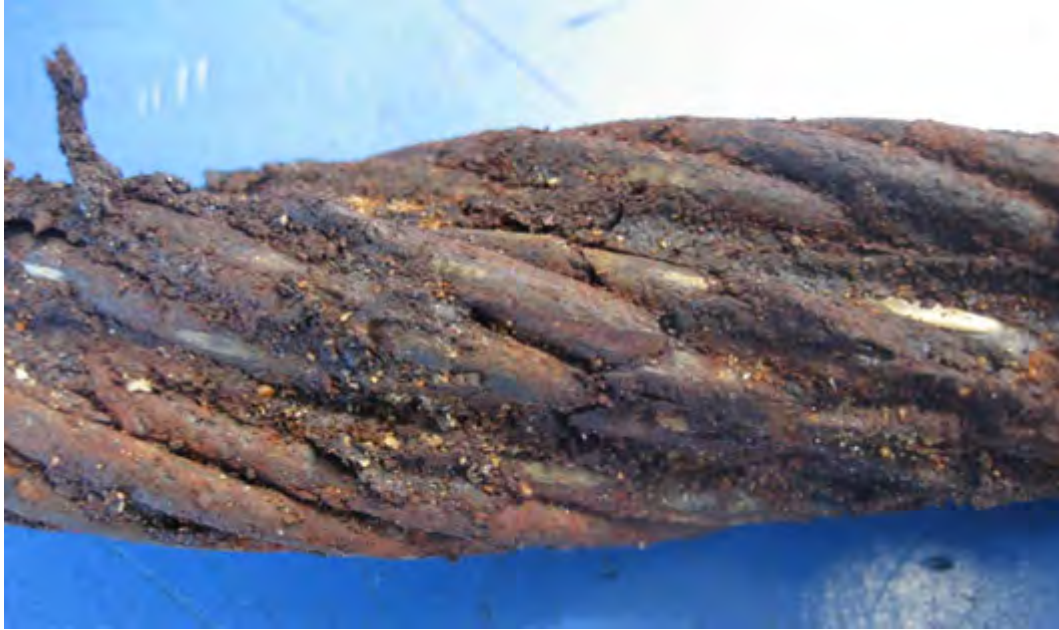
**Figure 10.35:** Bridle sample IWRC with three outer strands removed to show the core (all core strand wires broken).

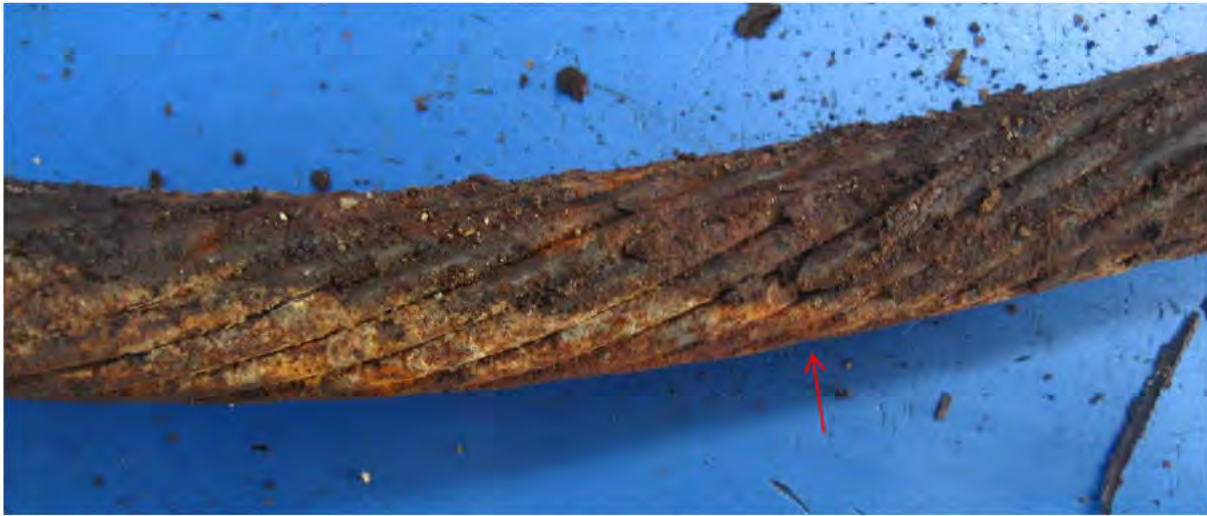
**Figure 10.41:** Bridle sample main strand as removed from the sample. The upper (darker coloured section) would have been towards the inside (IWRC), whilst the lighter section was on the outside of the wire rope. The intersection of these two areas is the valley position between the strands. Note the wire break at this interface (arrowed).

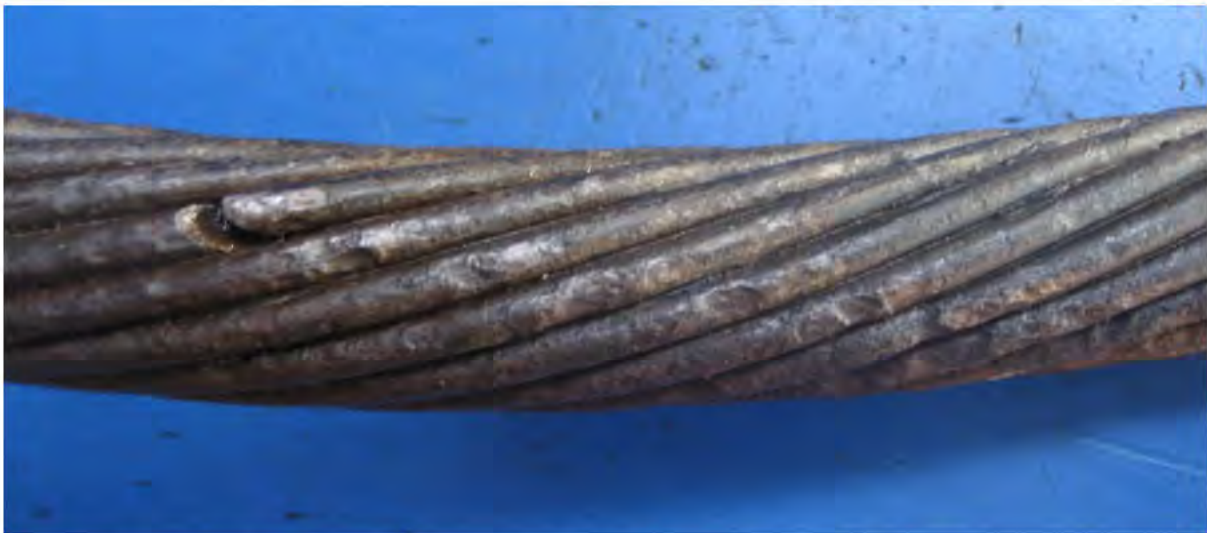
**Figure 10.42:** Bridle sample main strand after cleaning. Note the series of elliptical wear patches along the valley position from which wire breaks have/will initiate.

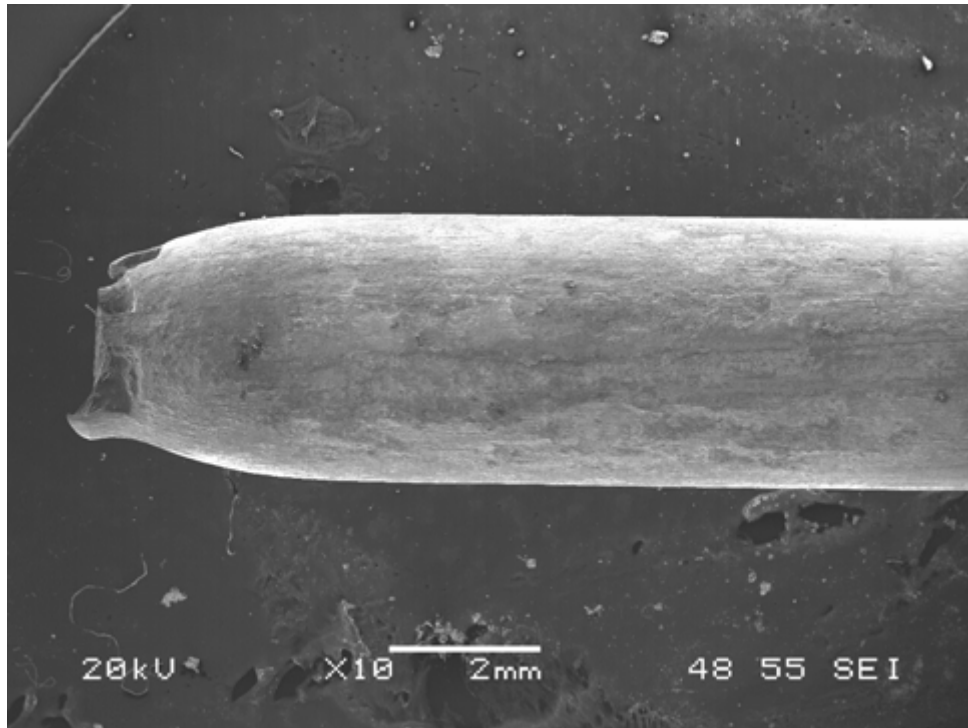
**Figure 11.4:** SEM image of tensile (cup and cone) failure of Wire 6 (outer strand second layer large wire).

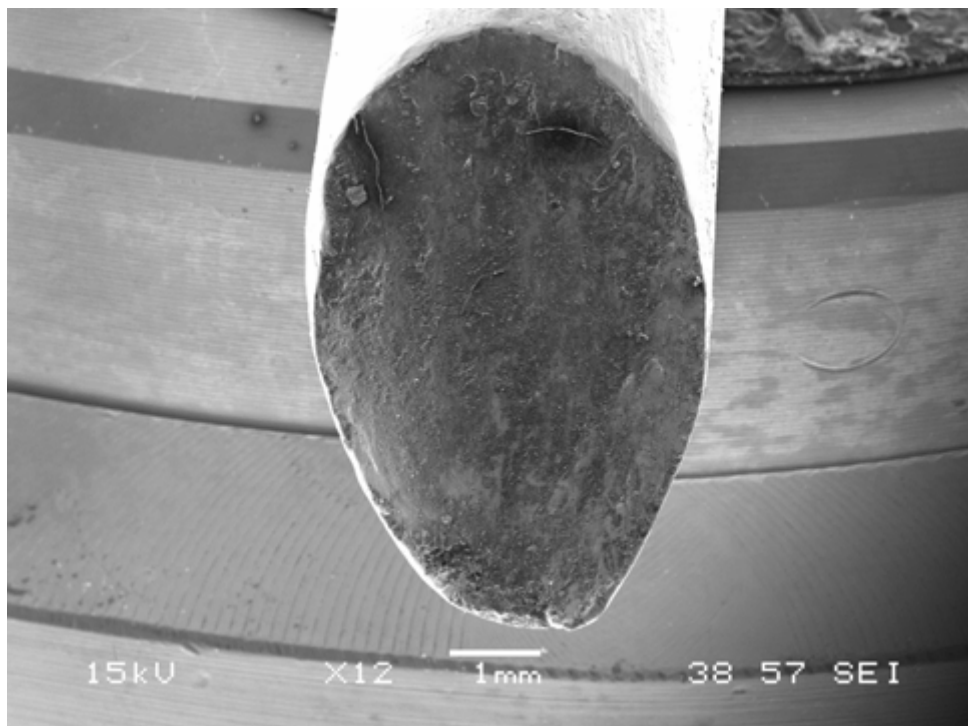
**Figure 11.5:** SEM image of shear failure of Wire 4 (outer strand outer wire).
