## ACCIDENT

<b>Aircraft Type and Registration:</b>	Hawker Sea Fury T Mk 20, G-RNHF	
<b>No &amp; Type of Engines:</b>	1 Bristol Centaurus XVIII piston engine	
<b>Year of Manufacture:</b>	1949 (Serial no: ES3615)	
<b>Date &amp; Time (UTC):</b>	31 July 2014 at 1601 hrs	
<b>Location:</b>	RNAS Culdrose, Cornwall	
<b>Type of Flight:</b>	Private	
<b>Persons on Board:</b>	Crew - 1	Passengers - None
<b>Injuries:</b>	Crew - None	Passengers - N/A
<b>Nature of Damage:</b>	Engine internal disruption, right wingtip, flap and minor fuselage abrasion damage	
<b>Commander's Licence:</b>	Military	
<b>Commander's Age:</b>	44 years	
<b>Commander's Flying Experience:</b>	3,545 hours (of which 232 were on type) Last 90 days - 54 hours Last 28 days - 35 hours	
<b>Information Source:</b>	AAIB Field Investigation

## ACCIDENT REPORT ADDENDUM

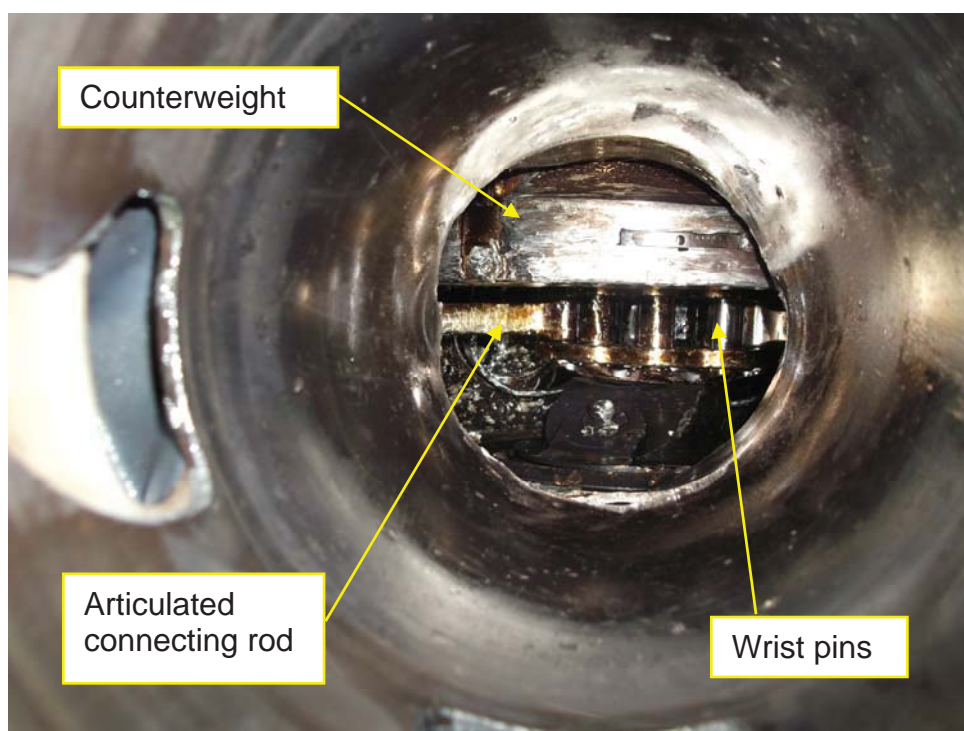
**Figure 2**

After the accident, the aircraft was recovered to a hangar at RNAS Culdrose and the damage assessed. The damage to the fuselage, wing and flaps was minor and attributable to the aircraft veering from the runway and sliding along the grass. The propeller blade damage was consistent with striking the ground at low power. The evidence suggested that a major but contained component failure had occurred within the engine, although there were no outward signs of distress. There were approximately 10 gallons of lubricating oil removed from the tank and oil and filter debris samples were sent for analysis. The engine was removed and transferred to the aircraft maintenance facility at North Weald. After a boroscope examination the cylinder heads were removed, which revealed that the No16 (front-row) piston and articulated connecting rod ('con-rod') were missing. Figure 2 shows the distressed wrist pins through the No16 cylinder. There was also substantial mechanical damage to the other visible con-rods, of which some were detached from the

master con-rod.

Master con-rod wrist pins viewed through the No16 cylinder

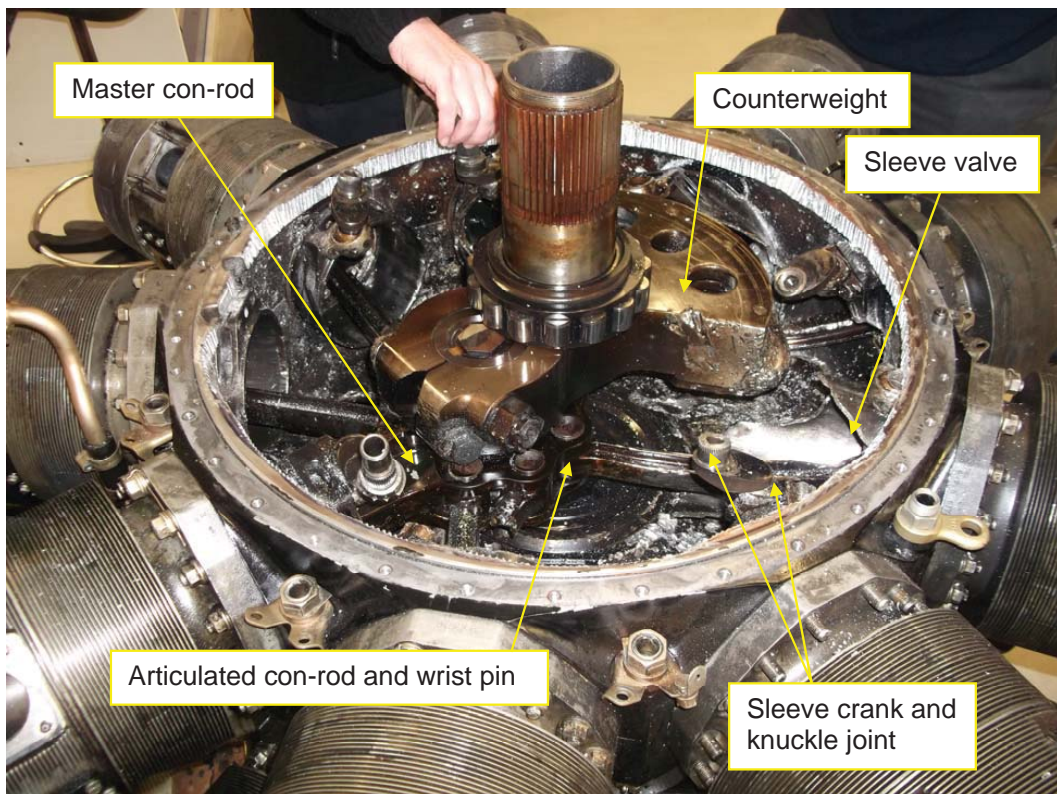
**Figure 3**

Further conventional disassembly was not possible due to distortion of the cylinders and sleeve valves. In order to gain access to the front row crankcase the gear carrier plate was chain drilled and removed. Figure 3 shows the crankcase component damage and debris.

Front row crankcase component damage

The majority of the components within the crankcase were severely damaged. All the sleeve driveshafts showed signs of torsional overload and some of the driveshafts had failed. The majority of the knuckle joints, which attach the drive crank to the sleeve, were damaged and in some cases had detached. Several of the sleeves had been severely damaged, in particular where they had extended out of their respective cylinders into the path of the crankshaft counterweight. Multiple impact marks were also present as a result of increasing amounts of churned-up debris. The front row sleeve valve gear trains were generally intact and meshed, except for one of the valve crank drive and idler gears which had damage indicative of gear tooth overload.

Closer examination of the debris removed from the crankcase identified forged steel con-rod and aluminium piston material. The remains of No16 piston were found loose and had the appearance of a pulverised and flattened sphere. The con-rod material, particularly from the wrist pin ends, showed signs of extreme heating and appeared to have been splattered with molten copper. Examination of the wrist pins and their associated holes in the master con-rod showed similar evidence and one of the broken con-rod wrist pin ends exhibited the characteristics of plastic deformation leading to failure. Lubricating oil was present throughout the crankcase but showed evidence of overheating and had lacquered various surfaces. It was also observed that the gear carrier diaphragm outer surface was discoloured with hot oil lacquering. Normally this surface would be a bright silver grey.
