Report on the investigation of the loss of control and
grounding of ro-ro passenger ferry

Hebrides

Lochmaddy, North Uist

25 September 2016

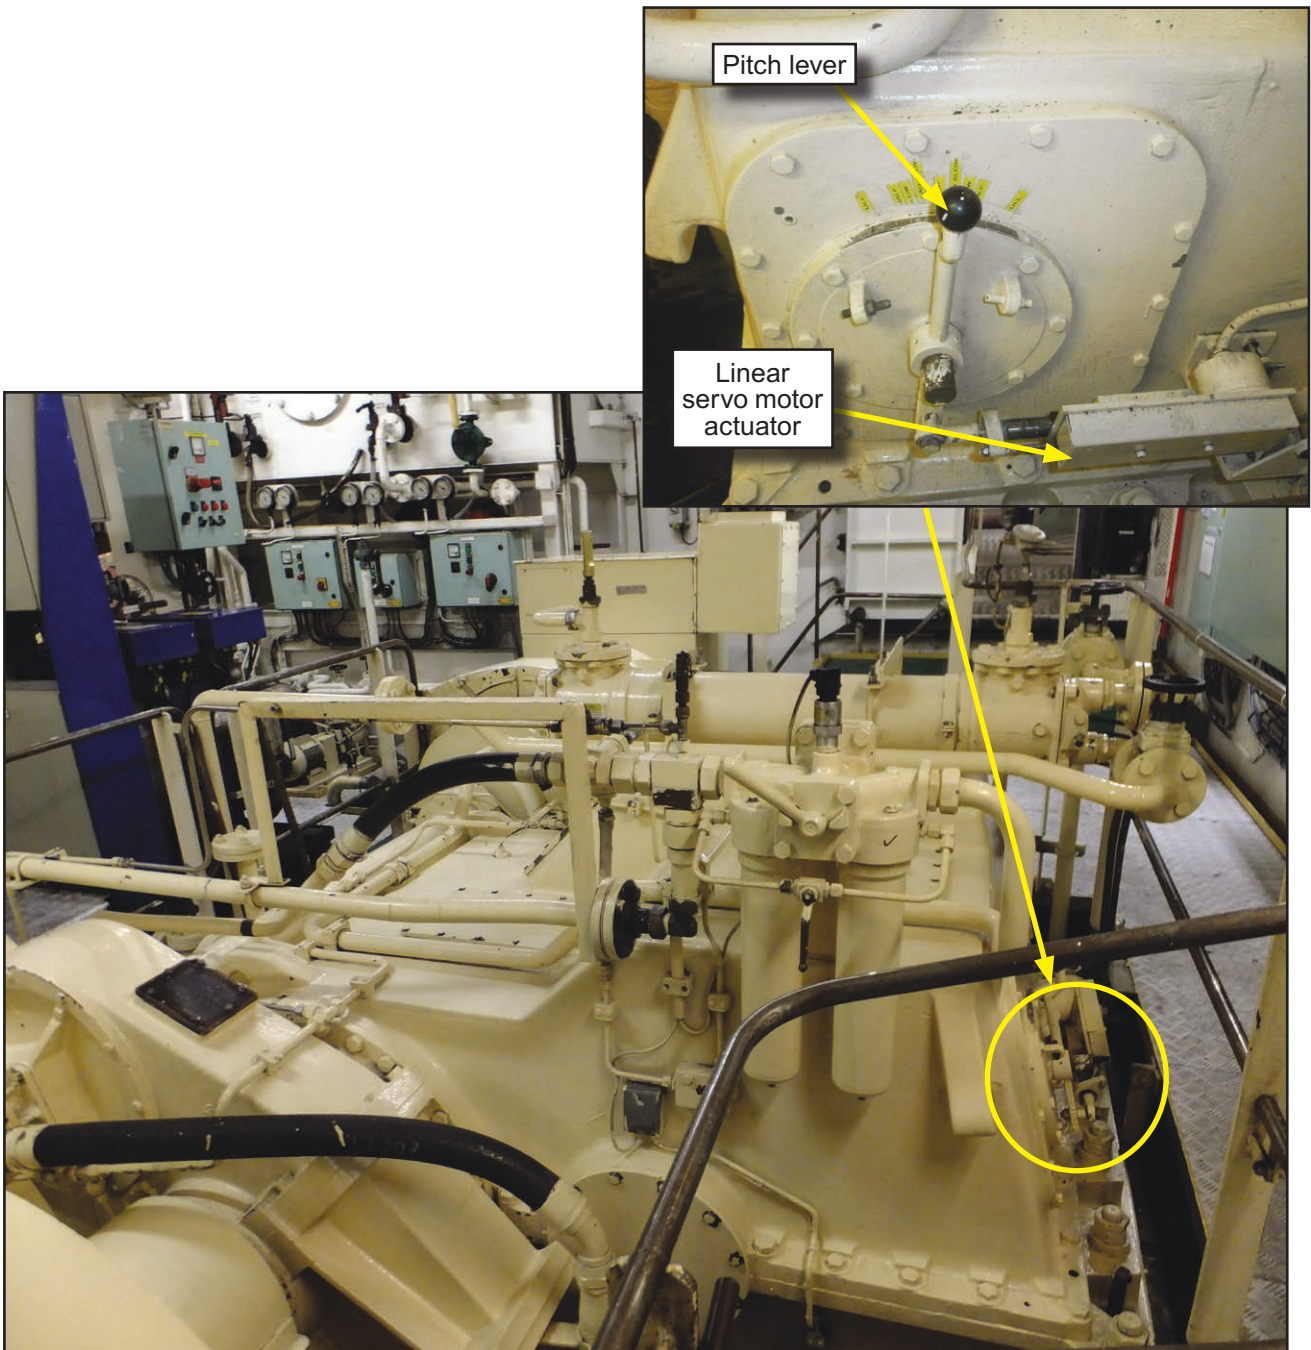
Figure 6: Port gearbox

While *Hebrides* was alongside in Lochmaddy, the ferry's engineers inspected a linear servomotor actuator sited on the port gearbox (**Figure 6**). The servomotor converted electrical signals from the control consoles into mechanical motion, which ultimately adjusted the pitch of the propeller blades. The conversion was achieved by an electric stepper motor rotating a shaft that moved a linkage rod via a ball screw mechanism. When

It is evident from the inspection carried out by *Hebrides's* engineers shortly after the accident, that control of the ferry's port CPP was lost due to a mechanical failure within the linear servomotor actuator sited on the port gearbox (**Figure 6**). The setscrew used to secure one half of the jaw coupling to the stepper motor 'D' shaped shaft had backed off from the shaft's flat surface (**Figures 12 and 14**). Consequently, although the stepper motor shaft rotated inside the jaw coupling in response to the electrical signals from the remote propulsion consoles, the coupling remained stationary and the shaft's rotary motion was not transferred to the ball screw mechanism. Therefore, the pitch set on the port CPP was unaltered.

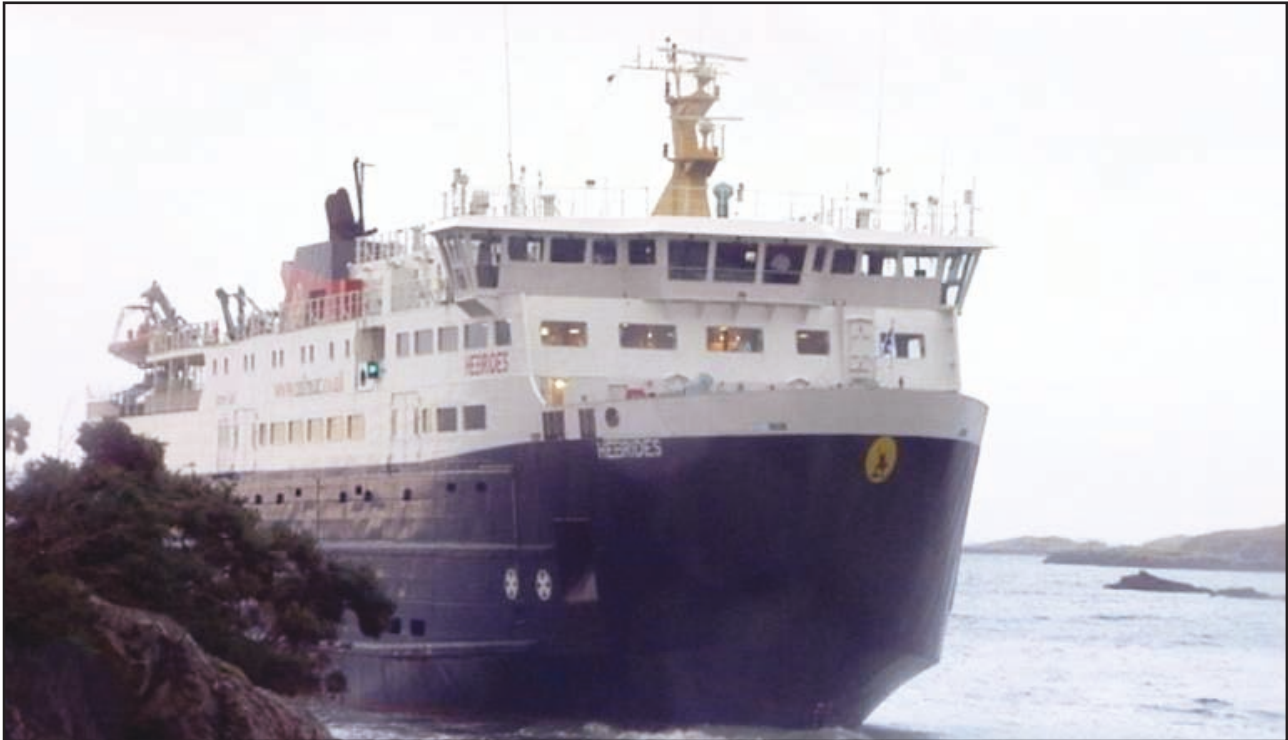
Hebrides's speed was now 5kts and the ferry's bow was swinging to port. As it did so, it ran over the outer mooring pontoons, causing some of the pontoons to overturn. Seconds later, at 1034, the ferry gently grounded and stopped in the water (**Figures 5 and 7**).

Figure 7: *Hebrides* aground

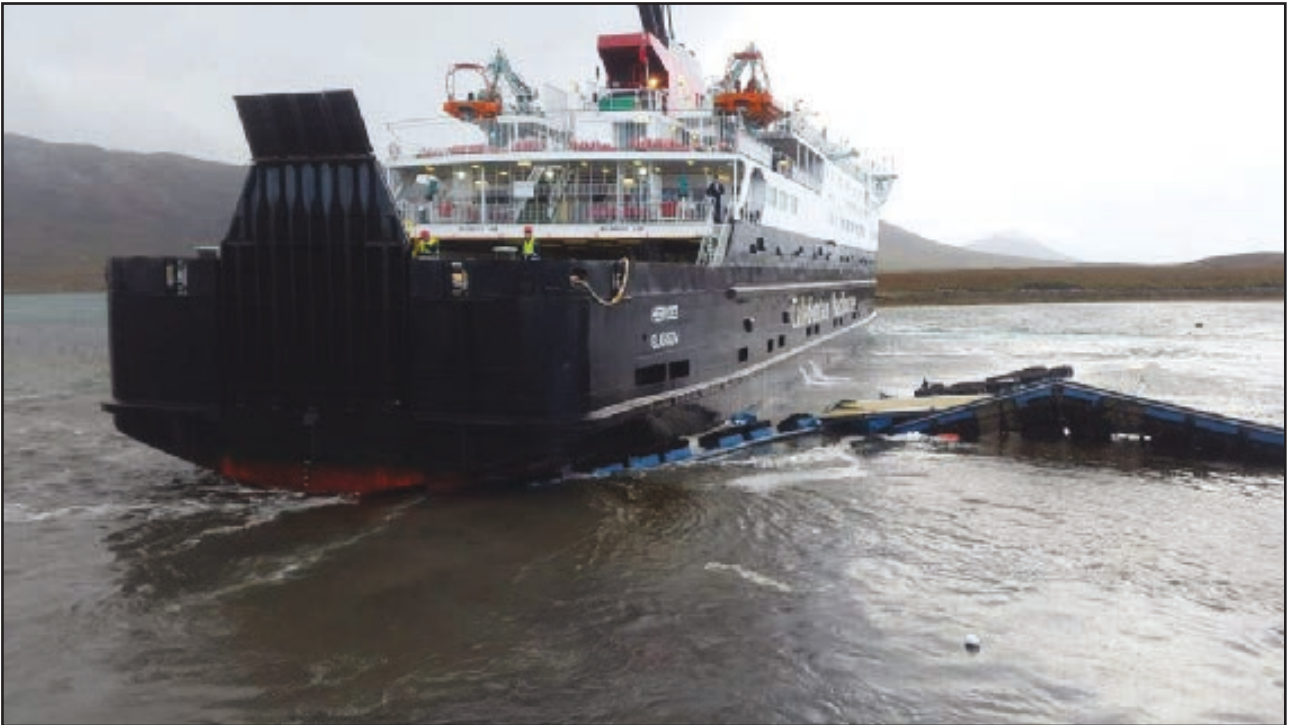
As *Hebrides* moved ahead at a speed of 3kts, the rubbing strake on the ferry's port side made heavy contact with the pier's fendering. The master then manoeuvred *Hebrides* into safe water to the east, where the chief officer and the ship's carpenter sounded the ferry's void spaces and tanks. No water ingress was identified. An announcement was made on the public address system to advise the passengers of

Figure 8: *Hebrides* backing over mooring pontoons

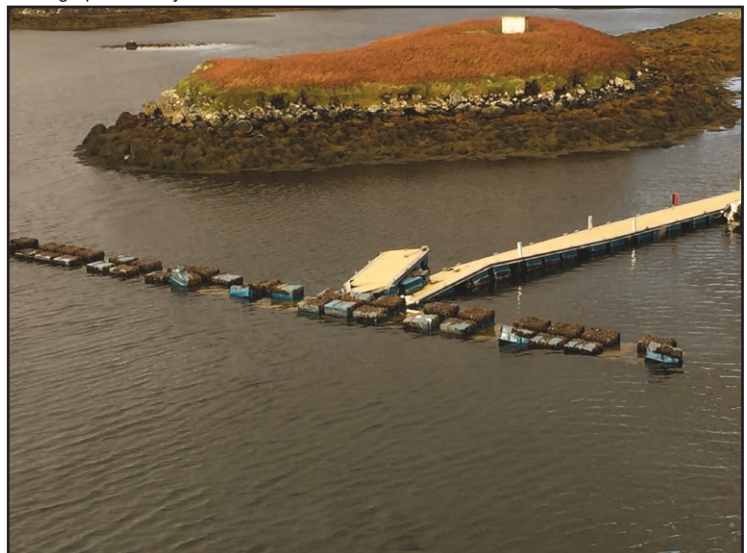
Several mooring pontoons in Lochmaddy were upturned and damaged (**Figure 9**). The hull plating along *Hebrides*'s starboard side above the flat bottom was indented and the ferry's starboard bilge keel was distorted (**Figure 10**). A length of mooring chain was also found wrapped around the starboard propeller shaft, which had damaged the outer stern tube seal and propeller (**Figure 11**).

Figure 9: Upturned pontoons

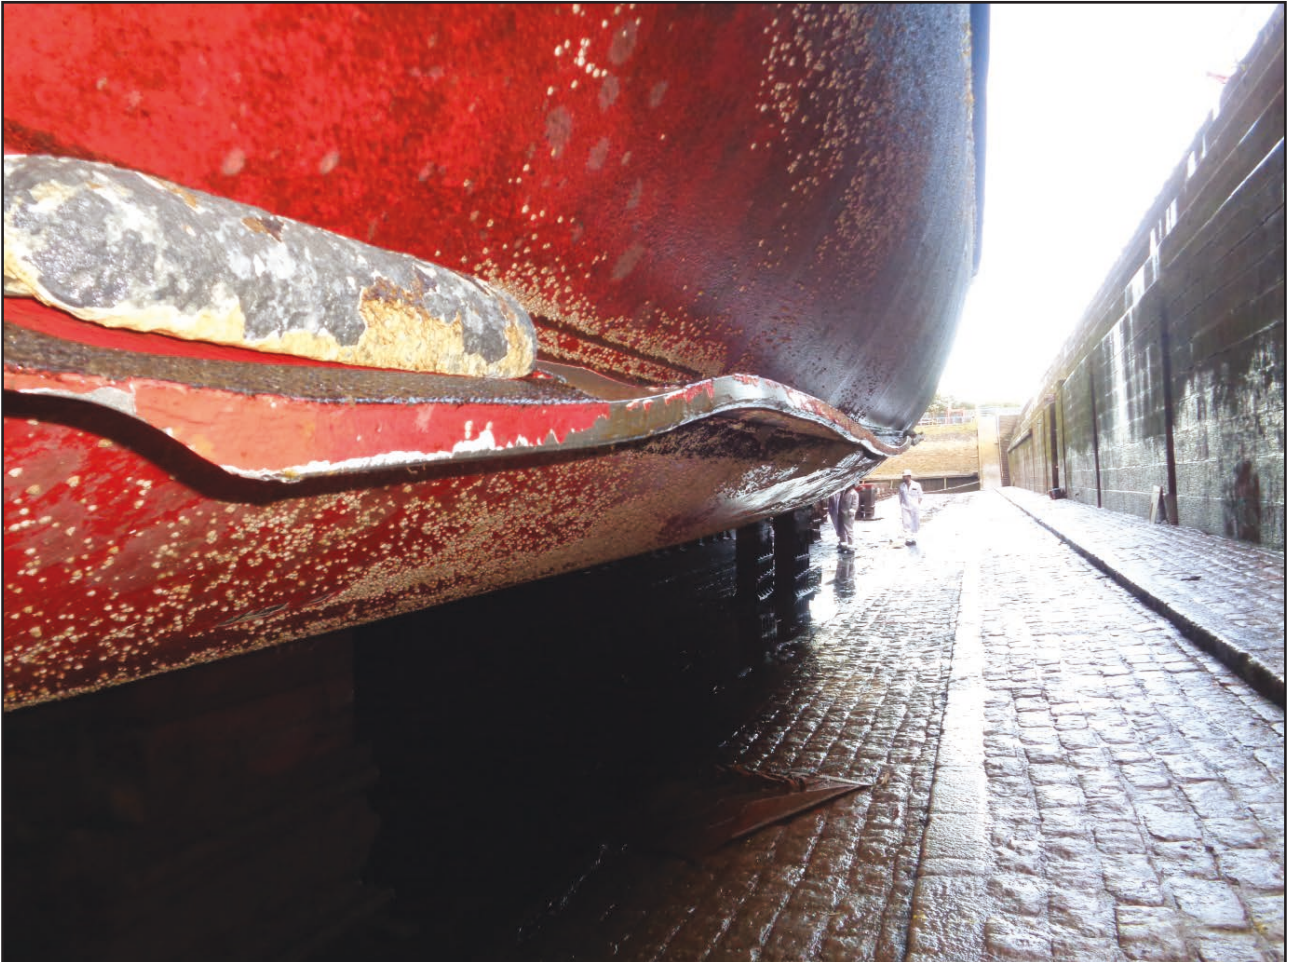
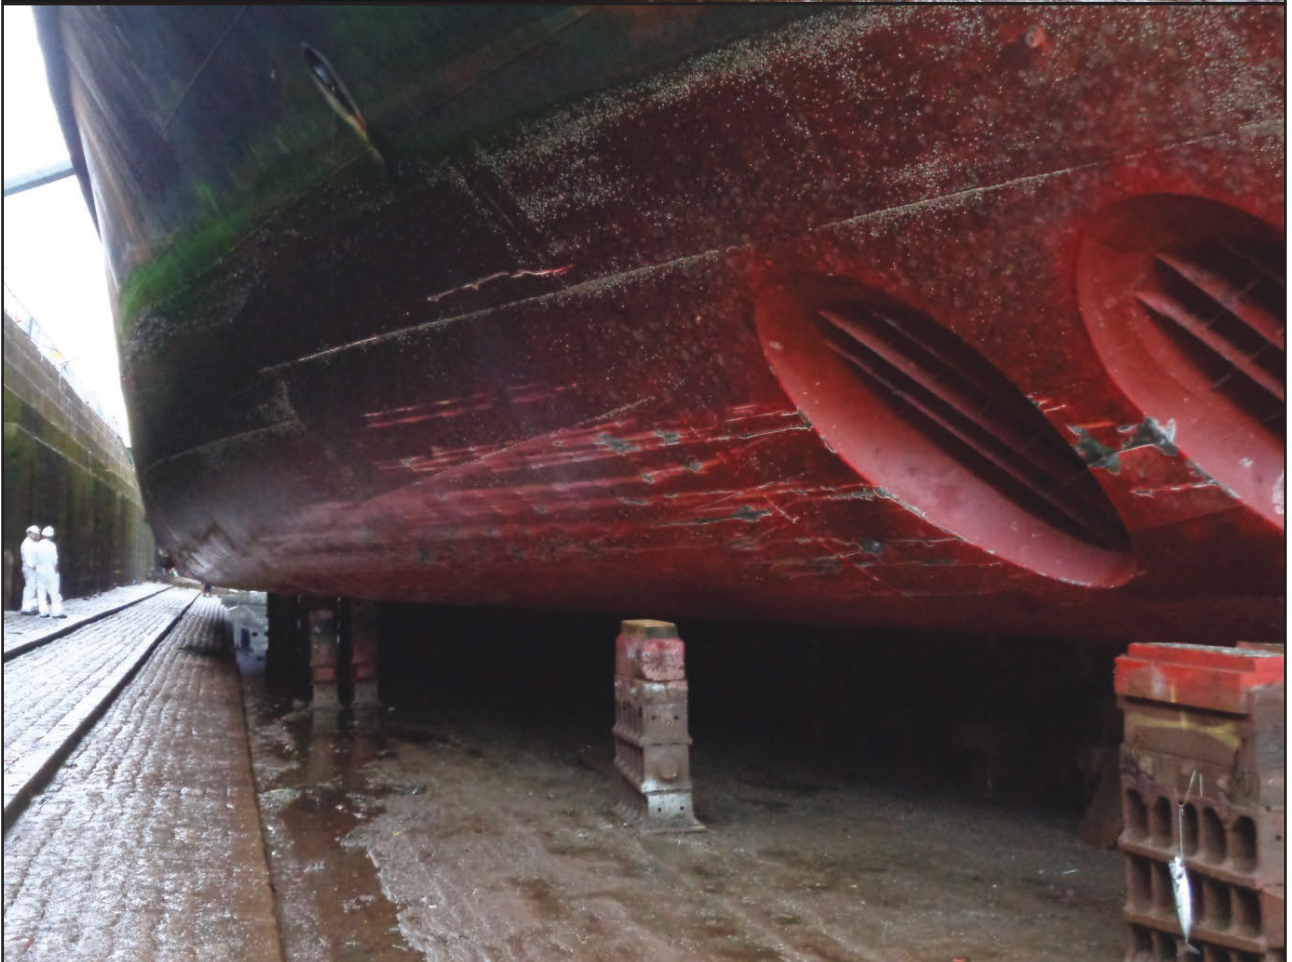
Figure 10: Damage to starboard bilge keel and hull bottom

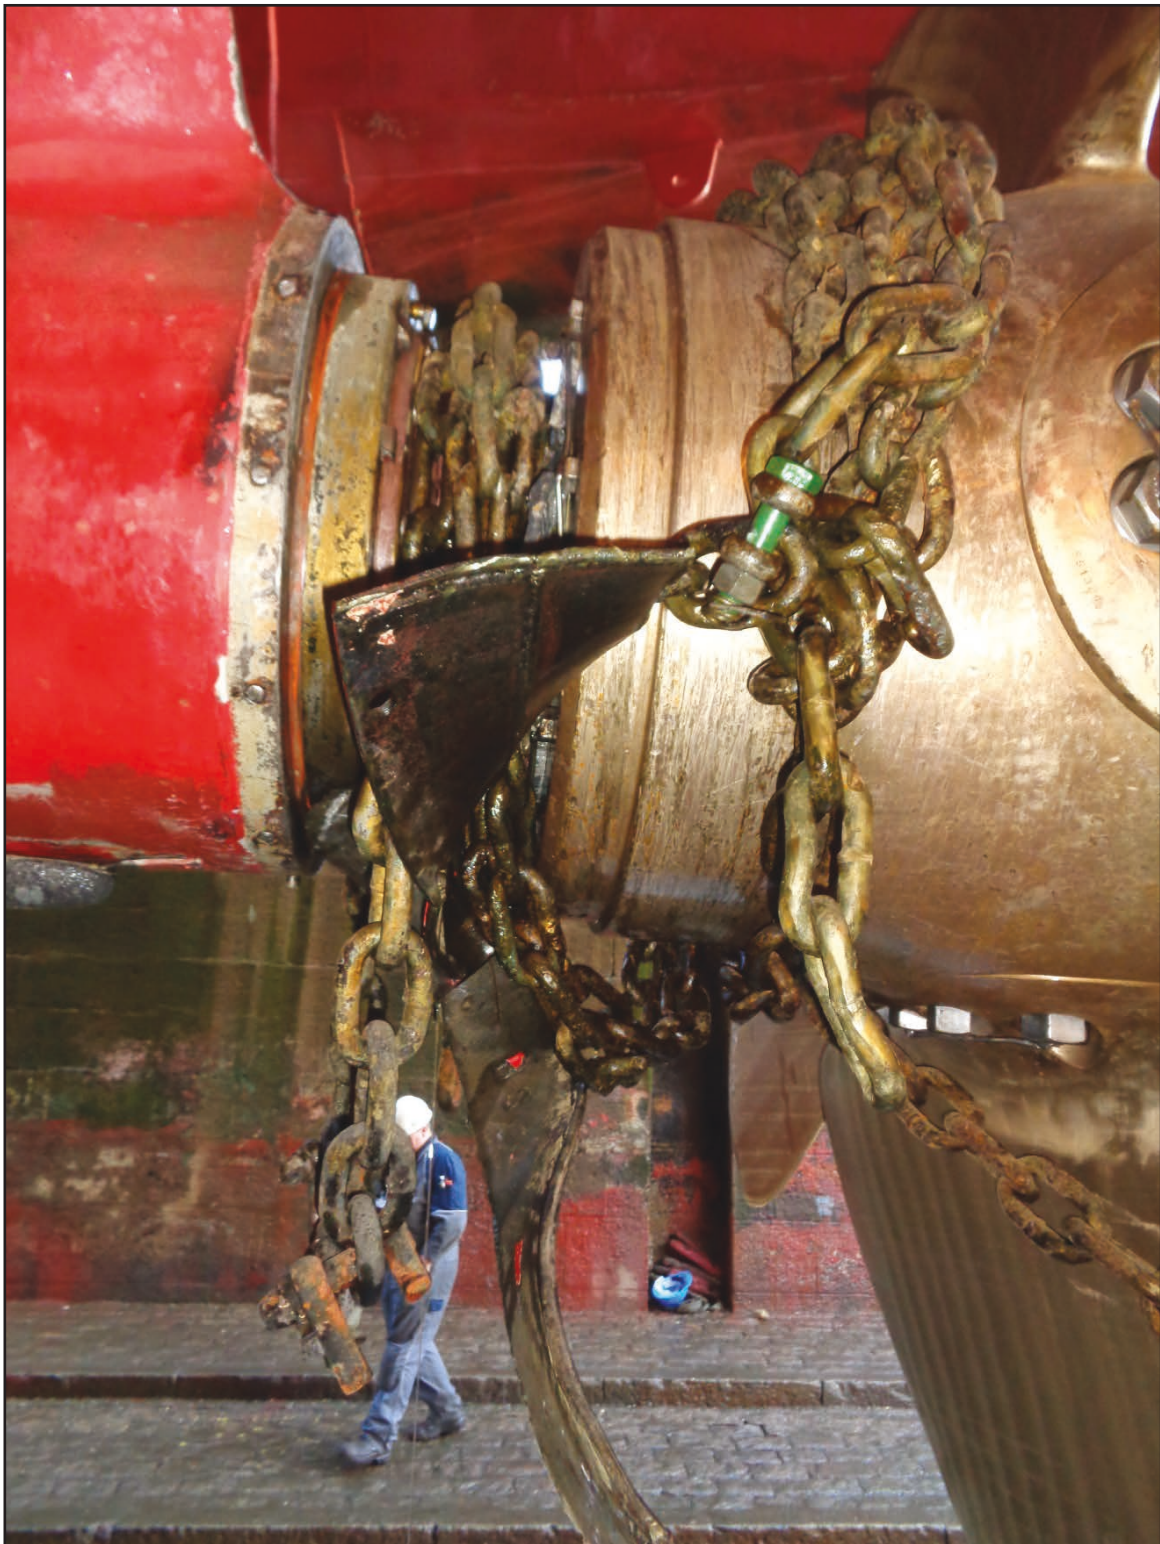
Figure 11: Mooring chain around starboard propeller

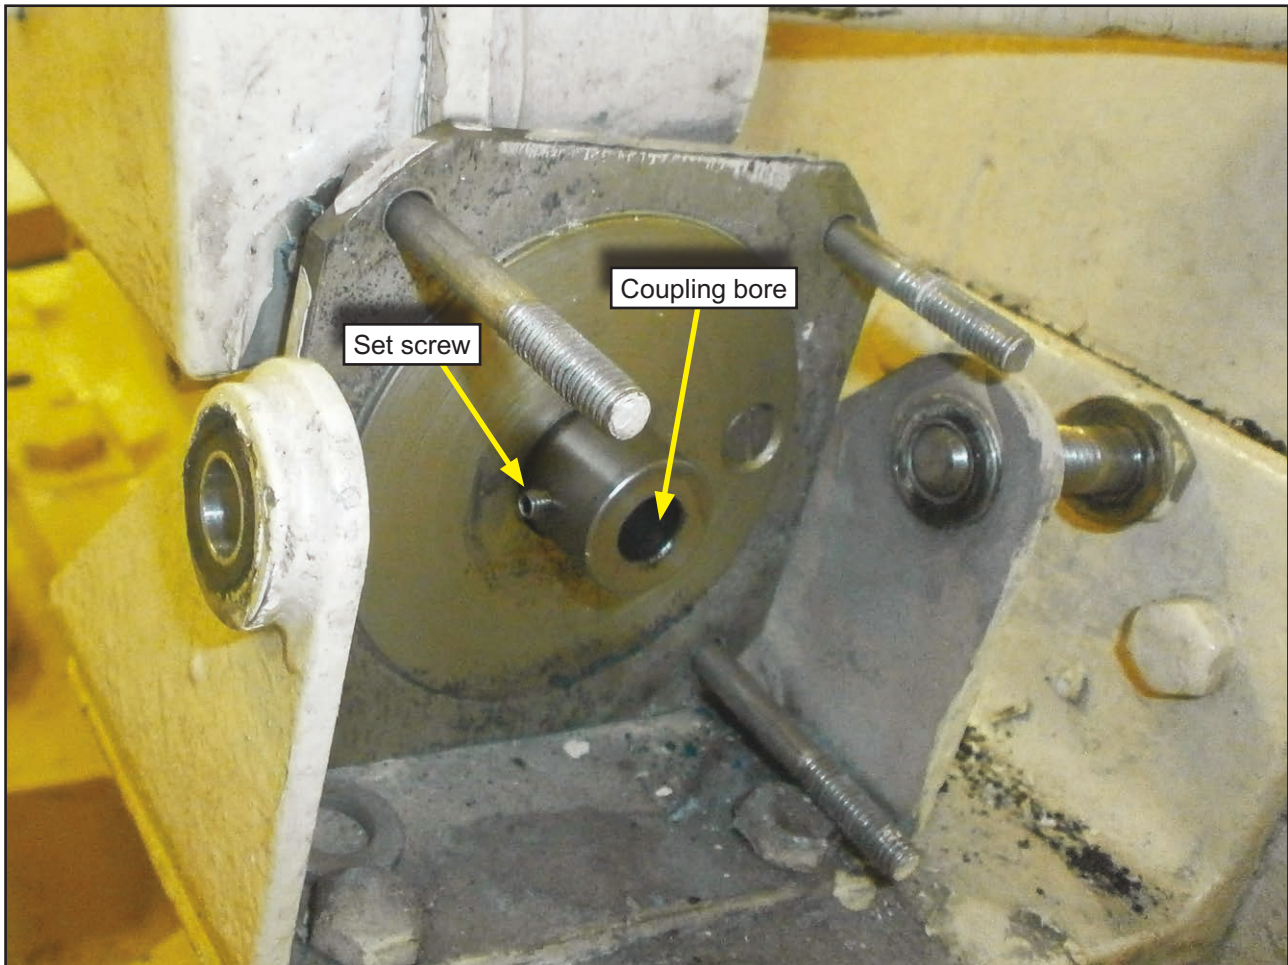
the engineers released the stepper motor from the servomotor assembly, it was apparent that a jaw coupling on the motor's shaft had loosened. The setscrew securing the coupling to the flat surface on the stepper motor's 'D' shaped shaft had backed off to the extent that the stepper motor shaft could be withdrawn without disturbing the coupling (**Figure 12**). See paragraph 1.7 for a description and detail of the actuator.

Figure 12: Position of jaw coupling setscrew (as found)

The RR technical analysis of the actuator (**Annex A**) and **Figures 12, 13 and 14** show that the 'cone' point of the setscrew had deformed under load and that the point had not penetrated the flat surface of the stepper motor shaft. However, the use of a 'cone' point setscrew in this type of application was not unusual, and the degree to which these factors contributed to the failure was marginal. 'Cone' point setscrews are generally suited to permanent fittings whereas 'cup' pointed setscrews are suited for use in conjunction with metals of differing hardness. Both types of setscrew were likely to have loosened and backed off if not used in conjunction with thread locking compound.

Hebrides's engineers, assisted by a service engineer from Rolls-Royce Marine (RR Marine), the original equipment manufacturer (OEM) for the propulsion control system, effected a temporary repair to make the actuator usable. The repair included using thread locking compound to secure the setscrew in place.

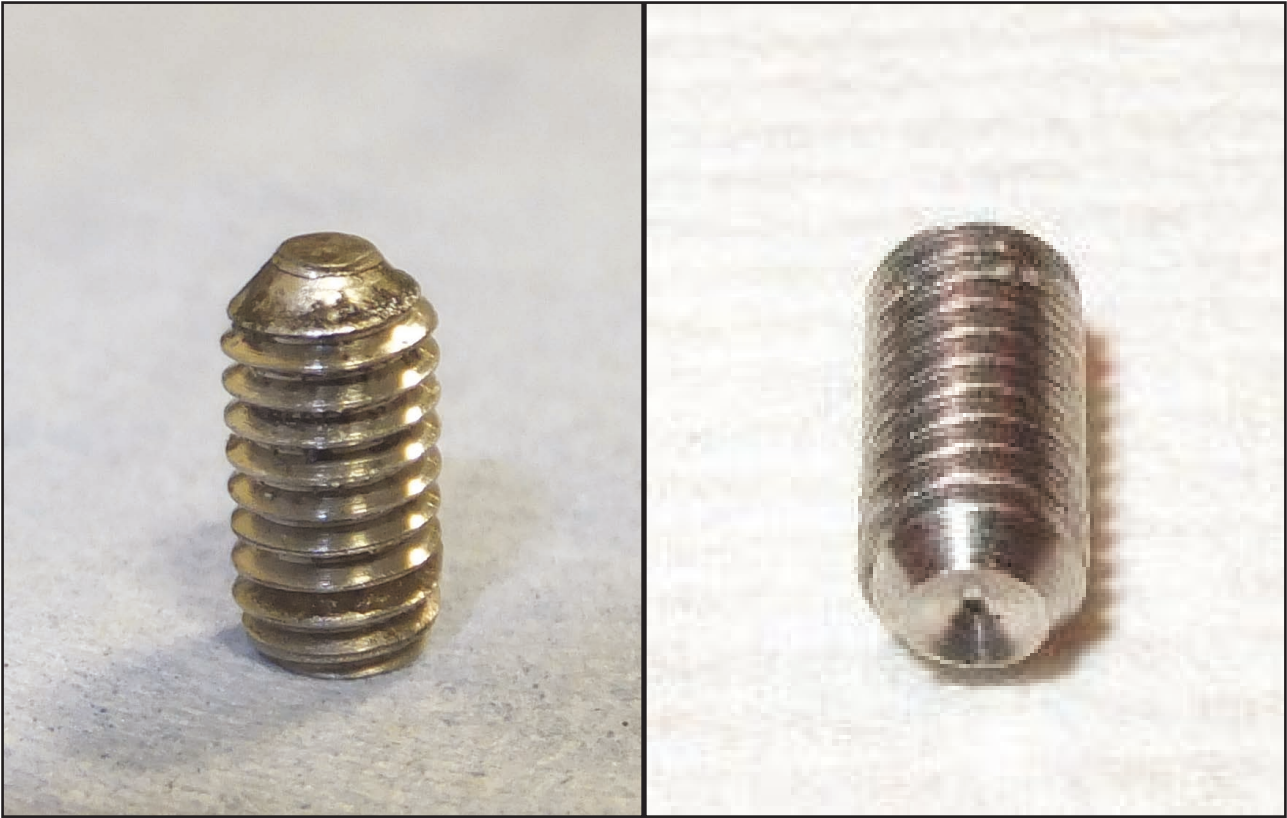
In January 2017, RR Marine passed the linear servomotor actuator that had been removed from *Hebrides* to its air safety investigation workshop for analysis. The analysis (**Annex A**) identified that the 'cone' point of the setscrew had not penetrated the stepper motor's shaft and had deformed under load (**Figure 13**). It also identified that the setscrew did not have any practical rundown torque⁴. The markings on the shaft indicated that the shaft had moved within the coupling prior to complete failure (**Figure 14**) and that a cup-pointed setscrew, not a cone-pointed setscrew, had originally been used in the assembly.

Figure 13: Deformed 'cone' pointed set screw and a 'cup' pointed setscrew

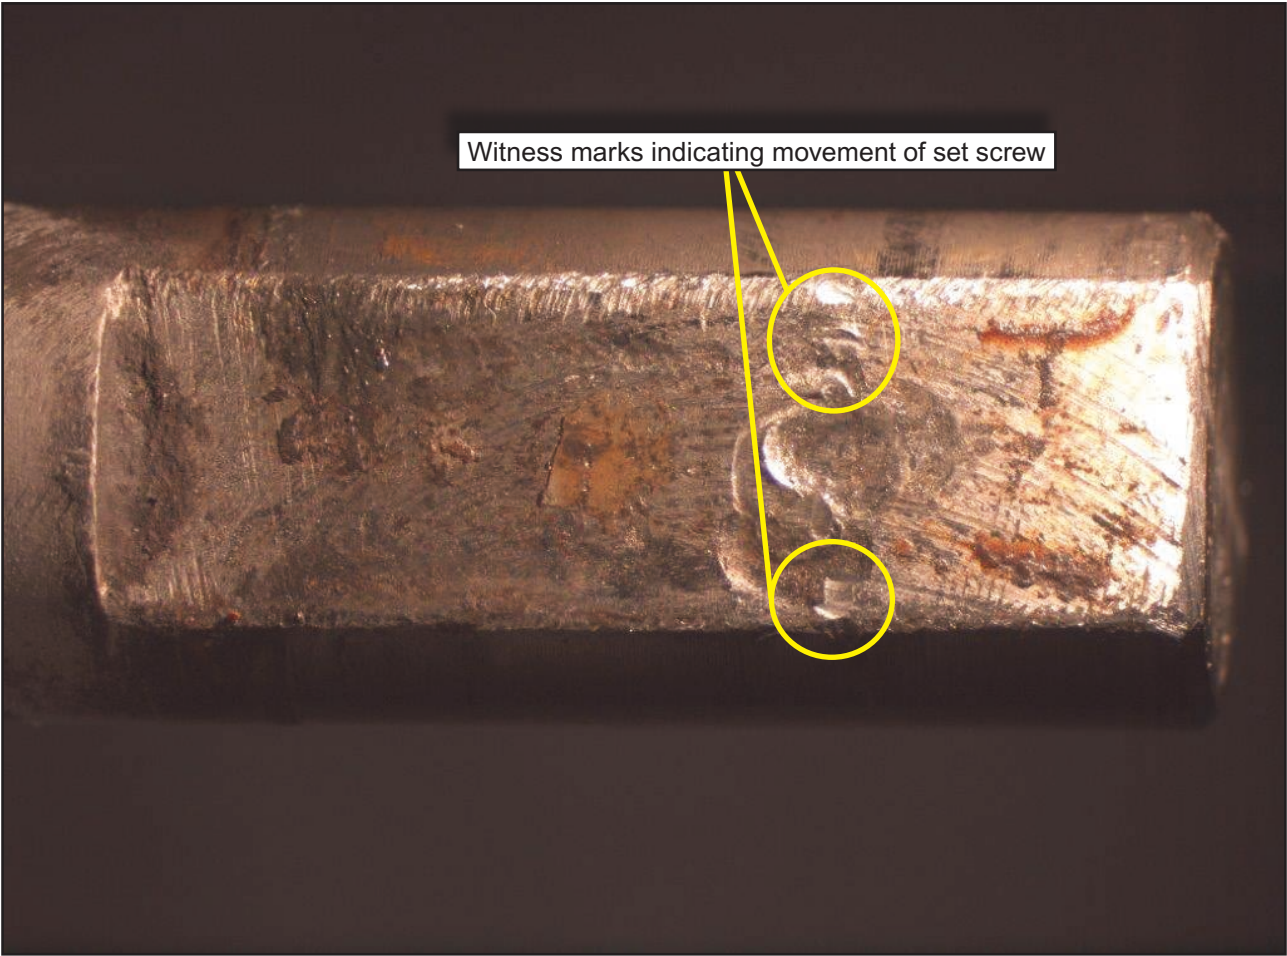
Figure 14: Marks on stepper motor shaft

The setscrew securing the jaw coupling to the stepper motor shaft had loosened since its installation in March 2016, and the markings on the stepper motor shaft (**Figure 14**) show that the shaft had moved within the coupling prior to its complete disconnection. That the pitch on the port CPP did not reduce below 50% ahead during *Hebrides's* approach to Lochmaddy indicates that the screw's complete disconnection from the stepper motor shaft occurred at about 1029, immediately after *Hebrides's* master reduced the pitch on both propellers from 60% to just over 40% ahead. The loosening of the setscrew was due to its lack of rundown torque, the absence of thread locking fluid and vibration during the actuator's operation. The vibration acting on the setscrew was potentially greater than usual due to the bore of the half coupling being locally drilled out to fit it onto the stepper motor shaft instead of being machined to the required tolerance.
