TECHNICAL REPORT

Discipline or report series#10 E&T Materials- Failure Investigation	Document number#12 DNS206728	Report number#52 DNS206728	Issue#13 2
Title#15 Investigation into the functional failure of a propulsion propeller pitch-control actuator of MV Hebrides, operated by Caledonian MacBrayne. Pitch control was delivered as part of the propulsion system by RR Marine.			
Authors#20 [REDACTED]		Telephone: [REDACTED]	Date#40 30/03/2017

Summary#60 The MV Hebrides ferry operated by Caledonian MacBrayne ran aground in Lochmaddy Marina in North Uist Sep 25, 2016 at 1105 a.m. LT while approaching the berth. It was reported that the grounding was caused by a technical failure of the port pitch control system. The pitch is set by a stepper motor which depends on a grub-screw for transfer of torque between the motor and the actuator via a three part coupling. The preliminary investigation carried out by the Marine Accident Investigation Board (MAIB) determined that the failure of the pitch control was caused by the grub-screw unscrewing from its intended position. In addition to the three parts of the coupling, the grub-screw and the motor shaft, the investigation also examined a new

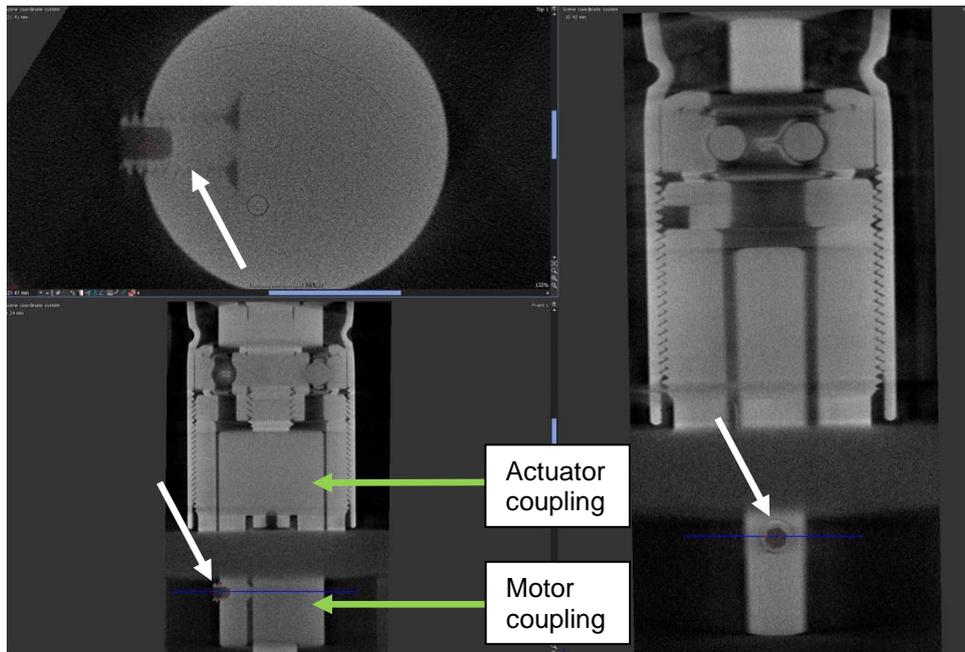
Prior to any disassembly the pitch control assembly was x-rayed using computer tomography (CT-scan). The CT-scan showed the grub-screw engaged and in correct position, see **Figure 3**. The assembly was disassembled in the RR Air Safety Investigation (ASI) workshop, under the supervision of personnel from MAIB. Initially only the motor, connecting block and actuator were separated, **Figure 4**. The motor coupling was securely fastened to the motor shaft. Untightening of the grub-screw to remove the motor coupling from the shaft required some force before it came loose. This suggested locking compound had been used on reassembly of the coupling following the incident. The actuator half of the coupling which is secured in position with a key and keyway, did not come loose. To forcefully remove it from the shaft would require further disassembly of the actuator assembly. As this half of the coupling was not of prime interest it was decided to leave it on the shaft.

Figure 3. Prior to disassembly of the pitch control assembly, the coupling was imaged by computer tomography. Upper left image: Section through the coupling, grub-screw and shaft in a plane normal to the shaft axis. The location of this section is marked by the blue lines in the lower left image and the right hand image. Lower left image: Section in a plane defined by the shaft axis and the grub-screw axis. Right hand image: Section in a plane parallel to the shaft axis and normal to the grub-screw axis, intersecting the grub-screw in the hexagonal socket. The large threaded portion and the ball bearing visible in the latter two images are part of the actuator sleeve. The grey band going across both these images is due to the actuator flange thickness preventing x-ray penetration. All three images above show the grub-screw (white arrows) engaged and in the correct position.

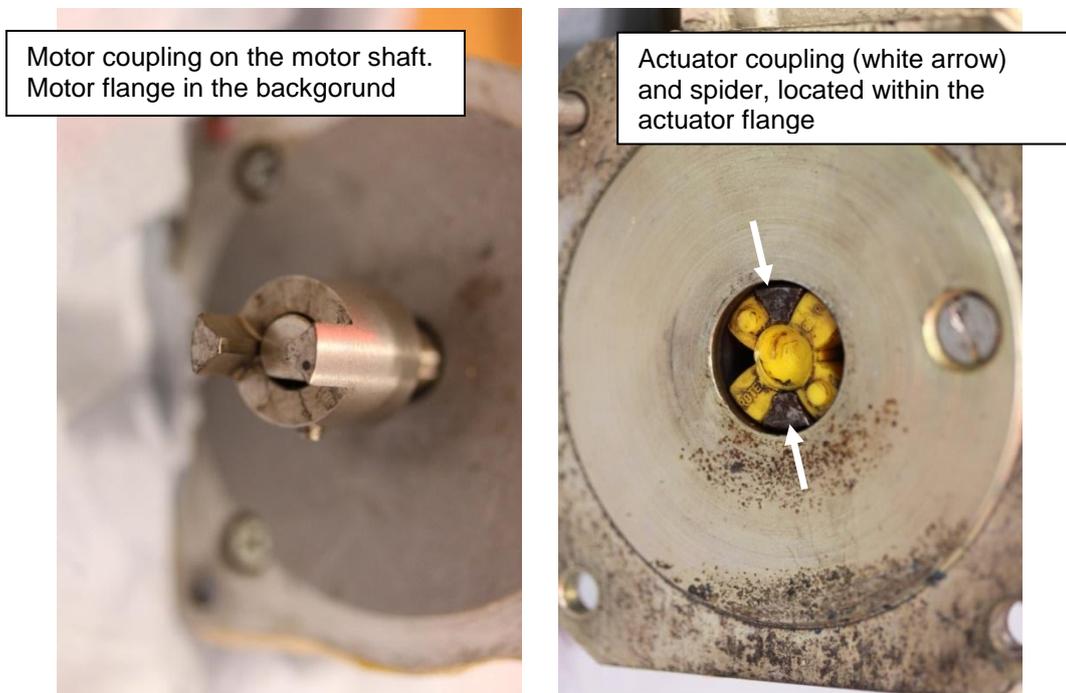
Figure 4. The images show the motor coupling and the actuator coupling with the spider, following disassembly. For scale, the outer diameter of the coupling is ~20mm.

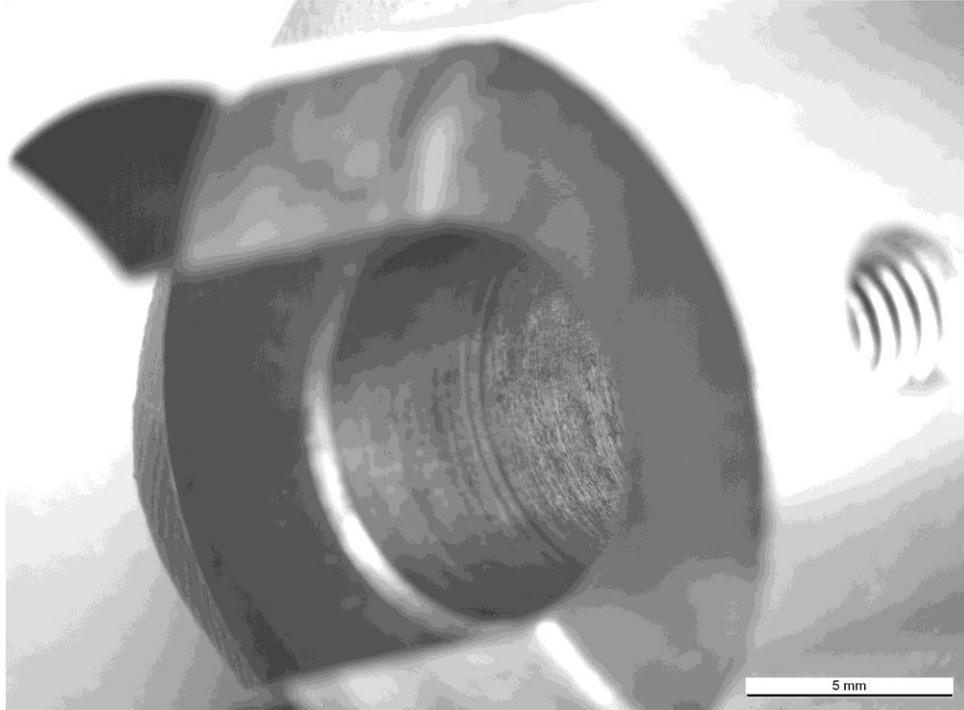
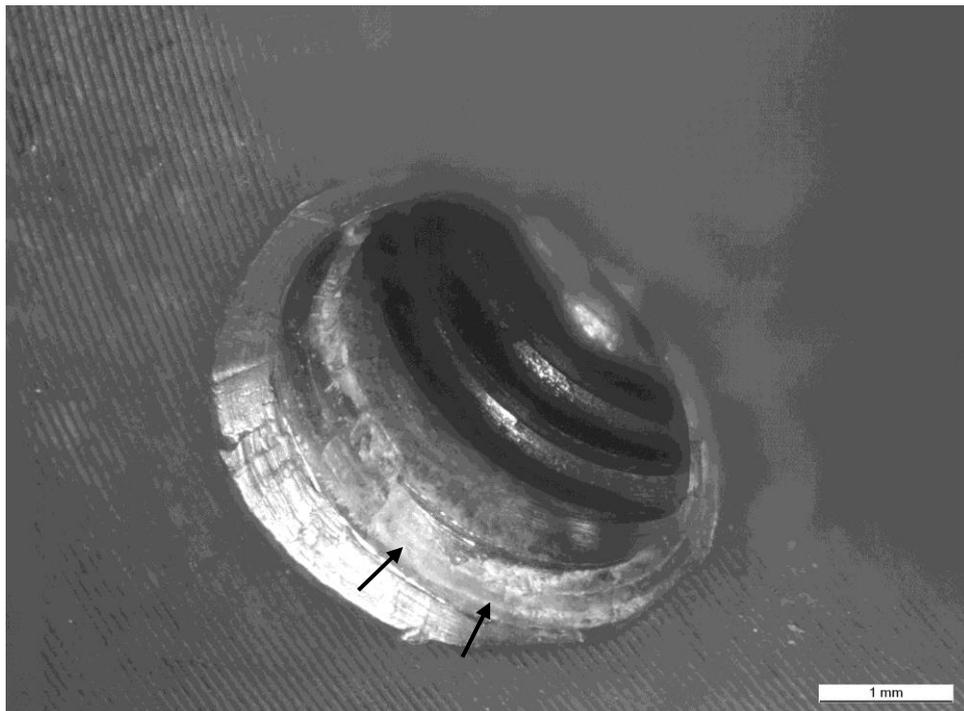
Figure 5. The upper image shows the relatively rough surface of the motor coupling bore and the 360° circumferential score. The lower image shows the threads for the grub-screw which were found to be in a good condition. The two black arrows indicate the presence of a locktite type material. Both images were taken after cleaning.

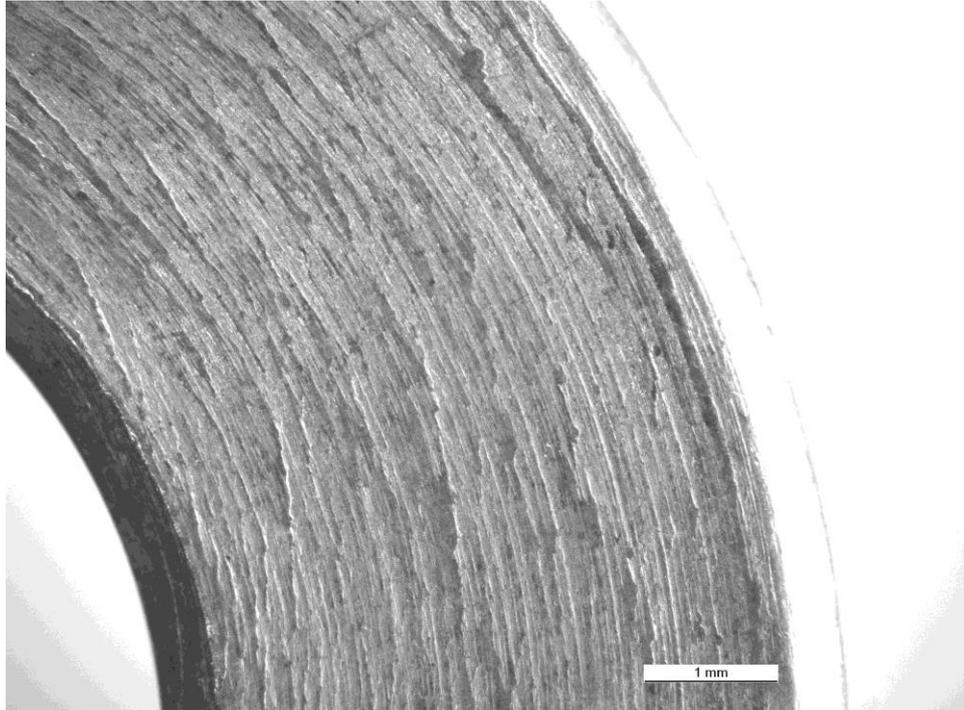
Figure 6. Visually, the motor coupling end-face (opposite to the prongs) had a rougher surface.

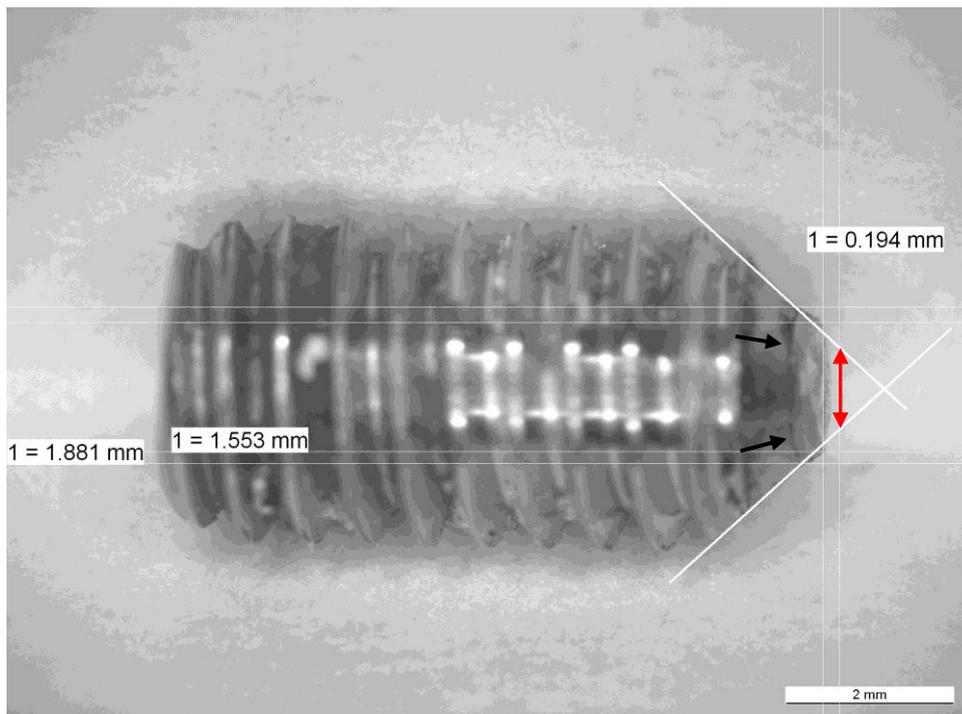
It should be noted that the deformed cone tip of the grub-screw had an approximate radius of ~0.85mm, see paragraph above. This is of a similar order to that of the conical shaped imprints within area B. The radius of the larger groove-shaped marks were similar to that of a conical shaped grub-screw (~1.16mm) that was supplied together with a new coupling in support of this investigation. See paragraph below “New coupling” (and **Figure 16**). This also suggested that two different grub-screws had been fitted to the shaft, see discussion.

Figure 7. The cone shape of the grub-screw had been deformed, resulting in an estimated ~0.2mm shortening of the length. This is based on an original tip diameter of 1mm (maximum allowable indicated with red arrow). A possible crack ran 360° around the cone adjacent to the deformed end-face, marked with black arrows. In the photograph the centre-line of the grub-screw is out of focus. This is due to the need for keeping the projected profile in focus to enable measurements to be taken.

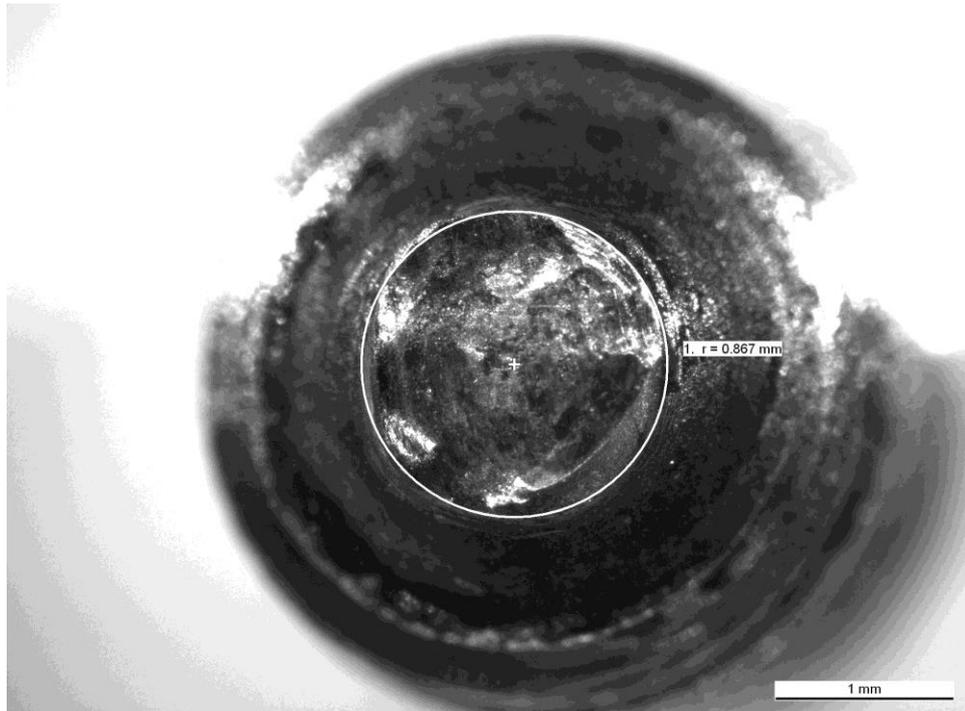
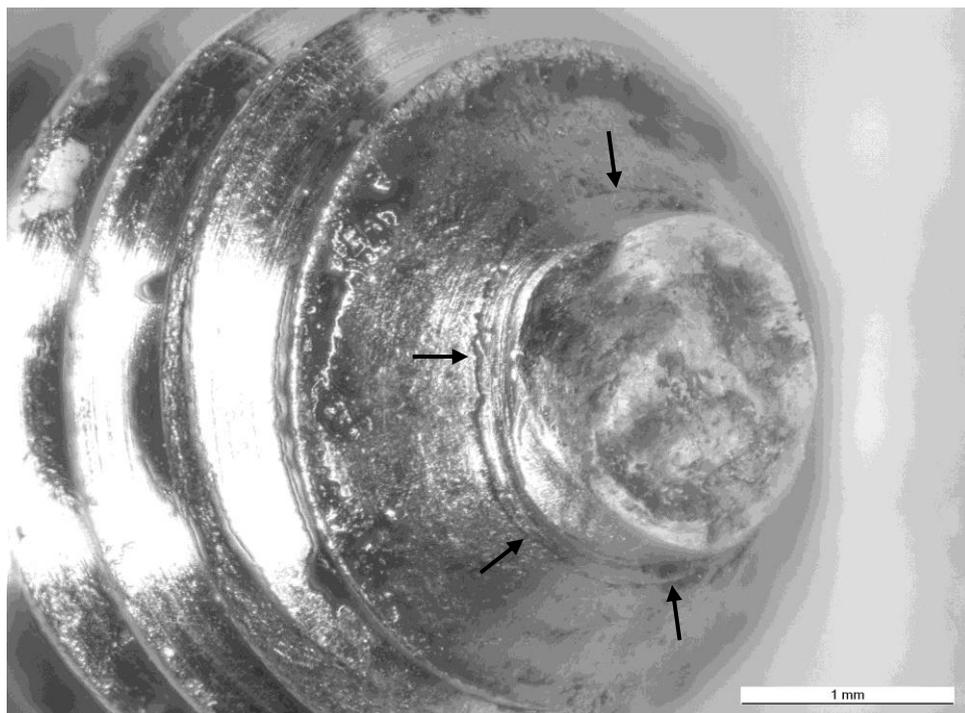
Figure 8. The deformed cone end-face had the approximate shape of a circle with a diameter of ~1.73mm. The deformed tip did not have a perfect circular shape and the drawn in circle of $r=0.867\text{mm}$ is for illustration rather than an accurate measurement. Hence within the text of the investigations the diameter of the deformed tip is stated to be ~1.7mm. The possible crack running 360° around the cone is marked with black arrows in the lower image.

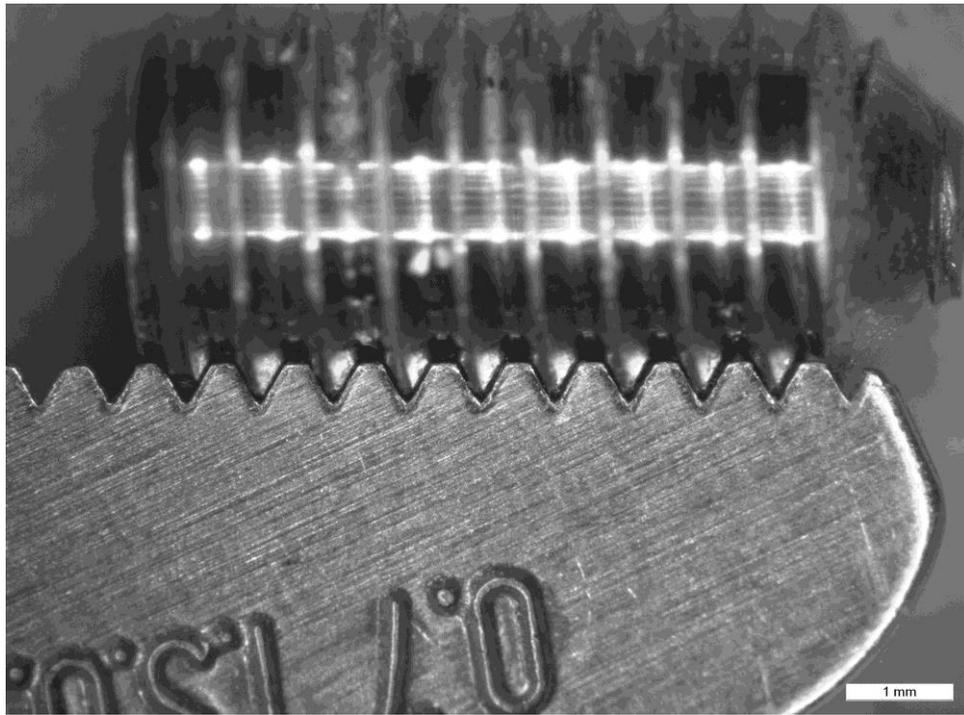
Figure 9. The threads were in a good condition and had pitch that fitted with the 0.7 gauge.

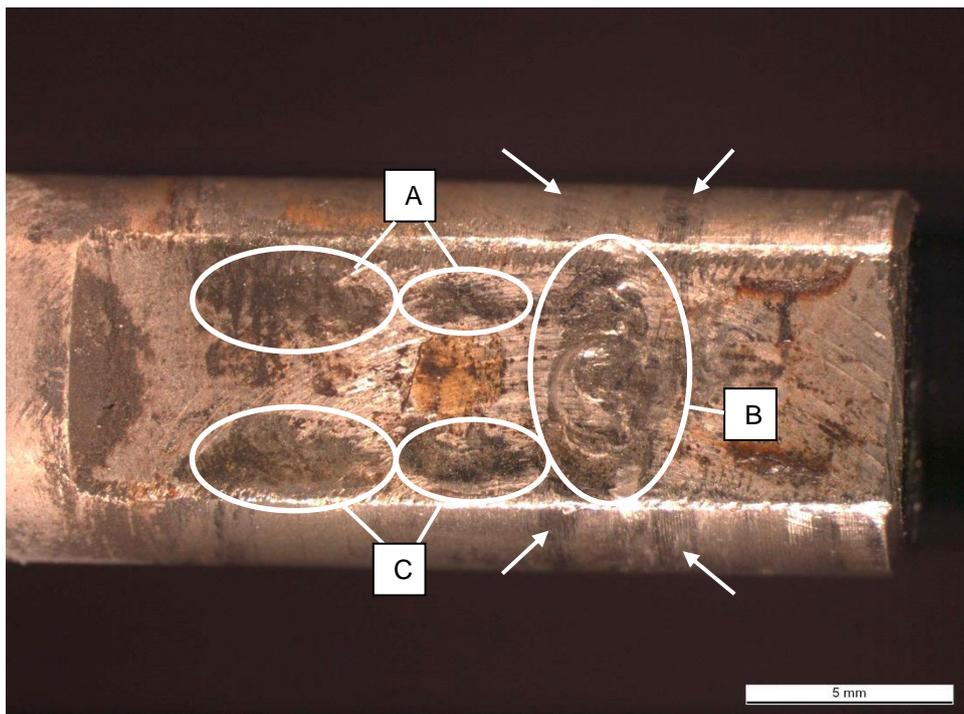
- It seems certain that the smaller cone shaped imprints on the motor shaft flat were caused by the event grub-screw, both prior to the event and after the event when the coupling was re-assembled to recover the situation. The circular groove shapes must have been caused by the grub-screw used in the motor coupling that was replaced during the service visit in March 2016 (Ref. 2). The location of circular shapes within area C demonstrated that this earlier motor-coupling had been able to travel nearly 10mm away from the actuator coupling. It is assumed that no other coupling and grub-screw have been used in the assembly in addition to those described above.

Figure 10. Engagement with the grub-screw had left numerous damage-marks on the motor-shaft flat in several distinct areas (encircled). The marks were visible as fretted/polished deformation. Areas marked A were predominantly fretted/polished deformation with no clear shape. Within area B the marks had taken on a circular shape. Also within area C the marks had a circular shape, but less distinct than in area B. See Figure 11. There was also evidence suggesting engagement with the grub-screw outside of the flat, on the shaft diameter (white arrows).

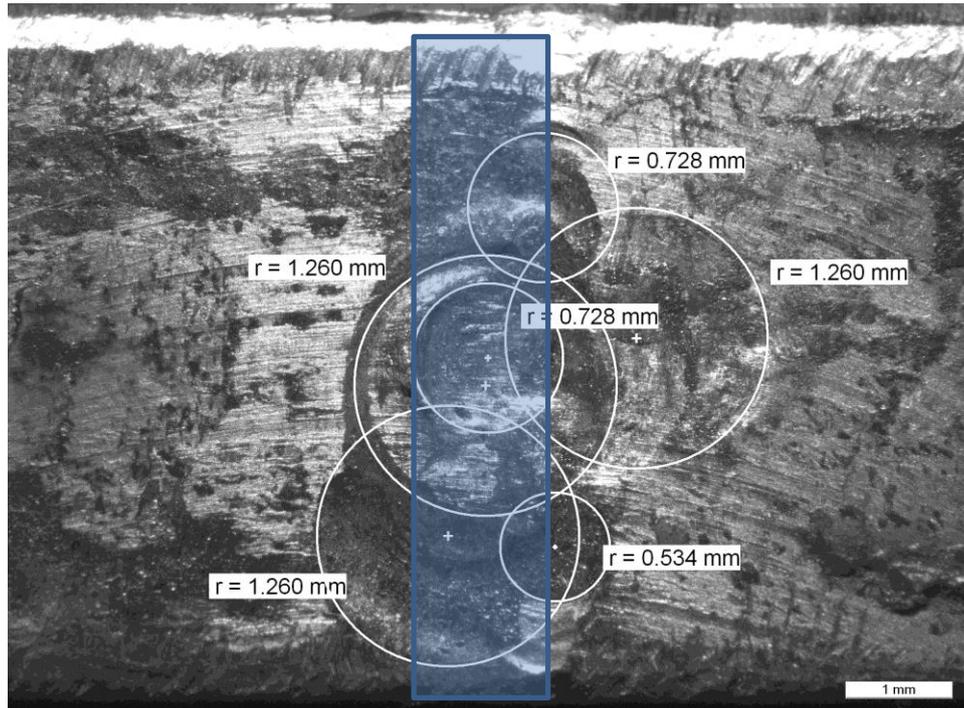
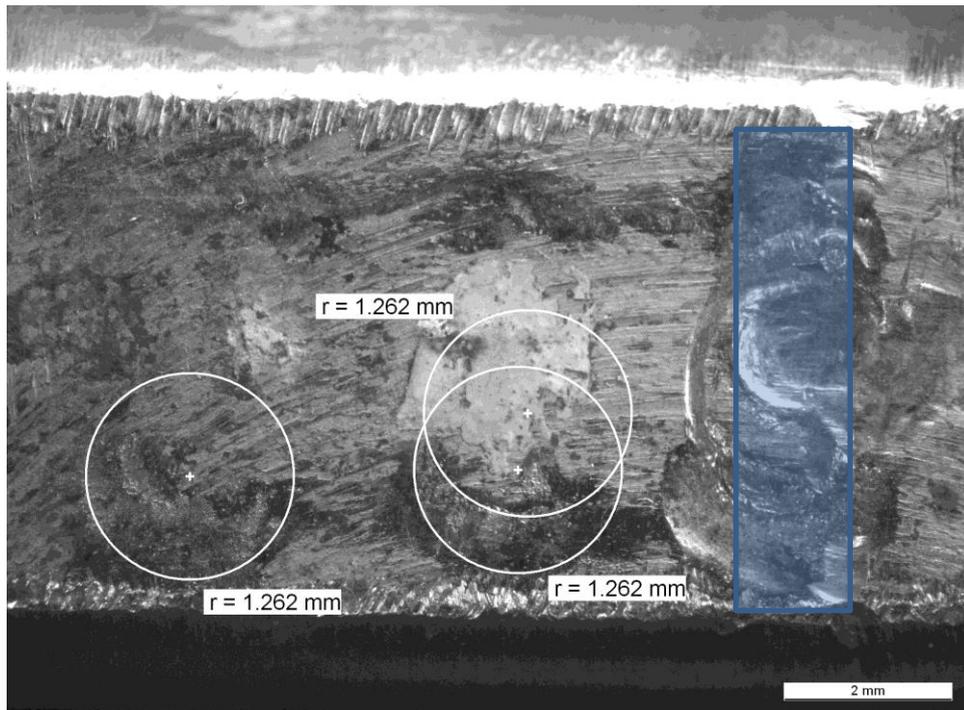
Figure 11. The images show circles fitted to the semi-circular shaped marks within areas marked B and C. The marks in areas marked C were less distinct than those in area B. The radius values are best estimates and should only be considered accurate to +/- 0.1mm. The shaded bands indicate the intended axial location for the grub-screw, 6.8mm to 7.8mm away from the shaft end-face. The band is drawn across the full width of the flat, though the intention is for the grub-screw to be centred.

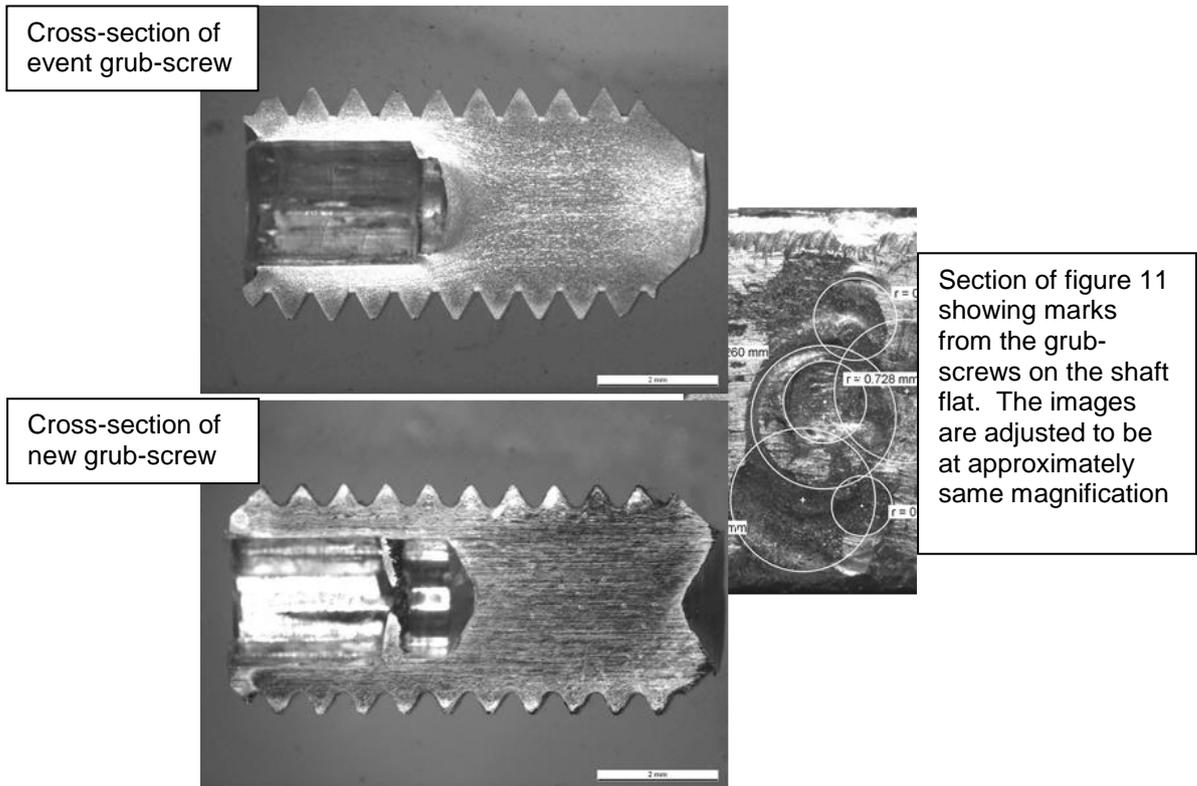
- It seems certain that the smaller cone shaped imprints on the motor shaft flat were caused by the event grub-screw, both prior to the event and after the event when the coupling was re-assembled to recover the situation. The circular groove shapes must have been caused by the grub-screw used in the motor coupling that was replaced during the service visit in March 2016 (**Ref. 2**). (It is assumed that no other coupling and grub-screw had been used in the assembly in addition the two described above). The location of circular shapes within area C demonstrated that this previous motor-coupling had been able to travel nearly 10mm away from the actuator coupling. Assuming that the previous coupling had the same geometry as the event coupling

Figure 12. The images, which are at same magnification, illustrate how the small imprints fit with the cone and the larger fit with the cup.

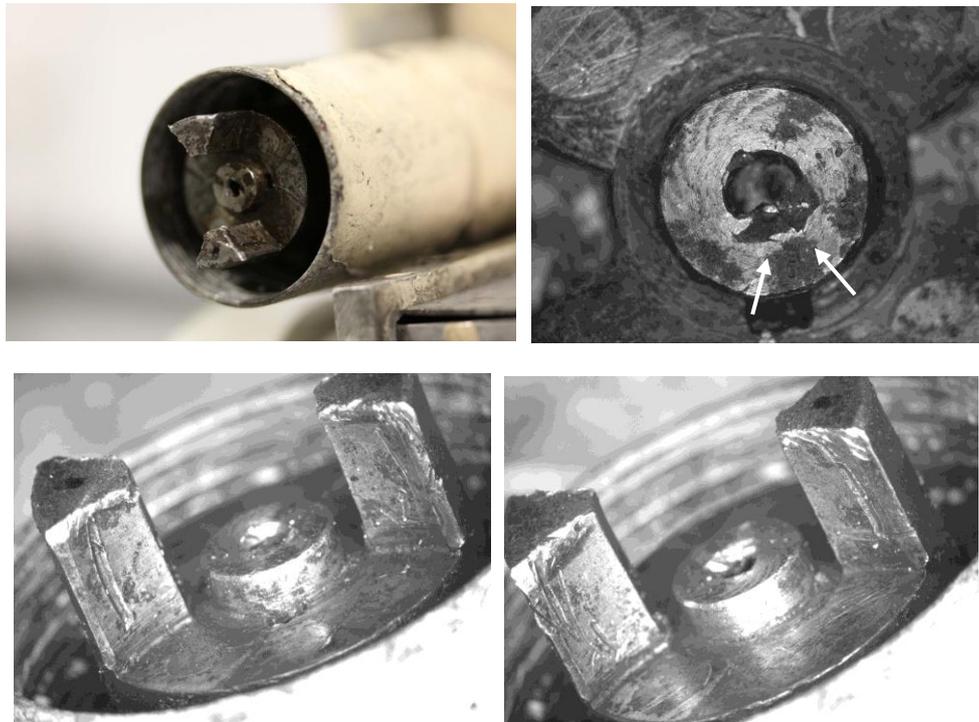
The actuator coupling was not removed from the actuator shaft. Consequently, due to its position within a sleeve and flange surrounding the shaft, it could only be partially examined. The shaft, depicted in **Figure 4** and **Figure 13**, had a dark grey surface and was clearly older than the motor-coupling. The end-face and the prongs were damaged, visible as scores and cuts to the surfaces. Rather than being a result of operation, the damage appeared consistent with attempts to remove the coupling from the shaft.

- The darker grey surface of the actuator coupling when compared with the motor coupling and the damage to the prong-surfaces, were consistent with this coupling being older and attempted removal as reported in Service Report dated 23.03.2017, **Ref. 2**.

Figure 13. Top left: actuator coupling pictured as located within in sleeve. Top right: damage to actuator shaft end-face (white arrow). Bottom left and right: damage to the load-carrying prong surfaces (rotated 180°). For scale, the outer diameter of the coupling is ~20mm.

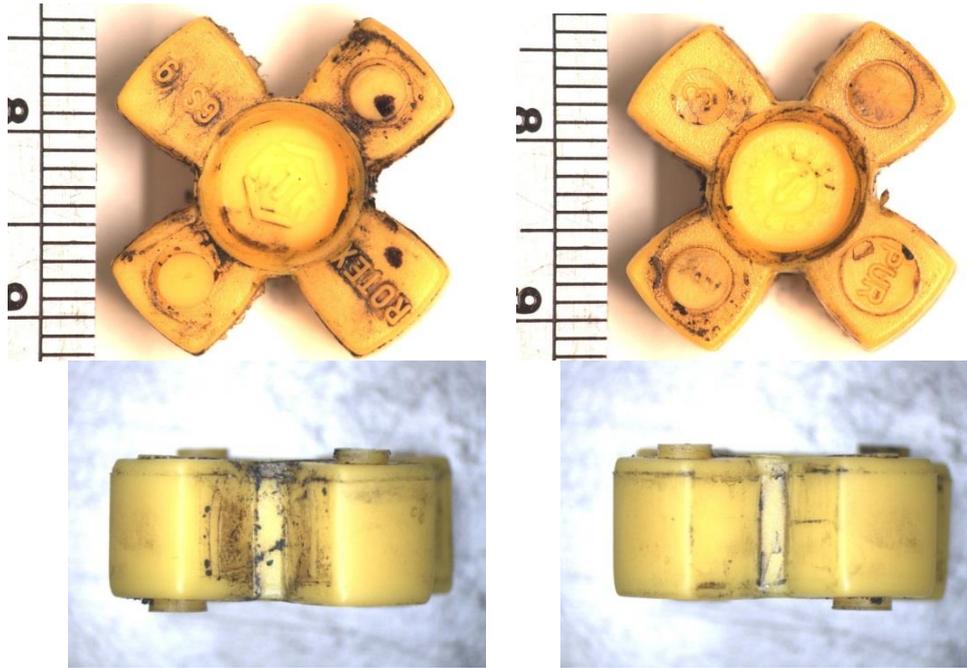
The spider was of a yellow colour and consisted of a hub with four equally spaced arms. It was marked ROTEX KTR GS9 on one face and PUR 3 on the other, see **Figure 14**. The end-faces and the arm surfaces facing the motor coupling prongs exhibited no evidence of damage. The arm surfaces facing the actuator coupling prongs exhibited some damage in the form of deformation. The observed damage was consistent with the poor condition of the actuator coupling prong surfaces.

Figure 14. The two upper images show spider end-faces with marking. The lower left image shows damaged prong loaded faces, that had contacted the actuator coupling. The lower right image shows undamaged prong loaded faces, that had contacted the motor coupling.

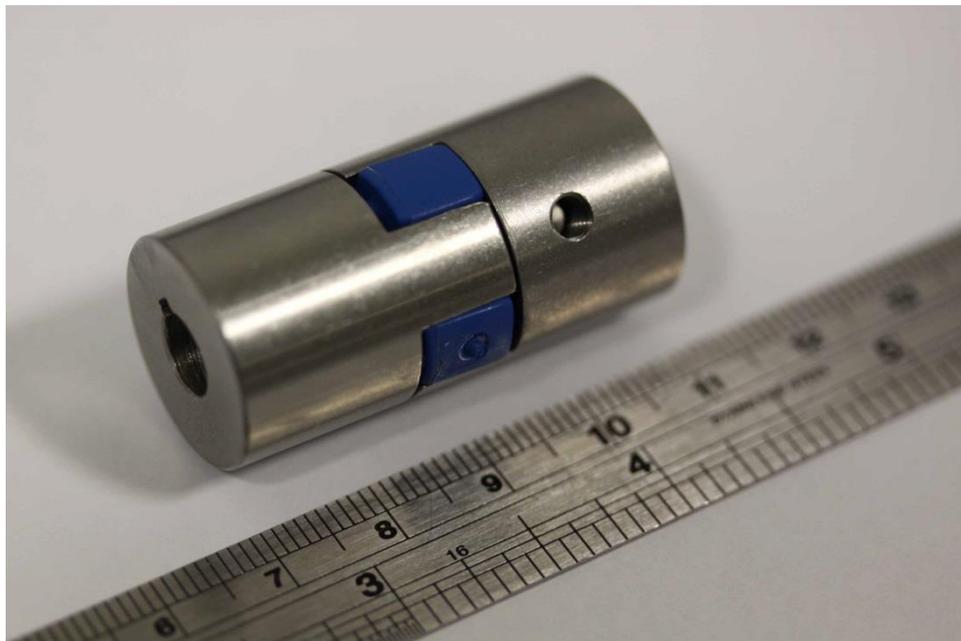
A new coupling was received through the same supply route as the replacement coupling would have been supplied to MV Hebrides. The coupling consisted of two coupling halves, a grub-screw and a blue coloured spider. See **Figure 15**. One coupling half was supplied with a threaded grub screw hole. The other half was machined to take a key. The grub screw was fairly loose with no practical run-down torque.

Figure 15. A new coupling was received through the same supply route as the replacement coupling would have been supplied to MV Hebrides. Motor coupling to the right with grub-screw hole and actuator coupling to the left with key-slot.

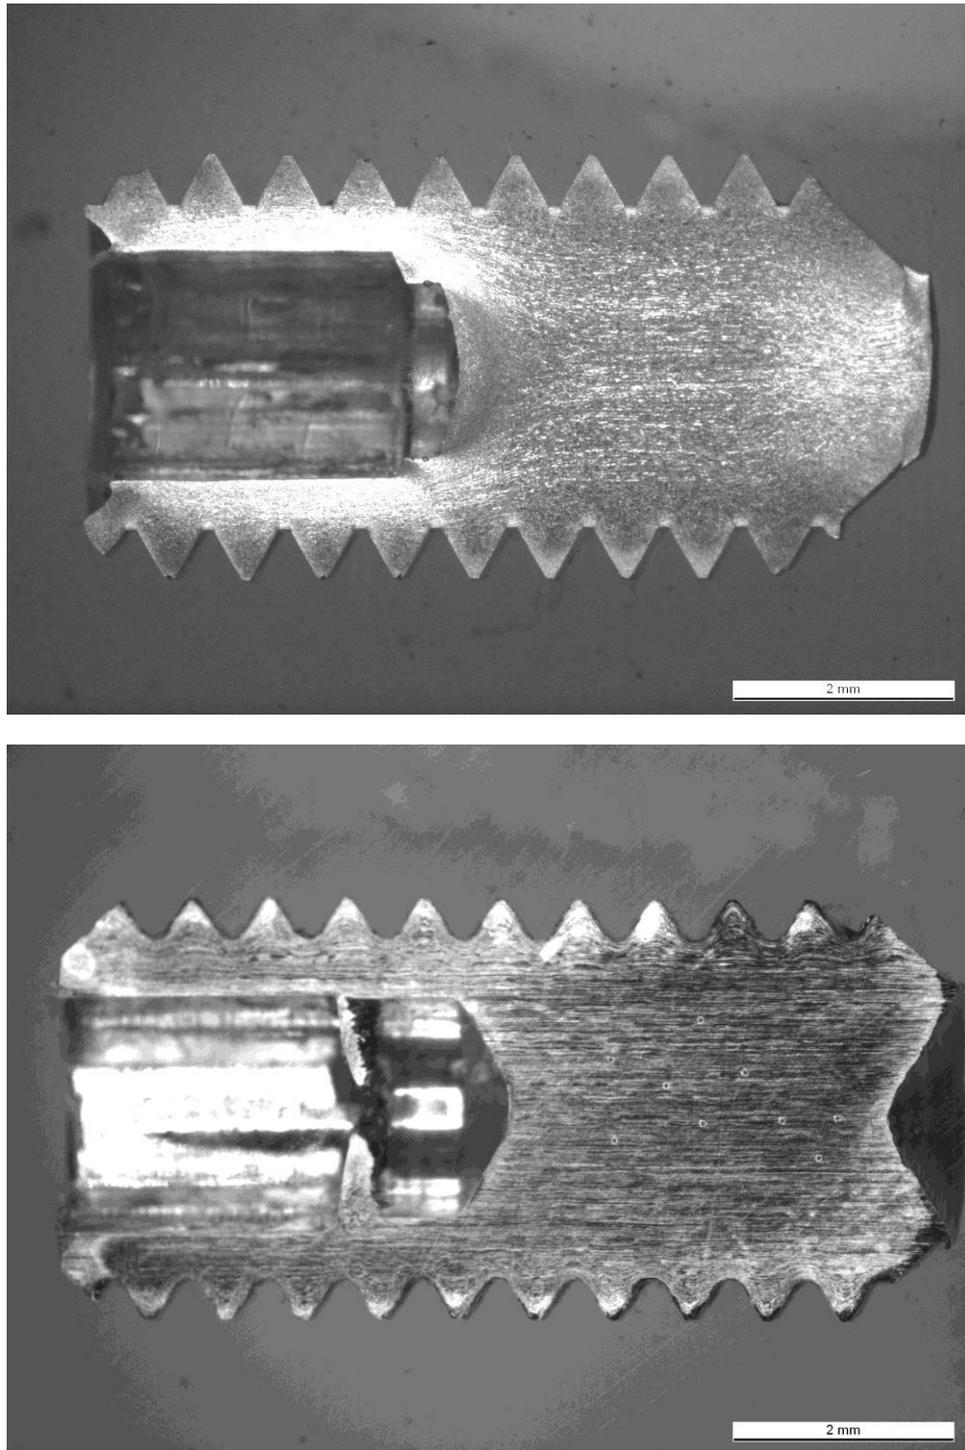
- 1) Event grub-screw: Cone and hexagonal socket were produced by upsetting of a straight work-piece. The threads, which were flat-bottomed, were then produced either by cutting or rolling. The flow lines following the thread profile are faint and could possibly have resulted from cutting. It should be noted that the specification, requires a minimum tread radius of 0.088mm. Upsetting of the cone and the socket will have caused notable work-hardening in the deformed areas.
- 2) New grub-screw: Cup was produced by machining. Hexagonal socket was produced by upsetting of a pre-drilled hole. The threads were produced by rolling and had a minimum radius in excess of the 0.088mm requirement. Due to the lack of significant deformation, a more uniform hardness would be expected.

Figure 16. The two images show the macro-structure of the event grubscrew (upper) and the new grubscrew (lower). The difference in flow lines resulting from the manufacture of the grubscrews is evident.

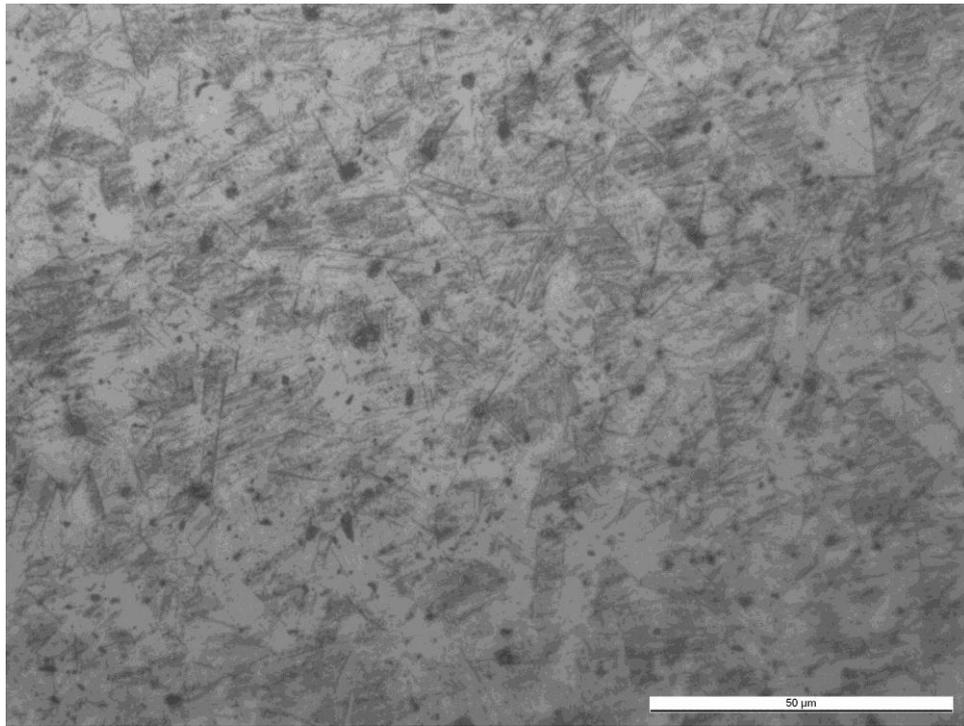
Figure 17. The shaft exhibited a fine grained austenitic structure with finely dispersed carbides and visible slip-bands.

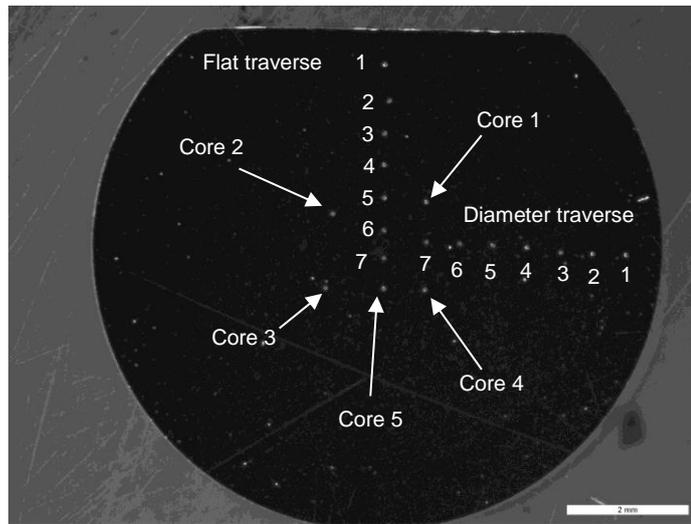
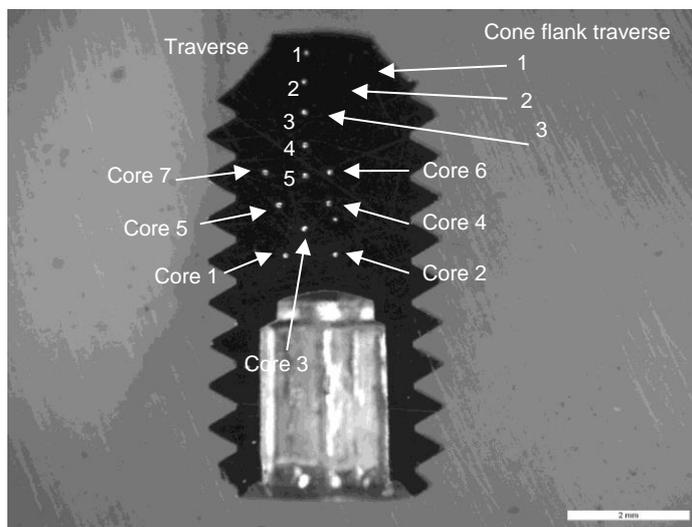
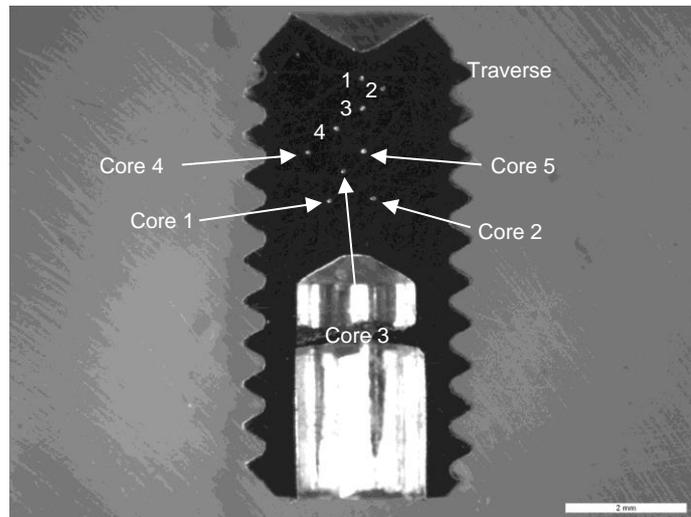
- The cone/cup tips of both grub-screws were found to be harder than the mating flat surface of the shaft. The difference was in the range of ~100HV for the event grub-screw and ~40HV for the new grub-screw. Though this investigation has been informed that the grub-screw was required to be harder than the shaft (**Ref. 3**), the specific requirement is not known. Hence it can't be concluded whether the grub-screws were conforming with respect to hardness.

Figure 18. The images show the position of the individual hardness indents, upper image is the motor shaft, followed by event grub-screw and new grub-screw.
