AAIB Bulletin S2/2017

SERIOUS INCIDENT

Aircraft Type and Registration:	Boeing 737-86J, C-FWGH	
No & Type of Engines:	2 CFM56-7B26E turbofan engines	
Year of Manufacture:	2011 (Serial No: 37752)	
Location:	On takeoff from Belfast International Airport	
Date & Time (UTC):	21 July 2017 at 1539 hrs	
Type of Flight:	Commercial Air Transport (Passenger)	
Persons on Board:	Crew - 6	Passengers - 179
Injuries:	Crew - None	Passengers - None
Nature of Damage:	Light fitting on runway damaged	
Commander's Licence:	Canadian Airline Transport Pilot's Licence	
Commander's Age:	38	
Commander's Flying Experience:	8,234 hours (of which 2,817 were on type) Last 90 days - 170 hours Last 28 days - 45 hours	
Information Source:	AAIB Field Investigation

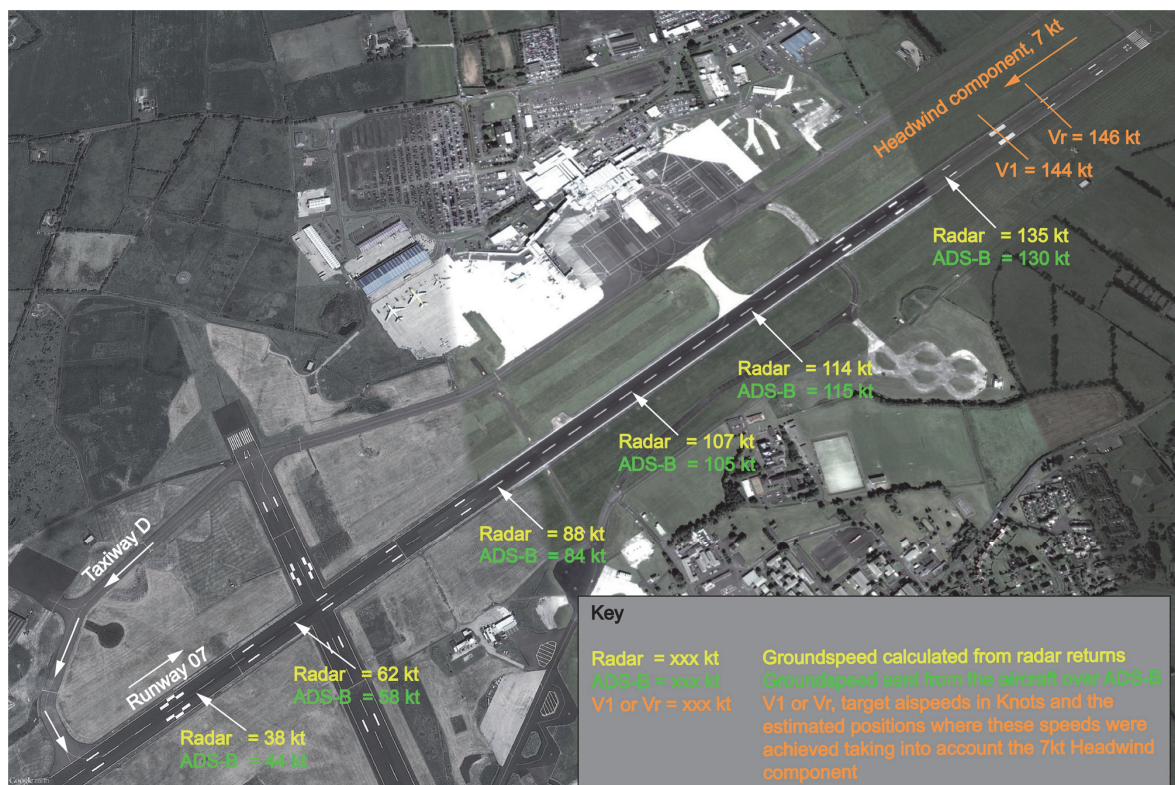
The crew were cleared for takeoff on Runway 07 from Taxiway D (Figure 1), which gave a Takeoff Run Available (TORA) of 2,654 m. During the takeoff, at around 120 to 130 kt, the crew realised that the aircraft was not accelerating normally. They estimated, during post-flight interviews, that they reached V_1 ¹ with around 900 m of the runway remaining and rotated shortly afterwards. The aircraft was seen, by multiple witnesses, during rotation and took a significant time to lift off before climbing at a very shallow angle.

The radar installation at Belfast International Airport tracked the aircraft along Runway 07 and during initial climb-out, when altitude data also became available from the aircraft's transponder. The radar returns allowed groundspeed for the aircraft to be calculated which was supplemented by both groundspeed and altitude data transmitted from the aircraft over its ADS-B⁴ data link. This data is shown in Figure 1 for the ground roll, where the text in yellow represents calculated groundspeed data from the radar track and, in green, the received ADS-B groundspeeds. Orange lines show the approximate position where the aircraft achieved airspeeds equivalent to V_1 and V_R ,⁵ taking into account a 7 kt headwind component.

Groundspeed data for the takeoff in relation to V_1 and V_R

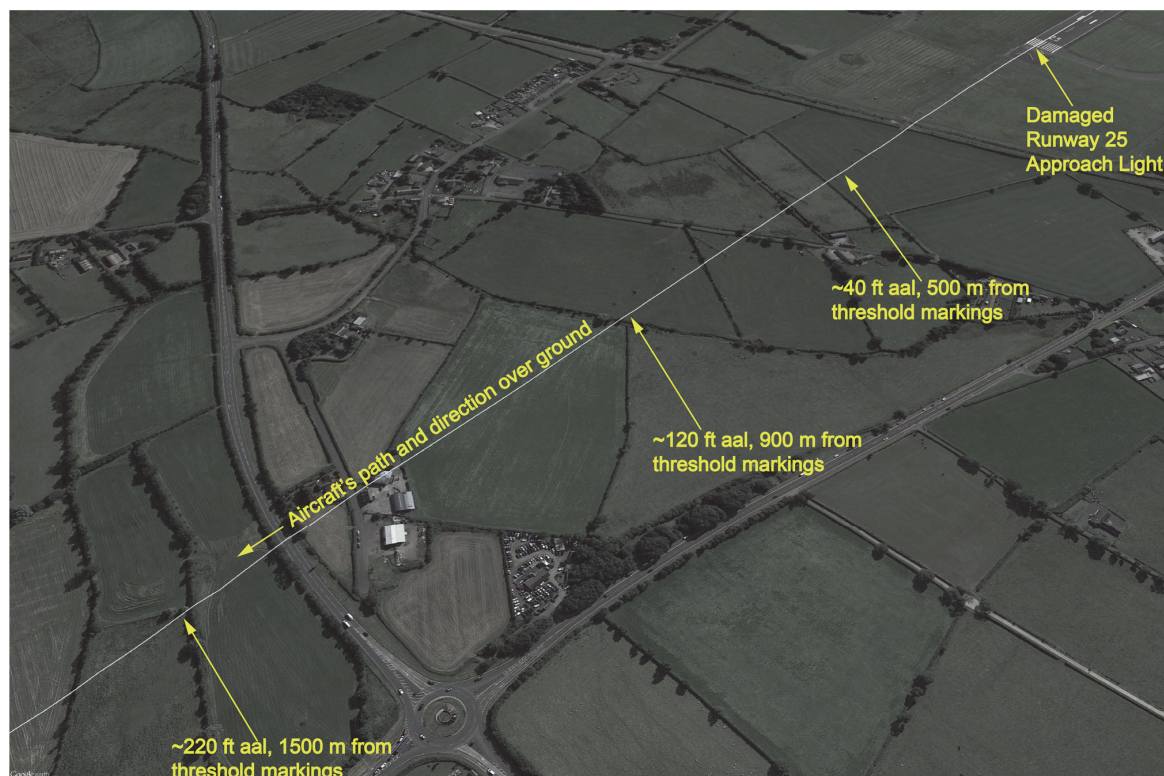
Figure 2 shows spot heights above the elevation of Belfast International Airport (268 ft amsl) for the aircraft's initial climb, derived from the aircraft's ADS-B reports (these heights are annotated 'above airfield level' (aal)). At no time during the climb-out was the aircraft's Enhanced Ground Proximity Warning System Mode 3 aural alert ("DON'T SINK") triggered⁶.

Vertical profile for the initial climb-out
