ACCIDENT

| Aircraft Type and Registration: | North American P-51D Mustang, G-MSTG |
| Date & Time (UTC): | 2 October 2016 at 1434 hrs |
| Location: | Topcroft Farm Airstrip, near Hardwick Airfield, Norfolk |

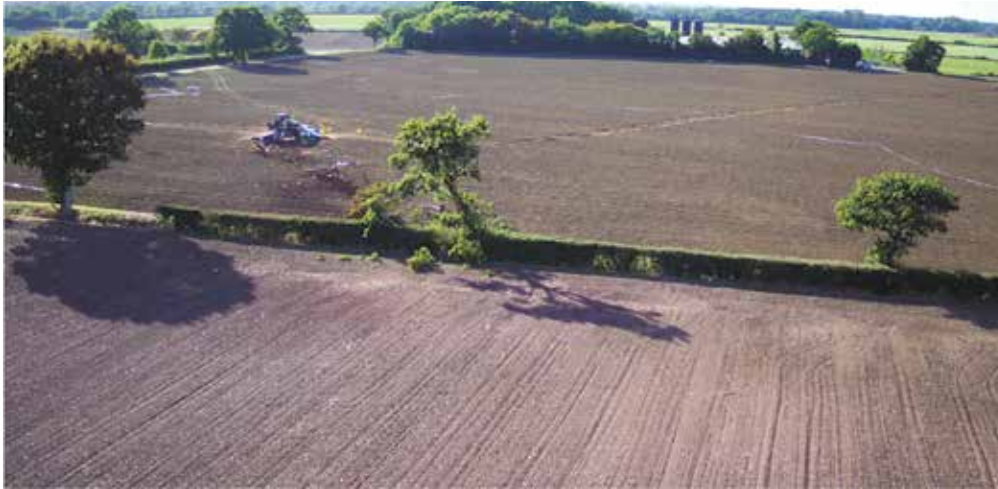
Figure 3
Accident site

The aircraft had struck a mature oak tree on the boundary between two fields with marks showing that one of the propeller blades had been the first point of impact. This had been rotating with sufficient power to slice upwards through the trunk and into a bough of the tree which detached and fell away. The tip of this blade was left deeply imbedded in the remainder of the trunk. After the propeller had hit the tree, the aircraft continued onward with the tree passing along the left side of the fuselage. The inner section of the left wing was struck by the tree causing the wing to detach, before the left tailplane then detached as it was also hit by the tree.

There was a 57 m debris trail on a bearing of 225° leading from the tree to the main wreckage. The aircraft had come to rest upright in the field beyond the tree, resting on its right mainwheel and tail wheel, with the trailing edges of the wing and tailplane tips dug into the soil.

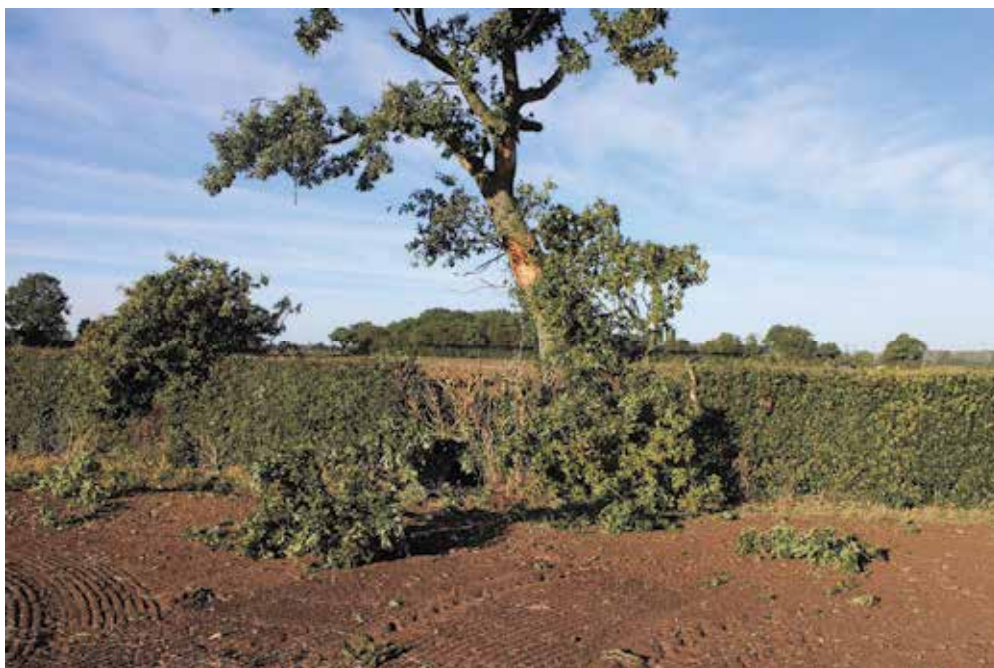
Figure 4
Tree strike in direction of aircraft travel

The magnitude and nature of the damage to the tree shows the engine was producing high power at the point of impact.

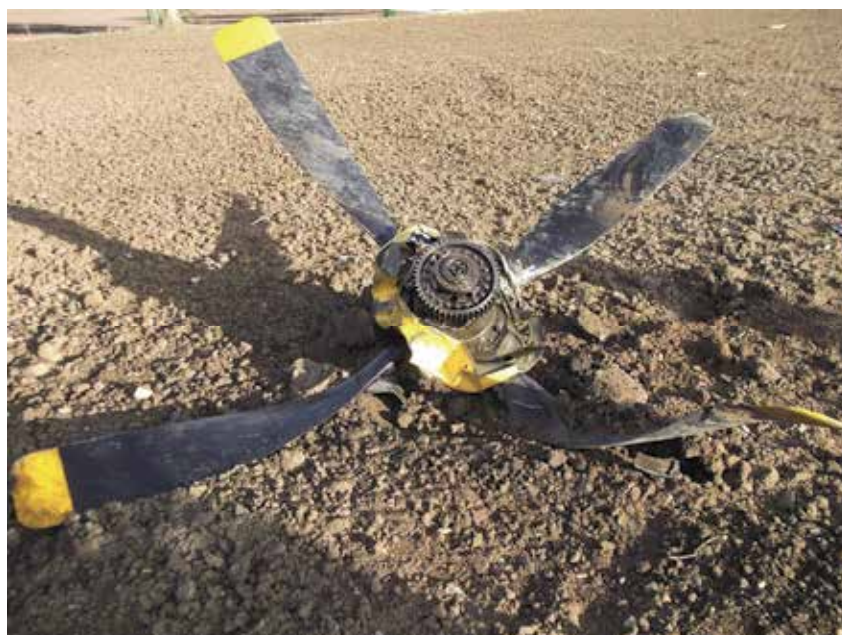
Figure 5 (right)
Propeller damage

The propeller had detached from the engine along with its drive gear and was lying in the wreckage trail close to the aircraft. All but one of the blades were complete but all were heavily distorted.

The aircraft then bounced on to its nose; the damage to the propeller spinner suggest the aircraft was at a near vertical attitude whilst rotating. The propeller was still under significant power at this point but detached during this impact. The aircraft inertia and rotation then caused the aircraft to carry on tail first to finally hit the ground pointing in the opposite direction to travel. The right wing and tailplane tips dug into the ground at this point bringing the aircraft to a stop. The damage to the engine bearers is likely to have occurred as a result of the torque shock as the propeller sliced through the tree. The impact at the left wing root released the self-sealing fuel tank from its bay rupturing its structure and fuel lines. The fuel in this tank was released and ignited. The majority of fire damage occurred in the remains of the tree bough and the ruptured tank. However, burning fuel appears only to have flashed over the front position of the cockpit just before or as the canopy detached.

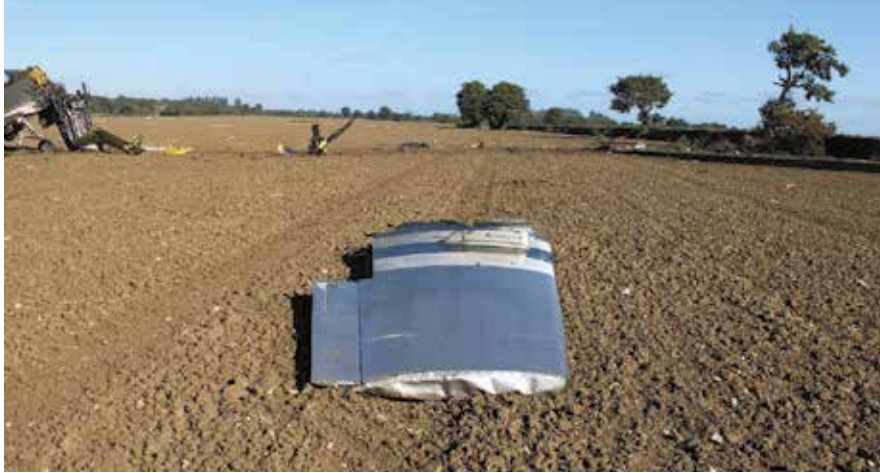
Figure 6
Left wing

The left tailplane was lying in a ditch near the base of the tree and the left flap and elevator was lying a short distance further on. The left wing was lying upside down in the field 65 m from the tree away from the main wreckage. The left main landing gear was still attached to the wing but was in the retracted position.

The nature and location of the damage show that the left wing root then hit the tree causing the left wing and flap to detach. The bending and distortion to the aircraft structure around the wing root and tailplane attachment suggest the aircraft was left wing low with a roll angle of approximately 60°.

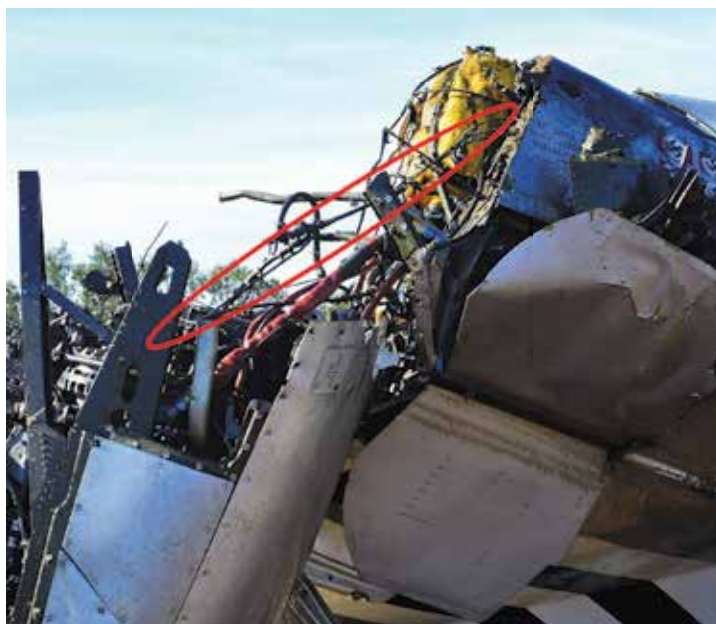
Figure 7
Engine control linkages under tension

The engine was partially detached from the fuselage but bent downwards resting on the ground on the remains of the reduction gearbox. The engine bearers were broken and distorted and the engine control cables and rods were still connected but had been pulled forward and were under tension. Various oil and coolant flexible pipes had been split or had parted from their rigid pipe connections. Figure 7 shows the partial detachment of the engine and the effect on the engine control linkages.

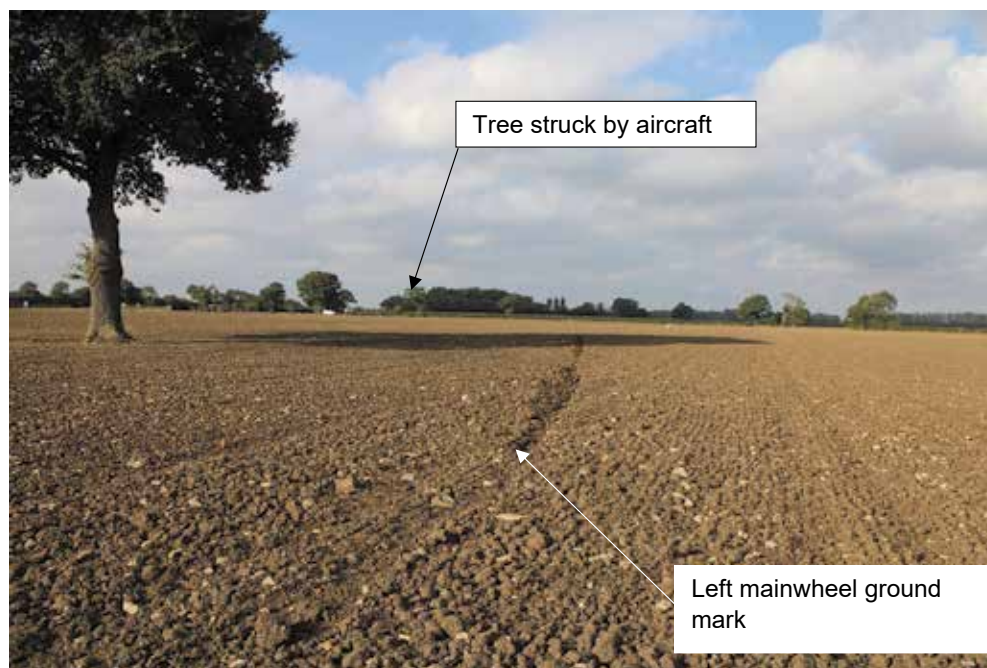
There were more wheel marks on the ploughed surface of the field next to the runway. These marks started with a tail wheel imprint and then the left mainwheel, the mainwheel mark being curved slightly to the left and approximately 100 m in length. About 29 m along the mark there was a parallel mark made by the right mainwheel. Both marks ceased as they approached the concrete track which ran across the field. There was another left mainwheel mark 100 m further on in the field on the other side of the concrete track. This mark was approximately 30 m long and was very distinctive as if the tyre had been running at an angle to the direction of travel, gouging the soil. There were no more ground marks up to the impact point with the tree. Figure 8 shows the final ground mark and the position of the tree hit by the aircraft.

Final tyre mark and impact tree

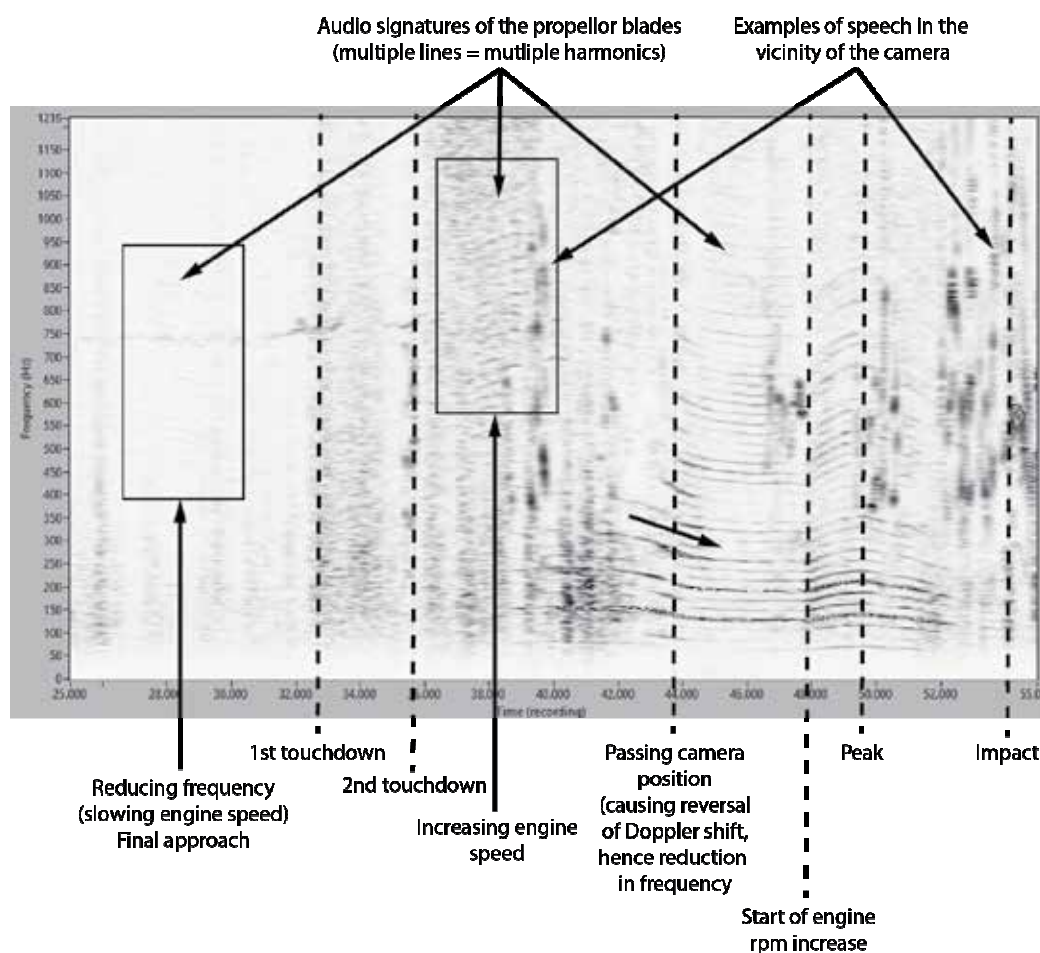
Figure 10

The audio signatures from the propeller were analysed and calculations indicated an engine speed of approximately 2,300 rpm just prior to initial touchdown. The audio signatures at this point were not prominent, indicating the engine was at low power. Just after the second touchdown, the signatures became prominent again indicating increased engine power and increasing engine speed. The engine speed was calculated to be approximately 2,800 rpm as the aircraft passed the camera, assuming the engine speed and ground speed were approximately constant as it passed. Six seconds before impact with the tree, the propeller speed rose again reaching a maximum after 1.5 seconds and then steadily reducing until the point of impact.

Spectrum Analysis of video audio
