ACCIDENT

| Aircraft Type and Registration: | Piper PA-30 Twin Comanche, G-ATMT | |
| Date & Time (UTC): | 15 January 2017 at 1427 hrs | |
| Location: | Near Aston Rowant Nature Reserve, Oxfordshire | |

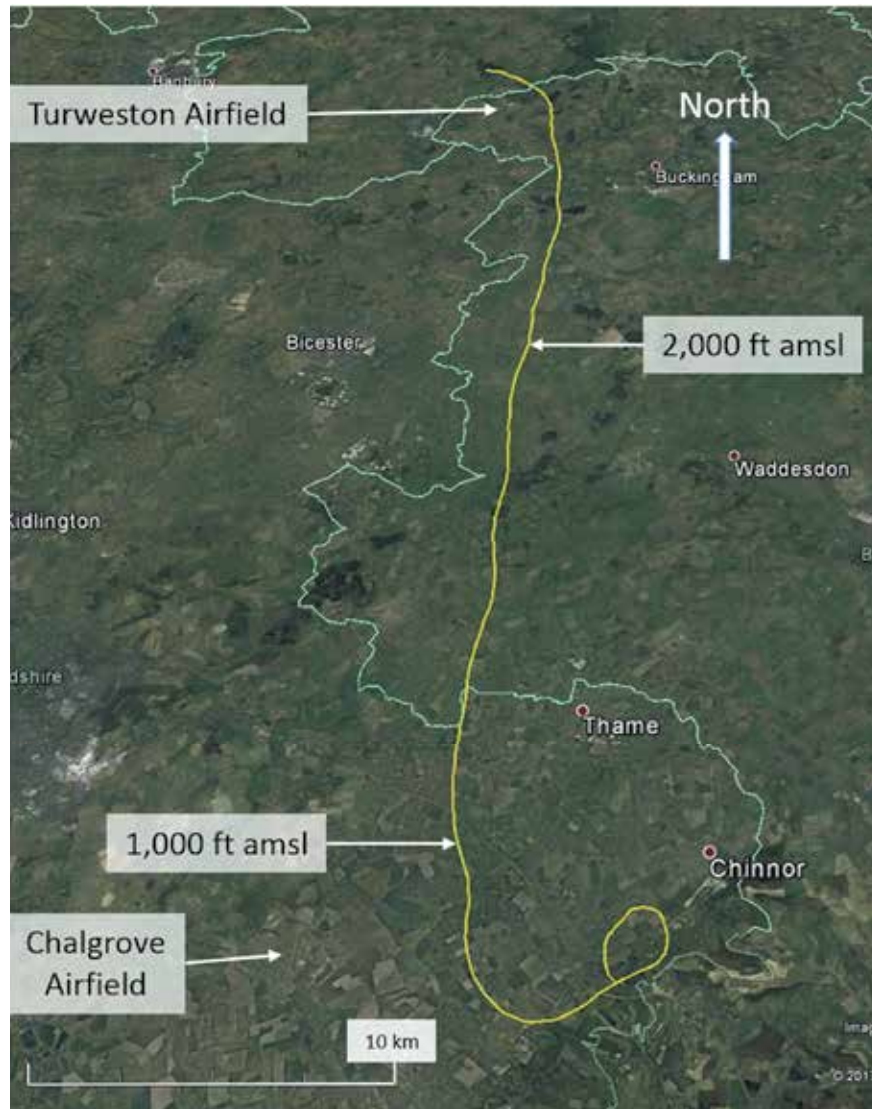
Figure 1

Track of the flight (©Google Earth)

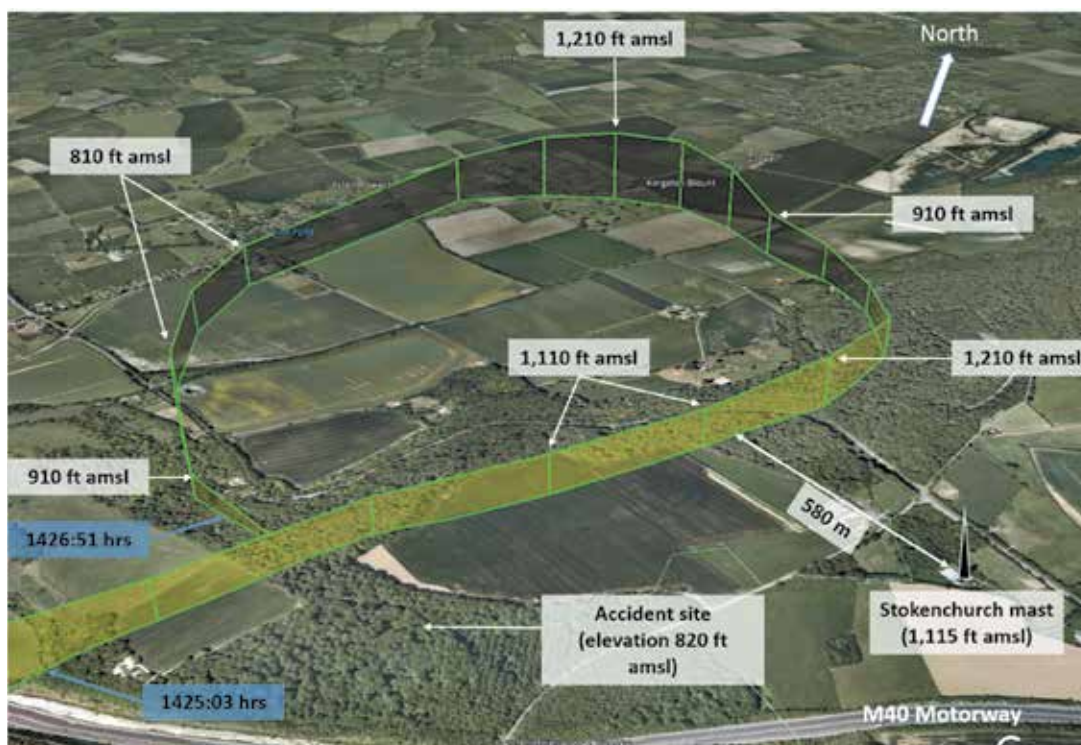
Figure 2

Final track of the aircraft (©Google Earth)

From the evidence available, G-ATMT was in IMC as it passed over the accident location, heading northeast, until impact, a time of approximately 1 minute 45 seconds (Figure 2). It had probably also been in IMC from the time it turned towards the ridge. Aircraft operating in IMC are subject to the IFR minimum altitude rule, which acts as a system defence against collision by guiding pilots to make a safe decision to stop a descent at MSA (if VMC has not been achieved) or climb to MSA (if entering IMC below MSA).

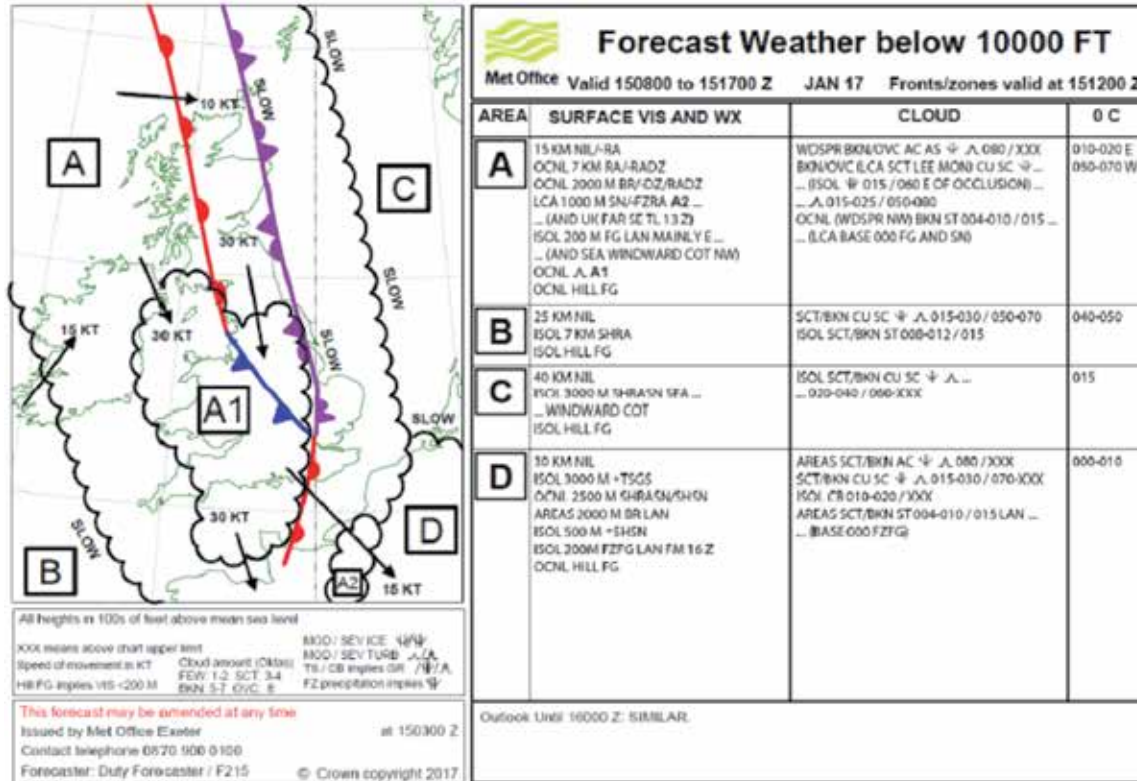
Figure 3

The flight was conducted largely in zone A1. The visibility was expected to be 15 km but occasionally it was expected to be as low as 2,000 m in mist, rain and drizzle, and there would be occasional areas of hill fog. Broken or overcast cloud was forecast with a base between 1,500 ft and 2,500 ft amsl, and there would be occasional broken cloud with a base of 400 ft to 1,000 ft amsl. The cloud base would be at ground level in any hill fog.

Forecast weather below 10,000 ft amsl (Met Office)

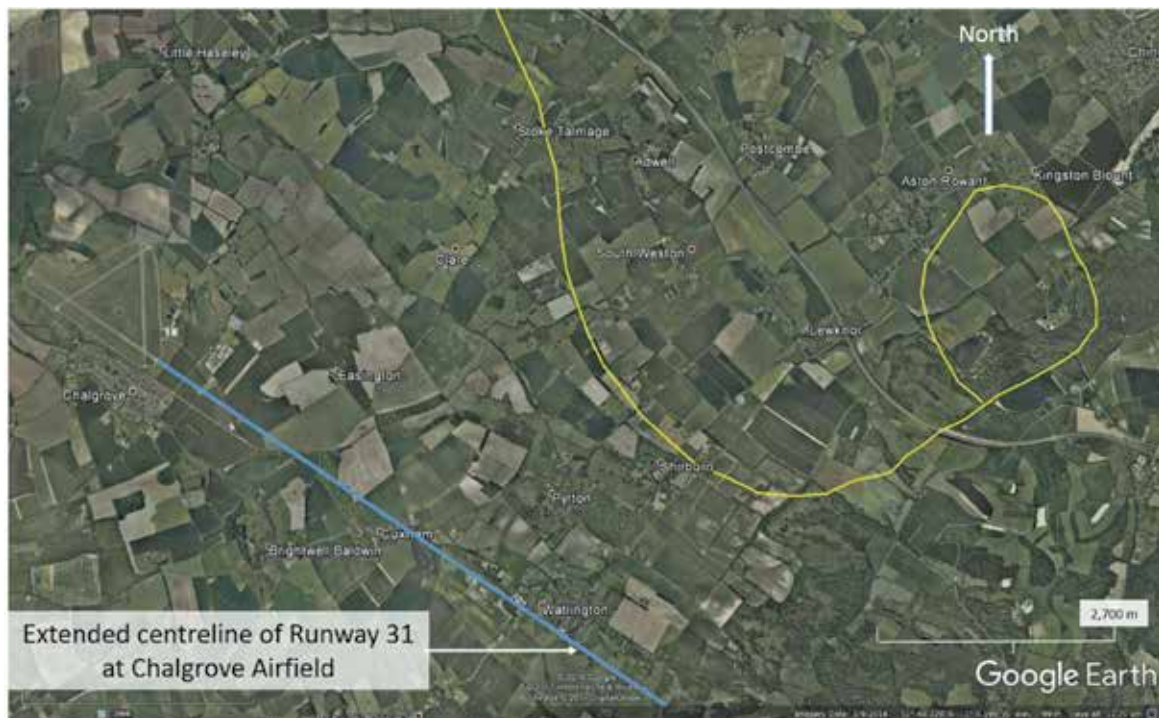
Figure 4

The aircraft's track took it to a point east of its intended destination of Chalgrove Airfield at an altitude of approximately 1,000 ft amsl. The radio was found tuned to the destination frequency, and the altimeter (which was found set to 1012 hPa) would have read approximately zero ft agl on the runway at the destination¹². Had the aircraft slowed down and turned right it would have been in a good position to join the extended centreline of Runway 31 at Chalgrove Airfield in preparation for landing. Instead, however, it turned left towards a ridge of high ground (the Chilterns) at approximately 1424 hrs (Figures 1 and 4).

G-ATMT's track relative to the extended runway centreline at Chalgrove Airfield
(©Google Earth)
