ACCIDENT

Aircraft Type and Registration:	North American P-51D Mustang, G-TFSI	
No & Type of Engines:	1 Packard Motor Car Co Merlin V1650-7 piston engine	
Year of Manufacture:	1944 (Serial no: 124-44703)	
Date & Time (UTC):	9 July 2017 at 1522 hrs	
Location:	Duxford Aerodrome, Cambridgeshire	
Type of Flight:	Private	
Persons on Board:	Crew - 1	Passengers - None
Injuries:	Crew - None	Passengers - N/A
Nature of Damage:	Aircraft sustained structural damage	
Commander's Licence:	Airline Transport Pilot's Licence	
Commander's Age:	55 years	
Commander's Flying Experience:	21,000 hours (of which 9 were on type) Last 90 days - 160 hours Last 28 days - 68 hours	
Information Source:	Aircraft Accident Report Form submitted by the pilot and further enquires by the AAIB

Synopsis

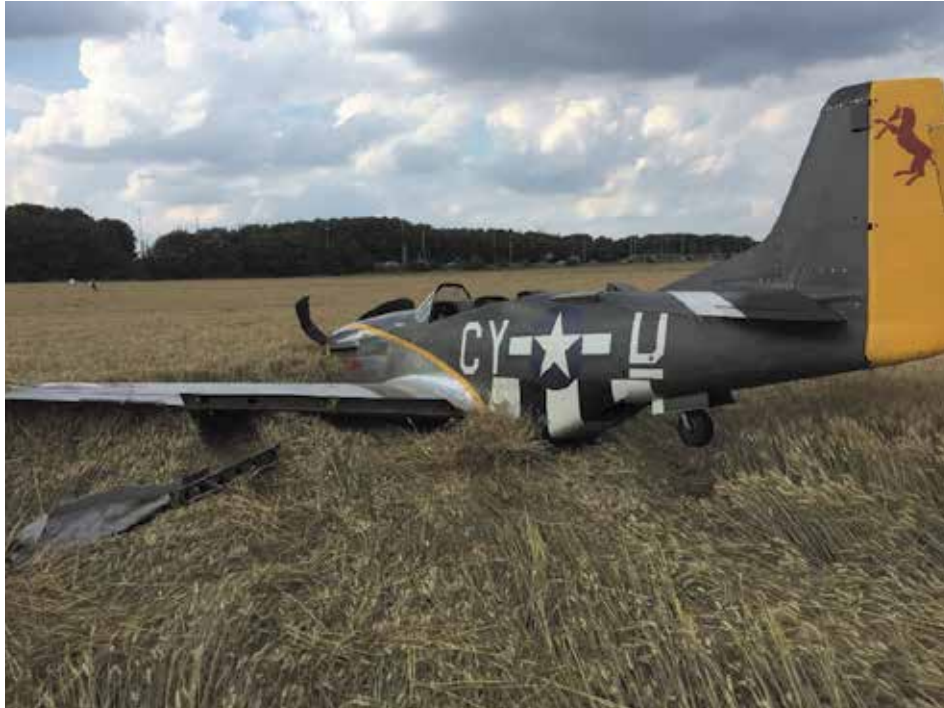
Figure 1

The engine stopped without warning during the latter stages of an air display and after it restarted and stopped several times, the pilot concluded he would be unable to return to the airfield. The aircraft sustained damage after a forced landing in a cornfield, but the pilot was uninjured. The cause of the engine stopping was not known at the time of publication of this report.

G-TFSI after the accident
(Image reproduced with the permission of the pilot)

At the time of publication of this report, the aircraft was being returned to the overhaul facility in the USA for investigation and repair. The cause of the engine stopping was not known, but based upon the reported symptoms, the maintenance agency suspected it to be carburettor related.
