ACCIDENT

Aircraft Type and Registration:	Piper PA-28-140, G-ATVO	
No & Type of Engines:	1 Lycoming O-320-E2A piston engine	
Year of Manufacture:	1966 (Serial no: 28-22020)	
Date & Time (UTC):	30 March 2017 at 1450 hrs	
Location:	Shoreham-by-Sea, West Sussex	
Type of Flight:	Training	
Persons on Board:	Crew - 2	Passengers - None
Injuries:	Crew - None	Passengers - N/A
Nature of Damage:	Aircraft submerged in seawater	
Commander's Licence:	Commercial Pilot's Licence	
Commander's Age:	48 years	
Commander's Flying Experience:	8,303 hours (of which 4,000 were on type) Last 90 days - 8 hours Last 28 days - 5 hours	
Information Source:	Aircraft Accident Report Form submitted by the pilot and further enquiries by the AAIB

Synopsis

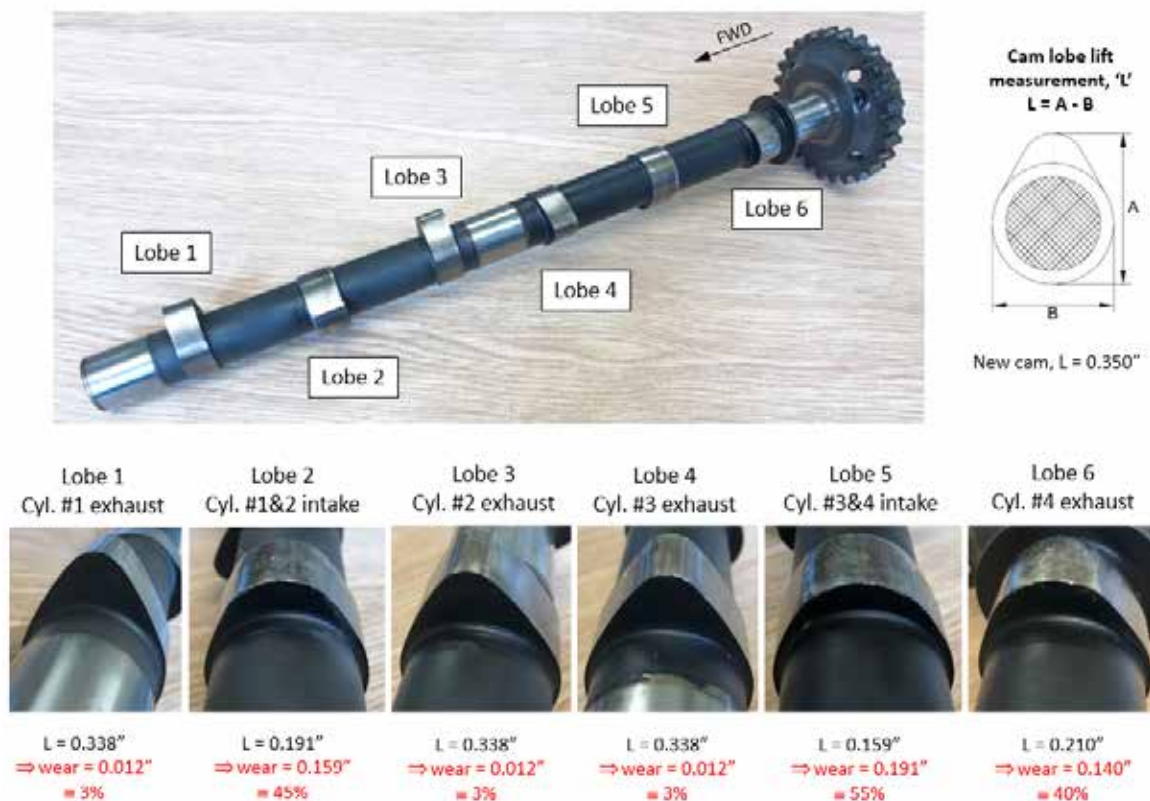
Figure 1

The aircraft's engine was inspected following its disassembly at an engine overhaul facility; the engine has accumulated 1,126 operating hours since its last overhaul. There were no failures evident that would account for an abrupt and complete loss of engine power, although it was noted that the camshaft lobes 2, 5 and 6 were significantly worn, Figure 1. The respective bearing faces of the tappet bodies were also heavily worn, with extensive surface spalling, Figure 2.

Worn camshaft removed from G-ATVO

Camshaft lobes 2 and 5 operate the inlet valves on the forward and aft pair of cylinders respectively. Camshaft lobe 6 operates the exhaust valve on the left rear cylinder.

The worn camshaft lobes would cause a loss of engine power output due to reduced inlet valve travel on all four cylinders and changes in valve timing. However, despite the level of camshaft lobe wear, the engine continued to run smoothly and produced sufficient power to allow the aircraft to take off and climb to 450 ft prior to the loss of power. When the engine was disassembled, no mechanical failures were apparent that could account for a sudden power loss.

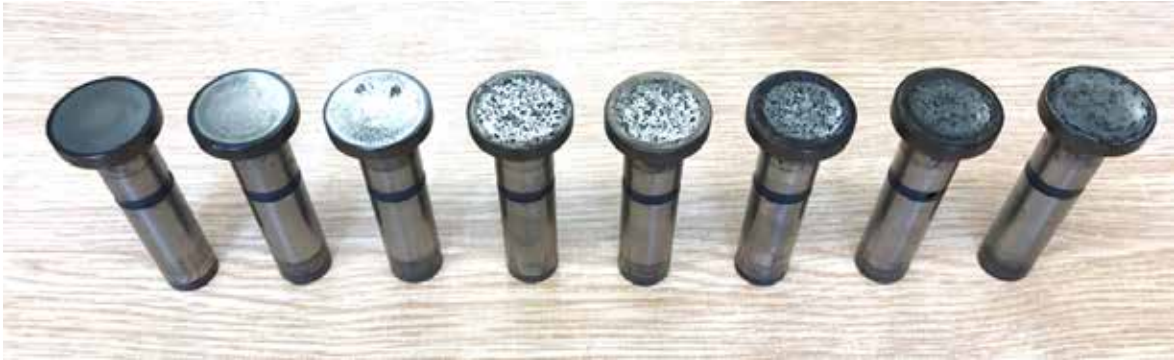
Figure 2

Tappet bodies removed from G-ATVO, showing spalling of the tappet faces

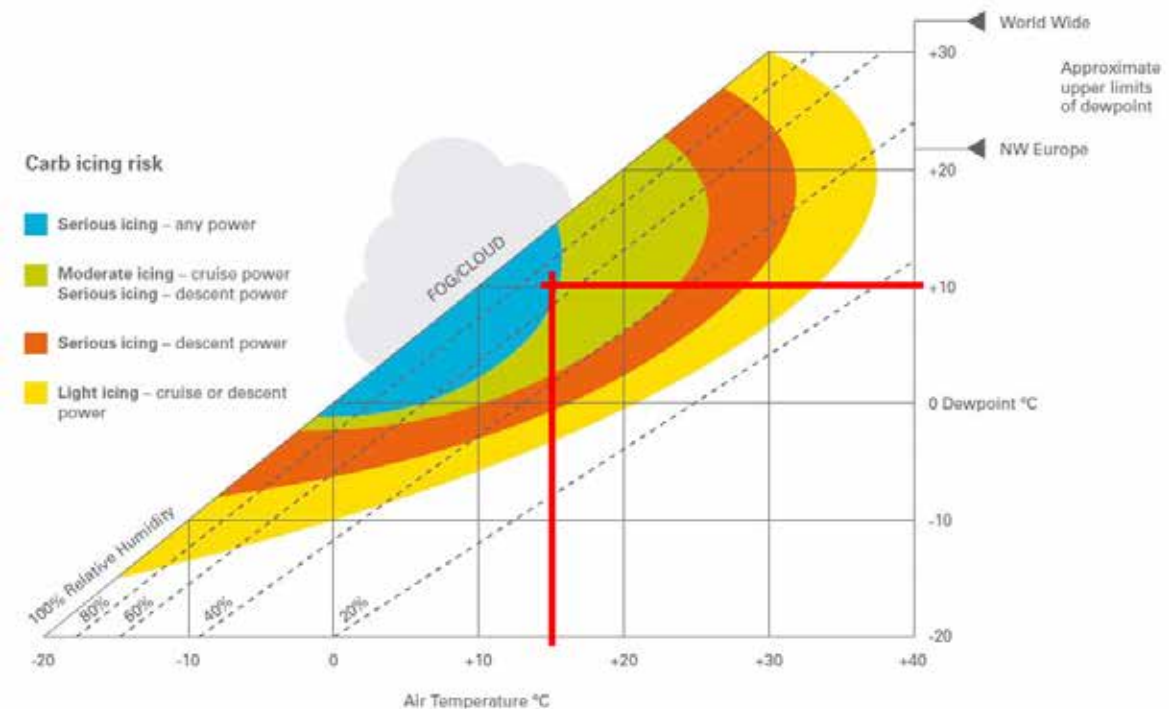
Figure 3

The weather conditions reported at the time the accident occurred were no cloud below 5,000 ft and a visibility of more than 10 km. The wind was from 120°M at 10 kt, the temperature was 15 °C and the dew point was 10 °C. The carburettor icing chart published by the CAA² indicates the possibility of a serious risk of carburettor icing at all power settings, Figure 3.

CAA carburettor icing chart
