## ACCIDENT

<b>Aircraft Type and Registration:</b>	Rotorsport UK MT-03, G-TELC	
<b>No &amp; Type of Engines:</b>	1 Rotax 914-UL piston engine	
<b>Year of Manufacture:</b>	2008 (Serial no: RSUK/MT-03/028)	
<b>Date &amp; Time (UTC):</b>	7 May 2017 at 1427 hrs	
<b>Location:</b>	Near Carrickmore Airfield, Co Tyrone	
<b>Type of Flight:</b>	Private	
<b>Persons on Board:</b>	Crew - 1	Passengers - 1
<b>Injuries:</b>	Crew - 1 (Minor)	Passengers - 1 (Minor)
<b>Nature of Damage:</b>	Damaged beyond economic repair	
<b>Commander's Licence:</b>	Private Pilot's Licence (A) and (G)	
<b>Commander's Age:</b>	59 years	
<b>Commander's Flying Experience:</b>	539 hours (of which 173 were on type) Last 90 days - 11 hours Last 28 days - 9 hours	
<b>Information Source:</b>	Aircraft Accident Report Form submitted by the pilot

## Synopsis

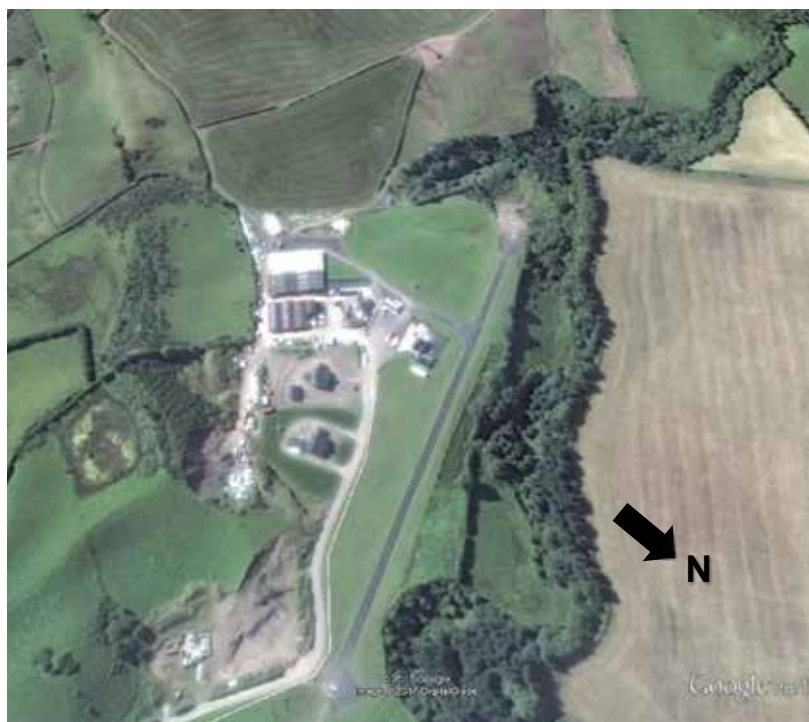
**Figure 1**

Carrickmore Airfield is situated at an elevation of 541 ft amsl on the side of a valley where the ground rises from the north to the south. Runway 26 has a hard surface of 375 m length, with a downslope. Immediately north of the airfield, alongside and below Runway 26, is a line of trees which shelters the runway in northerly wind conditions. At the western end of Runway 26 the ground falls away into a steep wooded ravine. An aerial image of the runway at Carrickmore is at Figure 1.

Airfield at Carrickmore in 2016, Runway 26 threshold at bottom of image
