ACCIDENT

Aircraft Type and Registration:	Rotorsport UK MTOsport, G-CGPG	
No & Type of Engines:	1 Rotax 912ULS piston engine	
Year of Manufacture:	2010 (Serial no: RSUK/MTOS/032)	
Date & Time (UTC):	27 July 2017 at 10:30 hrs	
Location:	Crouch Farm Strip, Swanley, Kent	
Type of Flight:	Private	
Persons on Board:	Crew - 1	Passengers - None
Injuries:	Crew - None	Passengers - N/A
Nature of Damage:	Severe damage to rotor blades, rotor mast and propeller and minor damage to tail fin	
Commander's Licence:	Private Pilot's Licence	
Commander's Age:	72 years	
Commander's Flying Experience:	323 hours (of which 323 were on type) Last 90 days - 10 hours Last 28 days - 1 hour	
Information Source:	Aircraft Accident Report Form submitted by the pilot

Synopsis

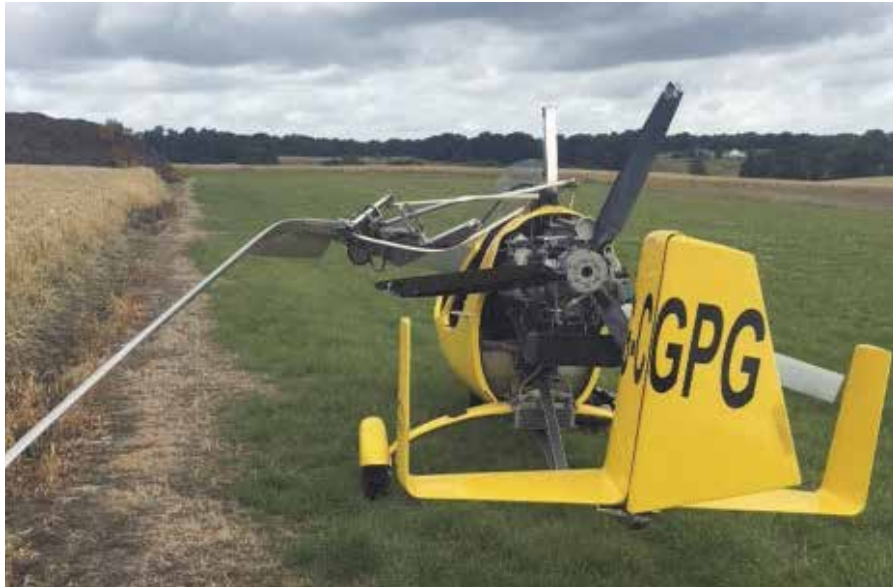
Figure 1

The pilot took off from Crouch Farm for a short flight to Rochester Airport but decided to return due to a radio problem. Before landing on the grass Runway 28, he looked at the windsock and assessed that the wind had not changed since his departure, when it was from 230° at 12 kt. Just before touchdown the gyroplane veered left, and the pilot believes that he then moved the control stick too much and either there was not enough airflow over the rudder to maintain directional control or his input to the rudder was insufficient. Consequently the rotor blades struck the ground and the rotor mast broke and collapsed, but the gyroplane remained upright and came to rest near the edge of the runway (Figure 1).

Rear view of G-CGPG after it came to rest at the edge of the runway, next to a crop

The pilot later assessed that he had probably experienced low-level windshear, caused by a crop approximately two feet tall which was adjacent to the runway. Usually, if he is unsure of the wind conditions, he makes an assessment during a low level pass along the runway and, had he done this, he may have realised there was a problem. He also noted that he had little recent flying practice and, if he had pressed harder on the rudder pedal and added some power to maintain rudder authority, he could probably have straightened the gyroplane and avoided the accident.

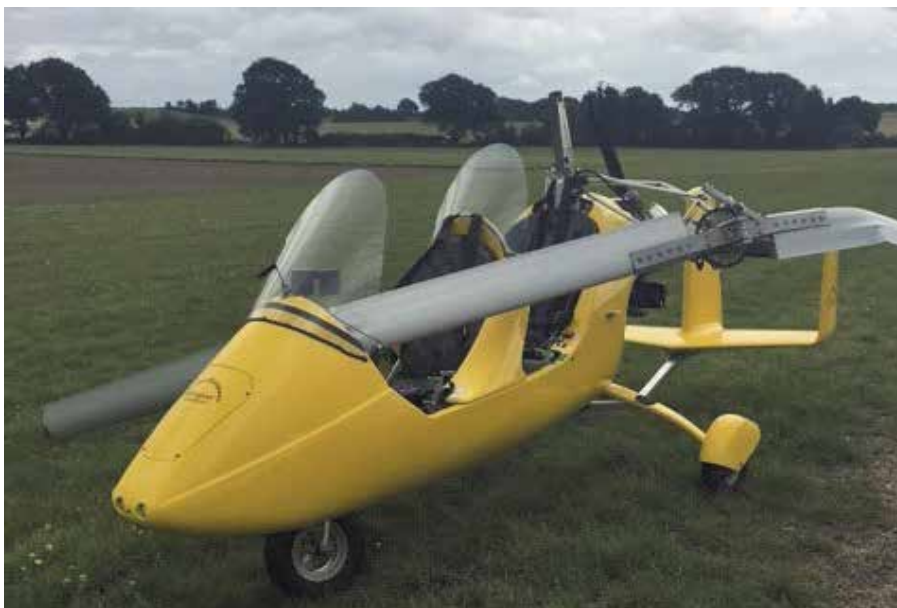
Figure 2

As the rotor blades slowed to a halt, one of them dropped gently into the pilot's lap, without injuring him, and he was able to lift it, unstrap and step out (Figure 2). All three propeller blades were damaged and the pilot assumes they made contact with the rotor during the accident.

View showing broken rotor mast and rotor blade resting across the pilot's seat
