ACCIDENT

Aircraft Type and Registration:	Robin DR400/180 Regent, G-ETIV	
No & Type of Engines:	1 Lycoming O-360-A3A piston engine	
Year of Manufacture:	2000 (Serial no: 2454)	
Date & Time (UTC):	7 December 2016 at 1327 hrs	
Location:	Rochester Airport, Kent	
Type of Flight:	Private	
Persons on Board:	Crew - 1	Passengers - 1
Injuries:	Crew - None	Passengers - None
Nature of Damage:	Right mainwheel spat severely cracked and brake unit damaged	
Commander's Licence:	Private Pilot's Licence	
Commander's Age:	76 years	
Commander's Flying Experience:	863 hours (of which 728 were on type) Last 90 days - 21 hours Last 28 days - 0 hours	
Information Source:	AAIB enquiries in response to a report from Rochester Airport

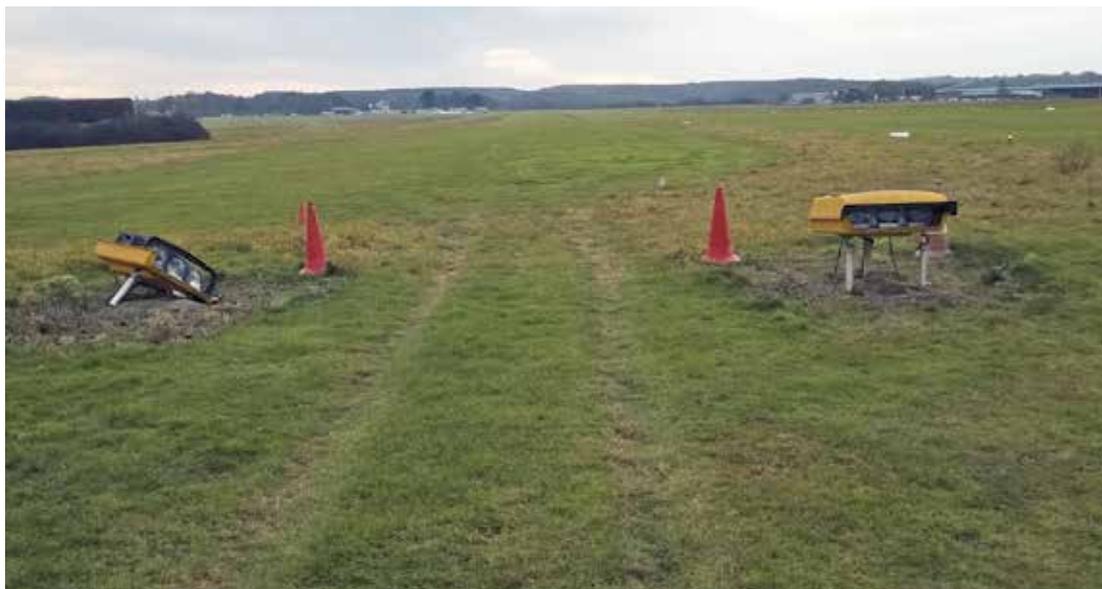
Figure 1

The pilot believed the aircraft was now close to stalling, because the power had not been increased, but he managed to regain control and land on Runway 20R. After taxiing to the apron he was made aware that the right mainwheel had struck an abbreviated precision approach path indicator (APAPI) unit positioned in the Runway 20L undershoot (Figure 1).

APAPI units showing damage to the left unit, in a view looking along Runway 20L from the undershoot. The units are installed for Runway 20R which is on the right of the photograph

The airfield duty manager was positioned to the east of the Runway 20R threshold when he observed the aircraft approaching left of the Runway 20L approach path. He described the aircraft as appearing to be “very low” and “very slow”. He estimated it was two feet above the ground, flying relatively slowly and still downwind and to the left of the Runway 20L threshold when it abruptly veered right towards Runway 20R. He had the impression the aircraft was close to stalling when the right mainwheel struck the left APAPI unit, which detached from its mountings.
