ACCIDENT

Aircraft Type and Registration:	Boeing 737-4Q8, OE-IAG
No & Type of Engines:	2 CFM56-3C1 turbofan engines
Year of Manufacture:	1992 (s/n 25168)
Date & Time (UTC):	4 October 2016 at 0455 hrs
Location:	Runway 25, Belfast International (Aldergrove) Airport
Type of Flight:	Commercial Air Transport (Cargo)
Persons on Board:	Crew - 2 Passengers - None
Injuries:	Crew - None Passengers - N/A
Nature of Damage:	Fractured lower torsion link on right main gear leg
Commander's Licence:	Airline Transport Pilot's Licence
Commander's Age:	45 years
Commander's Flying Experience:	5,900 hours (of which 900 were on type) Last 90 days - n/k hours Last 28 days - n/k hours
Information Source:	AAIB Field Investigation

Synopsis

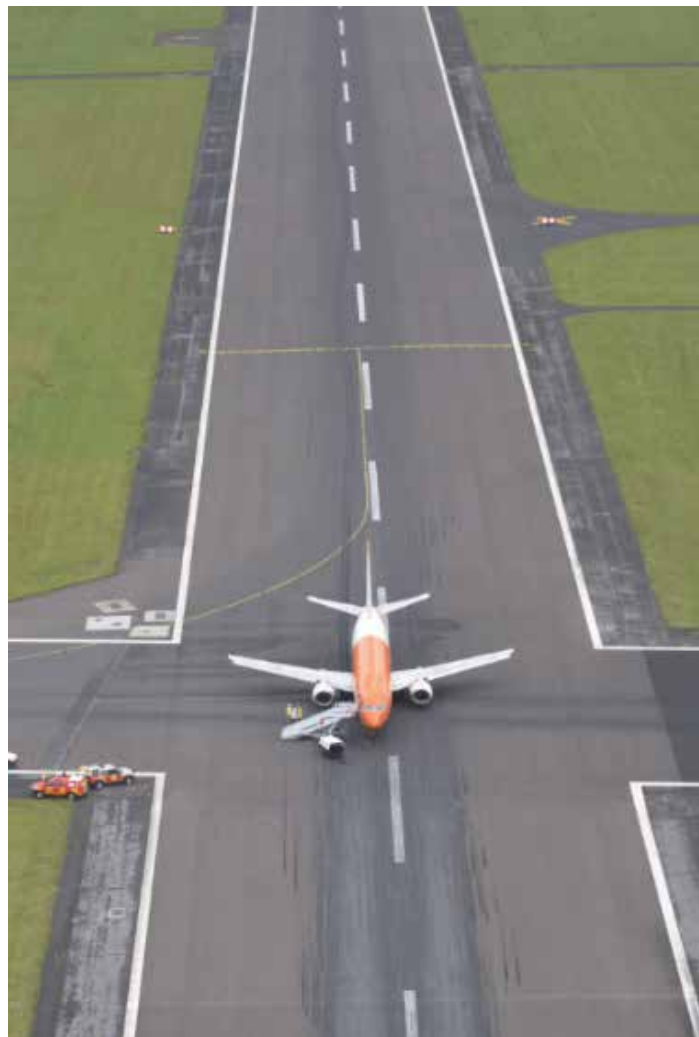
Figure 2

The aircraft stopped on Runway 25 at its intersection with Runway 17/35 (Figure 2).

Image showing aircraft stopped at intersection of the two runways

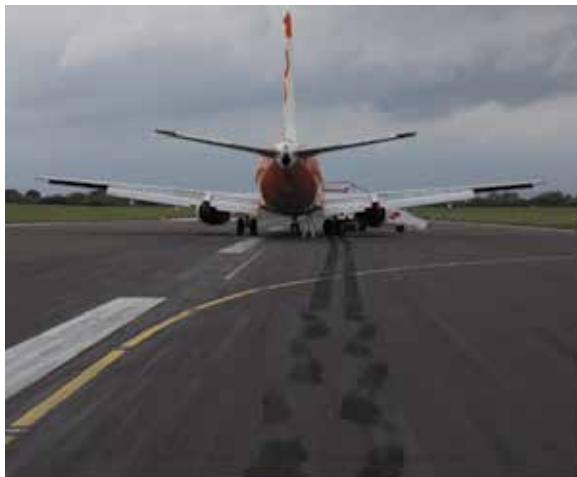
Figure 3

A pair of parallel tyre marks to the right of the centre line on Runway 25 had a distinctive 'S-shaped' pattern, and started approximately 900 m from the threshold of Runway 25. They continued to the main wheels on the right MLG leg; however for the last 60 m the two marks became straight (Figures 2, 3 and 4).

Image showing tyre marks close to the aircraft

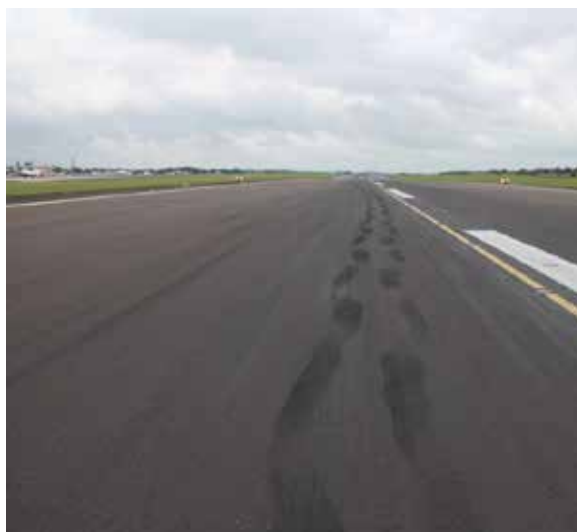
Figure 4

Image looking approximately east showing tyre marks

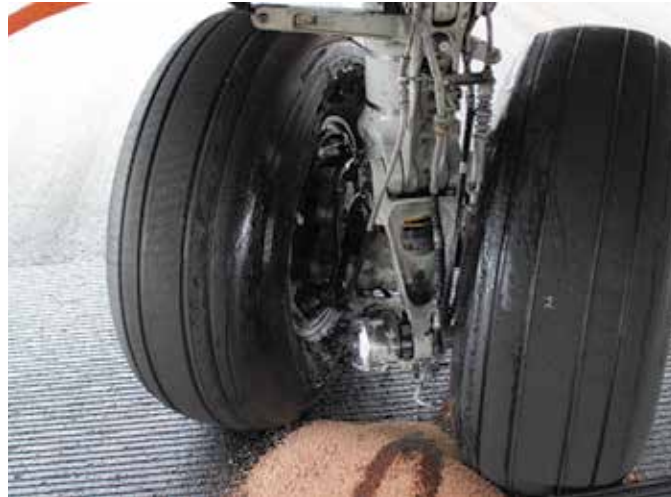
Figure 5

When inspected, both wheels of the right MLG were skewed to one side and there was significant damage to both wheel hubs and both tyres (Figure 5). Both tyres had remained inflated.

The lower torsion link on the right MLG had fractured. Several pieces of debris were recovered from the runway, including pieces of the bushings from the apex where the upper and lower torsion links join. It was not possible to make an accurate assessment of the shimmy damper link condition due to the high level of damage.

Image of right MLG showing torsion link

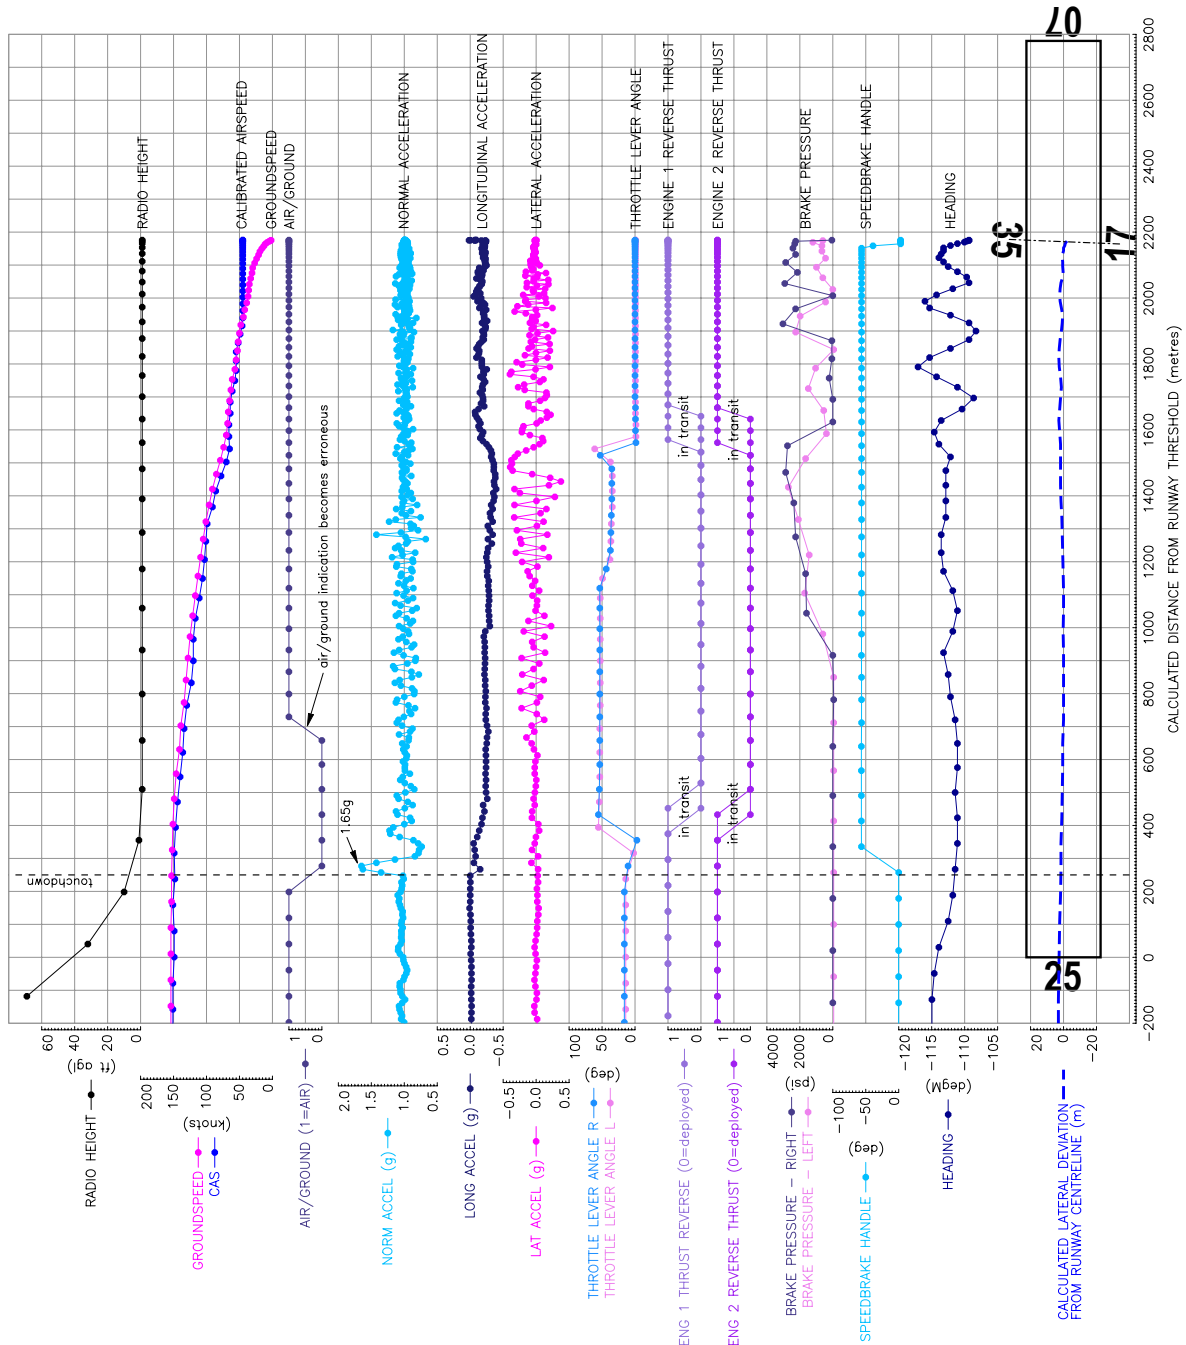
An analysis of the data indicates that the aircraft touched down about 250 metres beyond the threshold to Runway 25. The speed brakes deployed on touchdown and the thrust reversers were fully deployed by 530 m beyond the threshold. At about 690 m beyond the

threshold, the air/ground discrete erroneously changed to AIR, followed by oscillations in lateral acceleration.

At 950 m beyond the threshold, the brakes were applied. They were released temporarily after about 600 m when the thrust reversers were re-stowed. The aircraft then oscillated from the runway centreline before stopping 2,170 m beyond the threshold.

Figure 6
Pertinent FDR data and ground track on landing

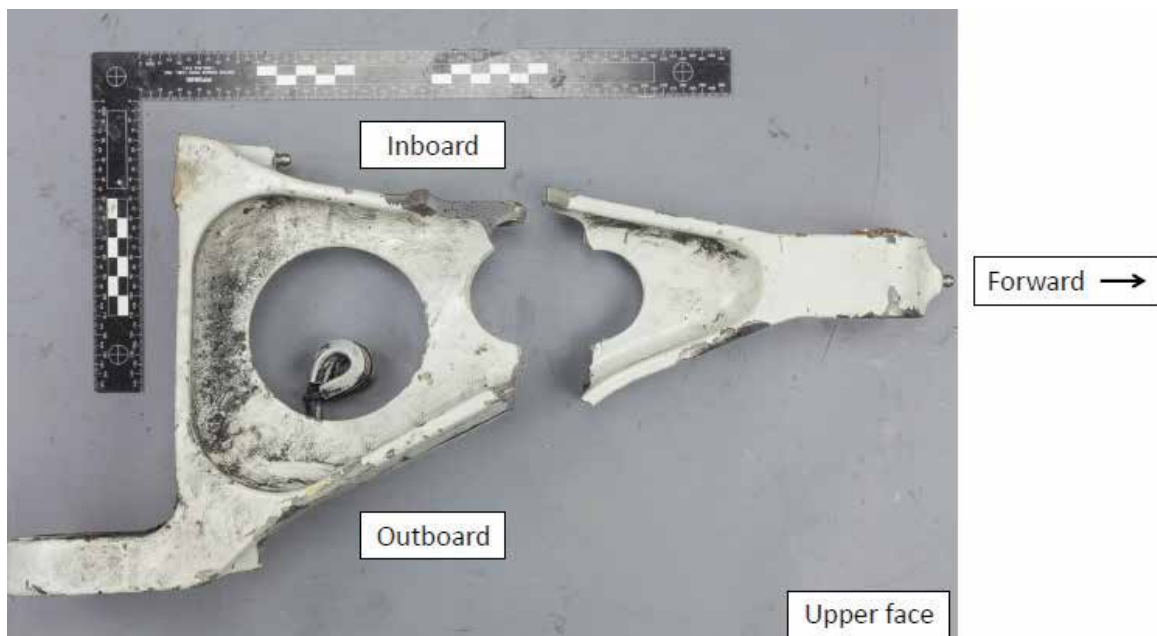
Figure 8

The two pieces of the fractured lower torsion link (Figure 8) were sent to a metallurgical laboratory for an assessment of the fracture surfaces (note the inboard lug at the top left of the image was cut during removal from the aircraft).

The assessment concluded that the torsion link had failed in overload. There was no evidence of fatigue. It was concluded that the failure of the torsion link was caused by shimmy.

Image of fractured torsion link (courtesy of QinetiQ)

The physical and recorded evidence indicate that the fracture to the lower torsion link on the right MLG leg was most likely caused by shimmy. This and previous occurrences show that the Boeing 737 MLG is susceptible to shimmy, particularly at higher landing speeds and for softer landings.
