ACCIDENT

Aircraft Type and Registration:	Europa, G-NDOL	
No & Type of Engines:	1 Rotax 912ULS engine	
Year of Manufacture:	1995 (Serial no: PFA 247-12594)	
Date & Time (UTC):	28 May 2017 at 1200 hrs	
Location:	Apperknowle, Derbyshire	
Type of Flight:	Private	
Persons on Board:	Crew - 1	Passengers - None
Injuries:	Crew - 1 (Fatal)	Passengers - N/A
Nature of Damage:	Aircraft destroyed	
Commander's Licence:	Light Aircraft Pilot's Licence	
Commander's Age:	79 years	
Commander's Flying Experience:	1,146 hours (of which 880 were on type) Last 90 days - 7 hours Last 28 days - 1 hour	
Information Source:	AAIB Field investigation

Synopsis

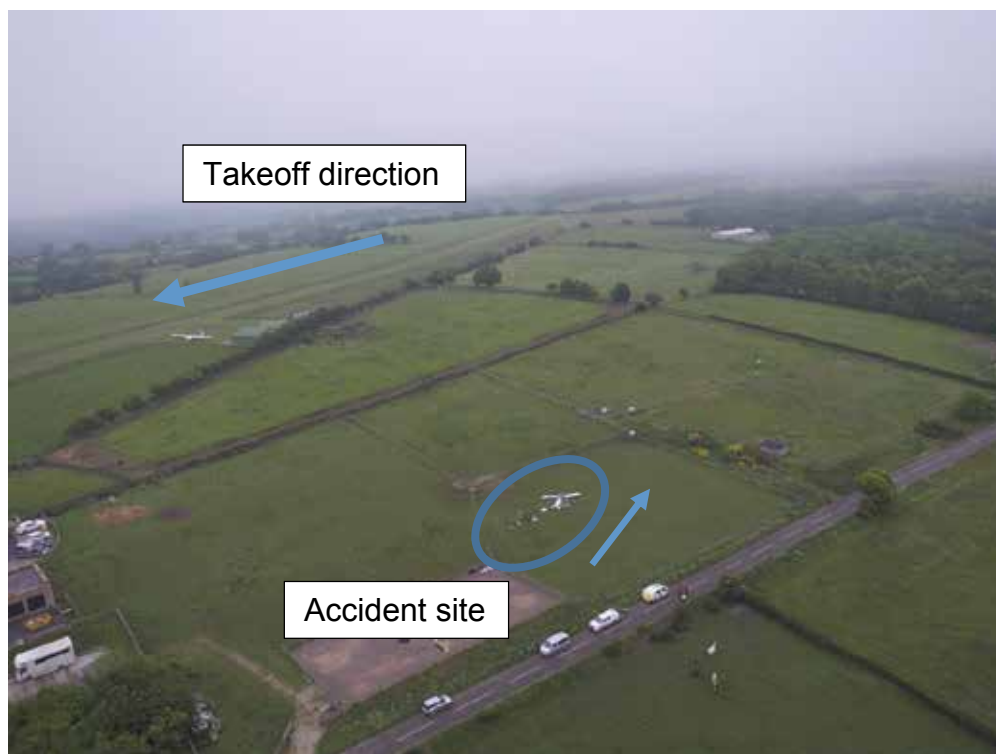
Figure 2

The accident site was located in a field approximately 200 m south of the runway at Coal Aston Airfield (Figure 2). The aircraft was inverted and the evidence indicated it had struck the ground in a steep nose-down attitude. The ground was hard; a thin layer of turf covered a hard stone sublayer. In addition to the main fuselage impact point, a clear mark in the ground was made by the leading edges of the wings.

The main wreckage came to rest approximately 19 m from the initial impact marks. Most of the wreckage was within the area between the main wreckage and the ground marks. A notable exception was a substantial piece of a propeller blade which was found approximately 39 m from the initial impact point and perpendicular to the wreckage trail.

Coal Aston Airfield and the accident site

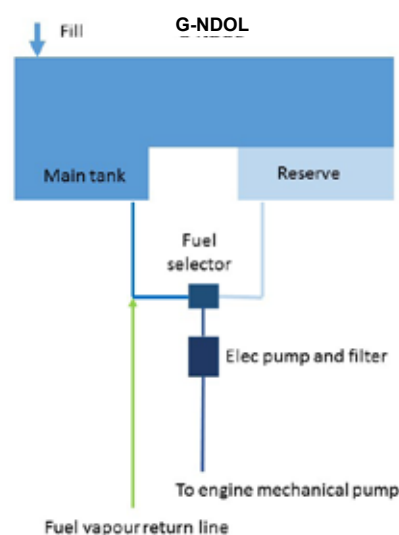
Figure 4

G-NDOL fuel system schematic

The fuel selector was configured such that the left side of the tank was used as *RESERVE* and the right side and remainder of the tank was designated as *MAIN*. This configuration was indicated by a placard close to the selector. This was the original design configuration but it was amended, by Europa, to the current configuration early in production.

No coarse fuel filters were found on the tank outlet fittings.

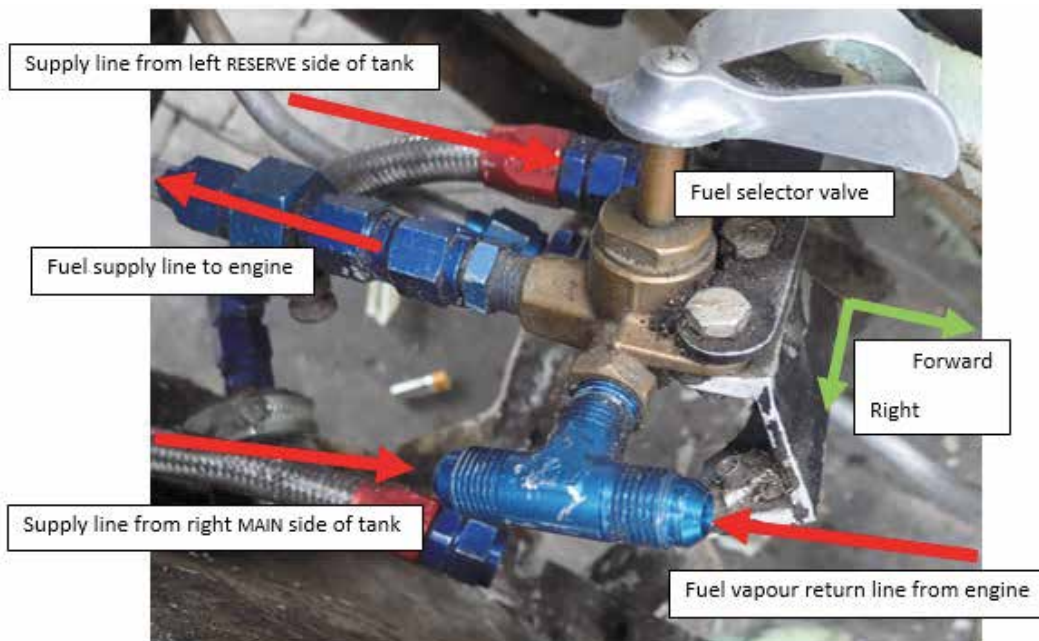
Figure 5

The fuel vapour return line was routed to a 'T' fitting on the fuel selector where it combined with fuel from what had been configured as the main tank (Figure 5).

Fuel selector valve showing 'T' fitting on inlet from right side of tank

There was one significant anomaly relating to the fuel system that may have been relevant to the accident. The fuel vapour return line was connected to the inlet of the fuel selector valve, rather than to the fuel tank. This would have the effect of routing any fuel vapour that formed in the fuel system back to the engine instead of returning to the fuel tank to dissipate.

Due to the installation of the fuel system on G-NDOL any fuel vapours that formed would not have been dissipated to atmosphere via the fuel tank vent as designed, but instead they would be recirculated back into the fuel supply to the engine and thereby increasing the risk of a disruption to the fuel supply to the engine.

On 19 July 2017 the LAA issued Airworthiness Information Leaflet LAA/MOD/247/010. This required a mandatory inspection, before next flight, of all Europa aircraft operating under an LAA administered Permit to Fly. The inspection was to check for the correct installation of a fuel vapour return line. Details can be found on the LAA website.

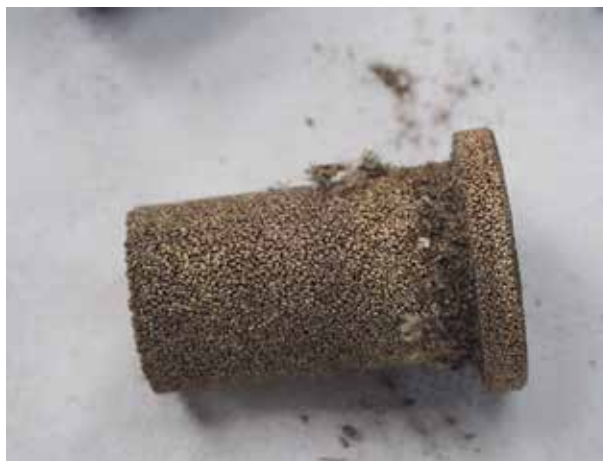
Figure 6

The fuel filter assembly was removed and its sintered bronze filter element was inspected. It was found contaminated with general dirt and debris which included insect remains (Figure 6).

Fuel filter element showing contamination found

A flow test was carried out to determine the degree of restriction caused by the debris. The first test was carried out using the filter element fitted at the time of the accident and the test was then repeated with a new element. On both occasions fuel was supplied to the filter by the electric fuel pumps from the aircraft. The results from both the old and the new filters were similar and the fuel flow recorded was well in excess of that required by the engine at full power.
