**SERIOUS INCIDENT**

<b>Aircraft Type and Registration:</b>	AW109SP Grand New, G-HLCM	
<b>No &amp; Type of Engines:</b>	2 Pratt & Whitney Canada PW207C turboshaft engines	
<b>Year of Manufacture:</b>	2017 (Serial no: 22369)	
<b>Date &amp; Time (UTC):</b>	2 August 2017 at 1514 hrs	
<b>Location:</b>	Private landing site near Clifton Dykes, Penrith, Cumbria	
<b>Type of Flight:</b>	Commercial Air Transport (Non-Revenue)	
<b>Persons on Board:</b>	Crew - 1	Passengers - None
<b>Injuries:</b>	Crew - None	Passengers - N/A
<b>Nature of Damage:</b>	Main rotor blade tip cap detached	
<b>Commander's Licence:</b>	Commercial Pilot's Licence	
<b>Commander's Age:</b>	57 years	
<b>Commander's Flying Experience:</b>	3,900 hours (of which 2,500 were on type) Last 90 days - 112 hours Last 28 days - 26 hours	
<b>Information Source:</b>	Aircraft Accident Report Form submitted by the pilot and further enquiries by the AAIB

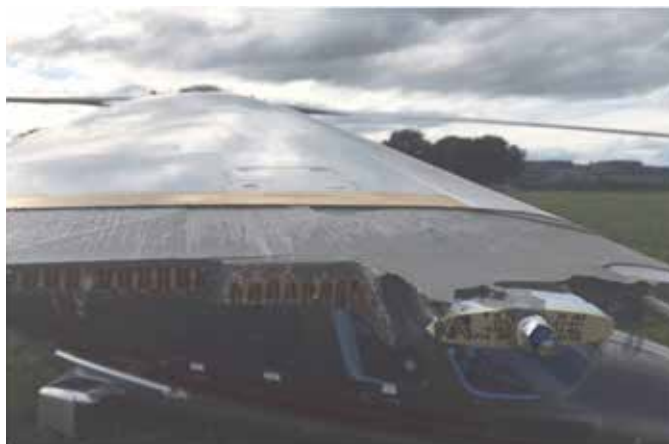
**Figure 1**

After shutdown it was apparent that the tip cap of one of the main rotor blades was missing (Figure 1). The cap was not recovered.

Damaged main rotor blade tip (looking towards the main rotor hub)

Investigation by the manufacturer established that the tip cap had detached because of a surface preparation error that had reduced the strength of the bonded joint.

The manufacturer identified the main rotor blades that were potentially affected and issued Service Bulletin 109SP-116 to introduce a periodic inspection.

The EASA issued Emergency Airworthiness Directive 2017-0176-E to mandate the requirements of the Service Bulletin.
