## ACCIDENT

<b>Aircraft Type and Registration:</b>	Piper PA-23-250 Aztec, G-BCCE	
<b>No &amp; Type of Engines:</b>	2 Lycoming IO-540-C4B5 piston engines	
<b>Year of Manufacture:</b>	1973 (Serial no: 27-7405282)	
<b>Date &amp; Time (UTC):</b>	30 June 2017 at 1542 hrs	
<b>Location:</b>	Shoreham Airport, Sussex	
<b>Type of Flight:</b>	Private	
<b>Persons on Board:</b>	Crew - 1	Passengers - 1
<b>Injuries:</b>	Crew - None	Passengers - None
<b>Nature of Damage:</b>	Nose landing gear and forward fuselage	
<b>Commander's Licence:</b>	Airline Transport Pilot's Licence	
<b>Commander's Age:</b>	47 years	
<b>Commander's Flying Experience:</b>	8,500 hours (of which 1,000 were on type) Last 90 days - 56 hours Last 28 days - 17 hours	
<b>Information Source:</b>	Aircraft Accident Report Form submitted by the pilot and additional enquiries made by the AAIB

## Synopsis

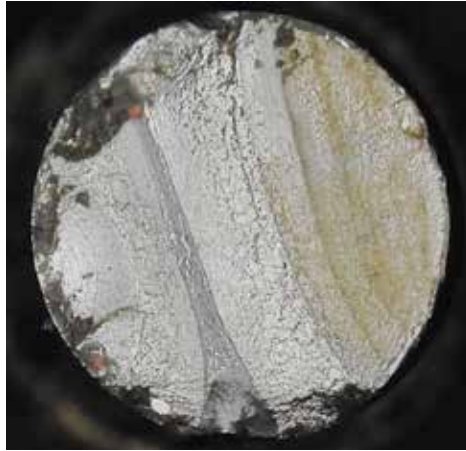
**Figure 1**

The upper drag link attachment bolt was found to be broken and the fracture faces showed evidence of reverse bending fatigue (Figure 1). Contamination/corrosion products indicated that the fatigue had been propagating for some time.

Broken drag link bolt, indicating reverse bending fatigue

The definitive failure mechanism was not established, but it was evident that the drag link attachment bolt had been exposed to cyclic loading that exceeded its capability. Failure of the inboard attachment lugs could result in 'flexing' of the drag link attachment and, therefore, excessive loading of the bolt.

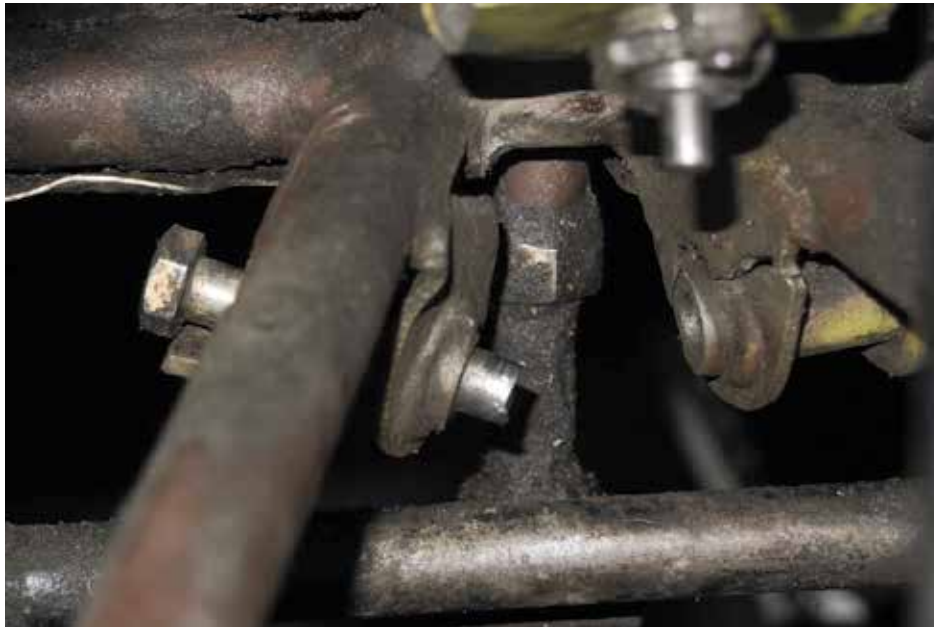
**Figure 2**

The upper drag link attachment lugs were distorted and both inboard lugs were cracked (Figure 2). The accumulation of dirt on the fracture faces indicated that the cracks had existed for some time.

Cracked and distorted drag link attachments  
(remnants of the drag link bolt are still in-situ)
