ACCIDENT

Aircraft Type and Registration:	Europa, G-BZTH
No & Type of Engines:	1 Rotax 912-UL piston engine
Year of Manufacture:	2002 (Serial no: PFA 247-12494)
Date & Time (UTC):	4 August 2017 at 1106 hrs
Location:	Near Parsons Barn, Long Compton, Warwickshire
Type of Flight:	Private
Persons on Board:	Crew - 1 Passengers - None
Injuries:	Crew - 1 (Minor) Passengers - N/A
Nature of Damage:	Forward fuselage distorted and fractured aft of firewall
Commander's Licence:	Private Pilot's Licence
Commander's Age:	72 years
Commander's Flying Experience:	802 hours (of which 661 were on type) Last 90 days - 45 hours Last 28 days - 4 hours
Information Source:	Aircraft Accident Report Form submitted by the pilot

Synopsis

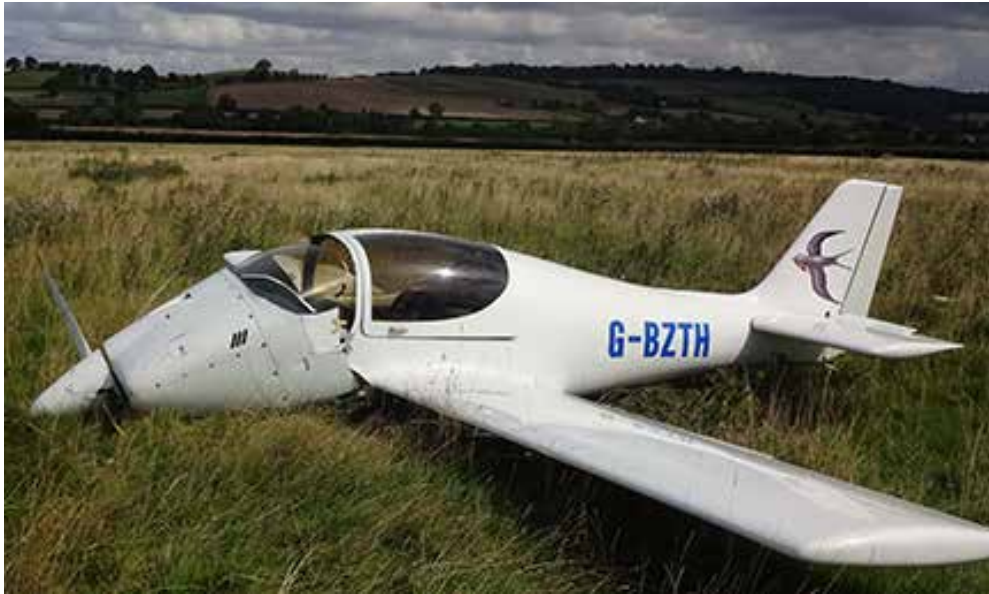
Figure 1

After running along the ground a short distance, the aircraft decelerated violently and came to a halt. The pilot exited through his door and then noticed there were ground ridges which were not visible from the air. He had landed across the ridges and it was one of these that caused the deceleration and the damage to the aircraft (Figure 1).

Following recovery of the aircraft, the pilot discovered that the oil drain plug for the engine was missing and the engine had seized due to lack of lubrication.

The engine and forward fuselage of G-BZTH seen resting on a ridge with the rear fuselage in a broad furrow

Prior to the flight the pilot had changed the engine oil, with assistance from a friend. The oil had been drained and the aircraft left unattended before the engine was refilled with oil, and an engine run was carried out to check the oil pressure. No oil leak was seen after the engine run, but it appears the oil plug was not refitted correctly, possibly due to some miscommunication, and it became detached during the flight, allowing the oil to escape.
