ACCIDENT

Aircraft Type and Registration:	Midget Mustang M-1, G-CHJO	
No & Type of Engines:	1 Continental Motors Corp O-200-A piston engine	
Year of Manufacture:	1998 (Serial no: 1726)	
Date & Time (UTC):	5 August 2017 at 1225 hrs	
Location:	North Coates Airfield, Lincolnshire	
Type of Flight:	Private	
Persons on Board:	Crew - 1	Passengers - None
Injuries:	Crew - None	Passengers - N/A
Nature of Damage:	Right main landing gear leg detached, skin damage to right wing and rear fuselage	
Commander's Licence:	Private Pilot's Licence	
Commander's Age:	78 years	
Commander's Flying Experience:	1,996 hours (of which 93 were on type) Last 90 days - 8 hours Last 28 days - 2 hours	
Information Source:	Aircraft Accident Report Form submitted by the pilot

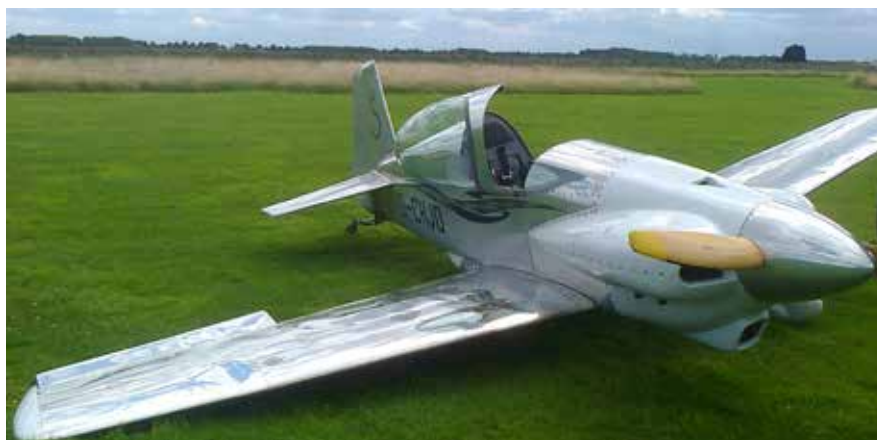
Figure 1

Following a firm landing, the aircraft rolled for approximately 100 m before the right main landing gear leg collapsed. The aircraft veered to the right and after it came to rest, in long grass adjacent to the runway, the pilot shutdown the engine and exited the aircraft normally. A photograph of the aircraft was taken (Figure 1) after it was moved to a grass parking area.

G-CHJO following failure of the right main landing gear leg

The pilot inspected the aircraft and discovered the right gear leg attachment bracket had failed near a weld. It was his view that the weld had not penetrated the metal sufficiently to achieve the required strength. He also discovered that the four attachment bolts on the bracket were only finger-tight and that they had been rotating. However, a detailed assessment of the failure was not made.
