ACCIDENT

Aircraft Type and Registration:	Piper L18C Super Cub, G-BIYJ	
No & Type of Engines:	1 Continental Motors Corp O-200-A piston engine	
Year of Manufacture:	1951 (Serial no: 18-1000)	
Date & Time (UTC):	18 July 2017 at 1007 hrs	
Location:	Pilmuir Farm, Lundin Links, Leven, Fife	
Type of Flight:	Private	
Persons on Board:	Crew - 1	Passengers - None
Injuries:	Crew - 1 (Serious)	Passengers - N/A
Nature of Damage:	Extensive	
Commander's Licence:	Private Pilot's Licence	
Commander's Age:	75 years	
Commander's Flying Experience:	1,059 hours (of which 584 were on type) Last 90 days - 7 hours Last 28 days - 2 hours	
Information Source:	Aircraft Accident Report Form submitted by the pilot

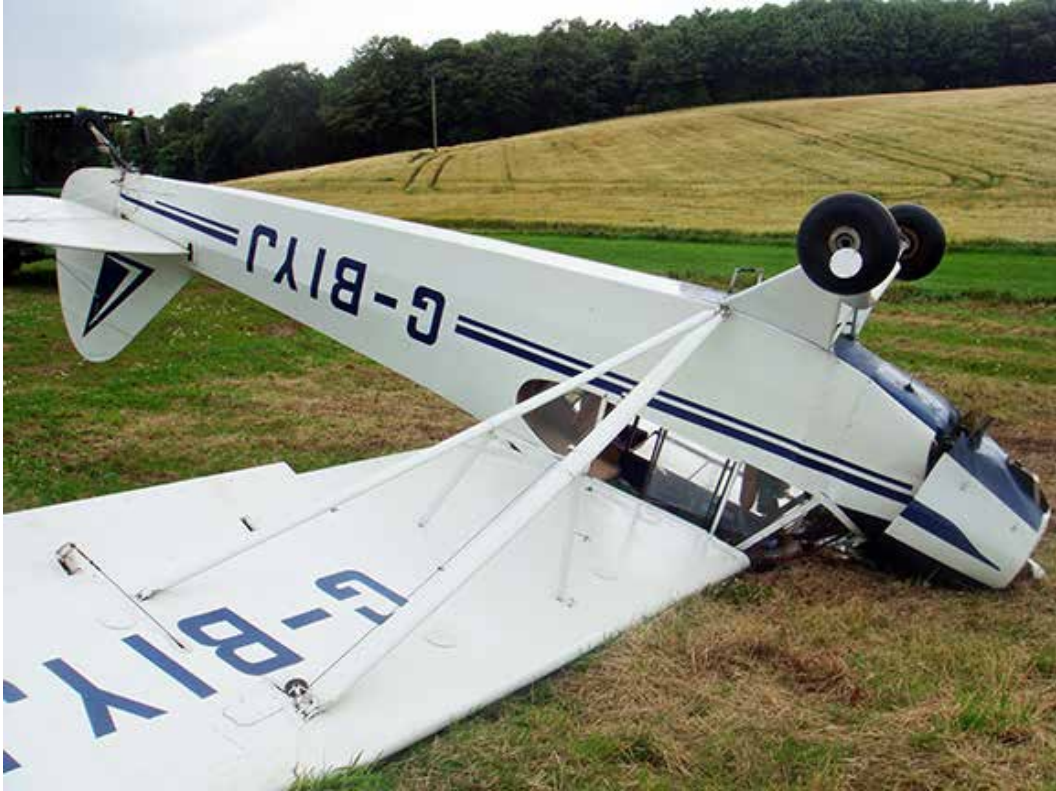
Figure 1

After being flipped upside down (Figure 1), the aircraft came to rest with the engine stopped and the pilot was able to turn off the electrics, undo his seat belt and escape through the door onto the upturned right wing. His assessment was that a sudden gust of wind caused the aircraft to swing right. He later discovered that, just before the accident occurred, a person spraying nearby crops experienced squally conditions which caused them to suspend their work.

The airstrip can be seen above the upturned fuselage and the farm vehicle is partly visible behind the tail of G-BIJJ
