ACCIDENT

Aircraft Type and Registration:	Vans RV-7A, G-ELVN	
No & Type of Engines:	1 Lycoming YIO-360-M1B piston engine	
Year of Manufacture:	2015 (Serial no: LAA 323-14930)	
Date & Time (UTC):	12 August 2017 at 1325 hrs	
Location:	Sywell Aerodrome, Northamptonshire	
Type of Flight:	Private	
Persons on Board:	Crew - 1	Passengers - 1
Injuries:	Crew - None	Passengers - None
Nature of Damage:	Extensive	
Commander's Licence:	Light Aircraft Pilot's Licence	
Commander's Age:	57 years	
Commander's Flying Experience:	88 hours (of which 43 were on type) Last 90 days - 23 hours Last 28 days - 8 hours	
Information Source:	Aircraft Accident Report Form submitted by the pilot and enquiries made by the AAIB

Synopsis

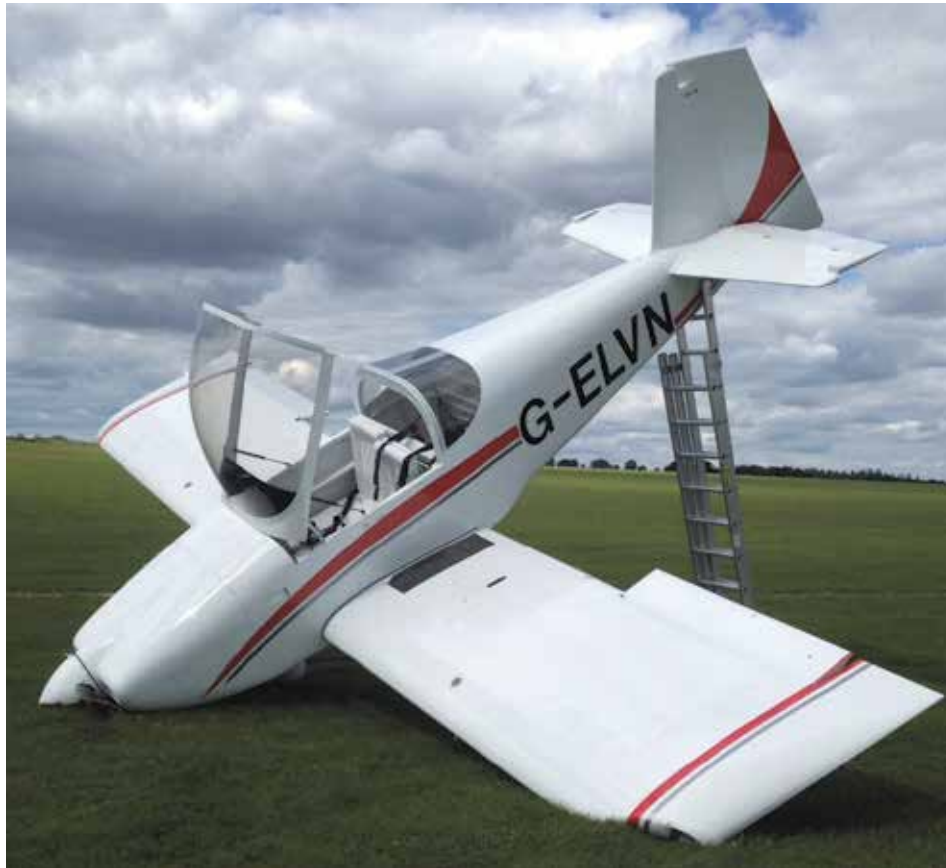
Figure 1

The aircraft landed heavily on the nose landing gear which collapsed, the propeller struck the ground and the aircraft slid to a halt in a tail-high attitude, resting on its lower engine cowling and left wingtip. The pilot stated that he was not familiar with the aerodrome's grass landing surface and found it difficult to judge his height above the runway while landing.

G-ELVN after the accident,
with runway centreline markings visible to the aircraft's right

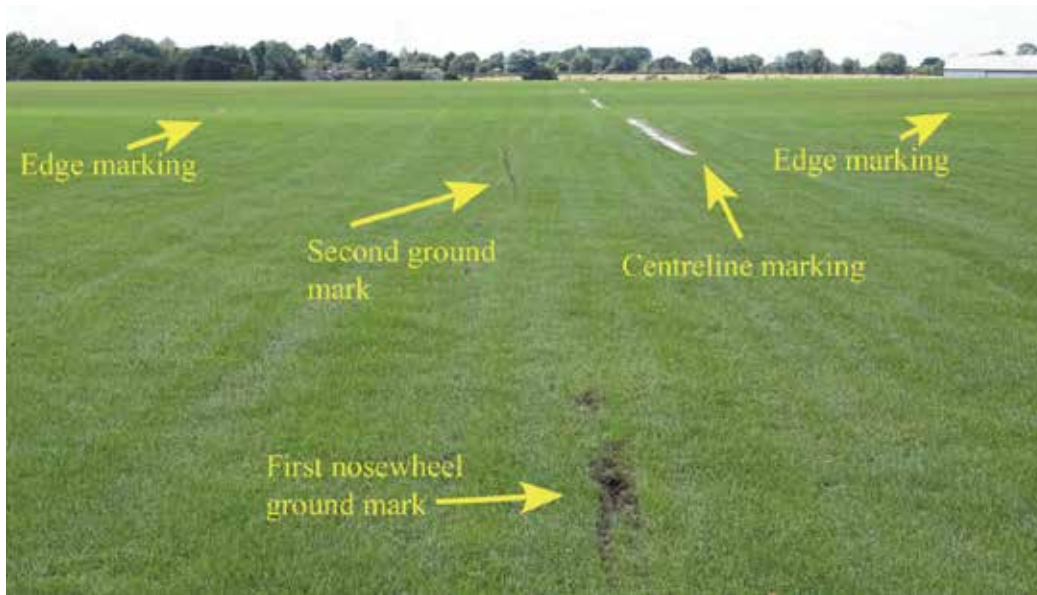
Figure 2

The aerodrome authority stated that the markings on Runway 23 accord with the CAA's '*Licensing of Aerodromes*' publication¹ and were re-chalked less than four months before the accident. A photograph taken after the aircraft was moved shows two ground marks made by the nose landing gear, with the gap between (Figure 2) which suggests that the aircraft landed heavily on the nose gear and then bounced. A historic photograph of the aerodrome (Figure 3), illustrates the markings on Runway 23 from the air.

Marks on runway seen from eye level
(Photograph courtesy of Mr Jeff Bell)

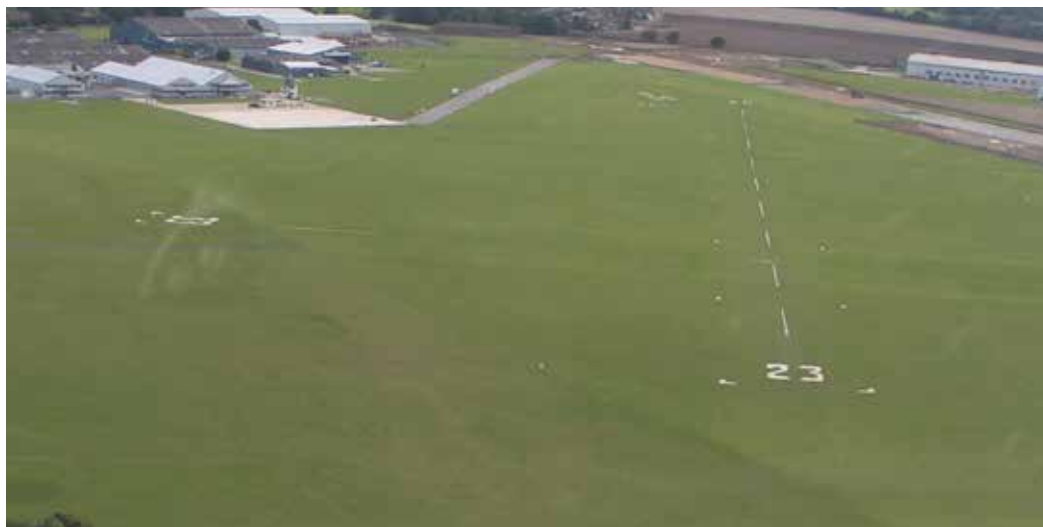
Figure 3

Aerial photograph of Sywell Aerodrome, dated 2008, showing the Runway 23 markings
(Photograph courtesy of Mr Jeff Bell)
