Report on the investigation of the  
grounding of the ultra-large container vessel

***CMA CGM Vasco de Gama***

Thorn Channel, Southampton, England

22 August 2016

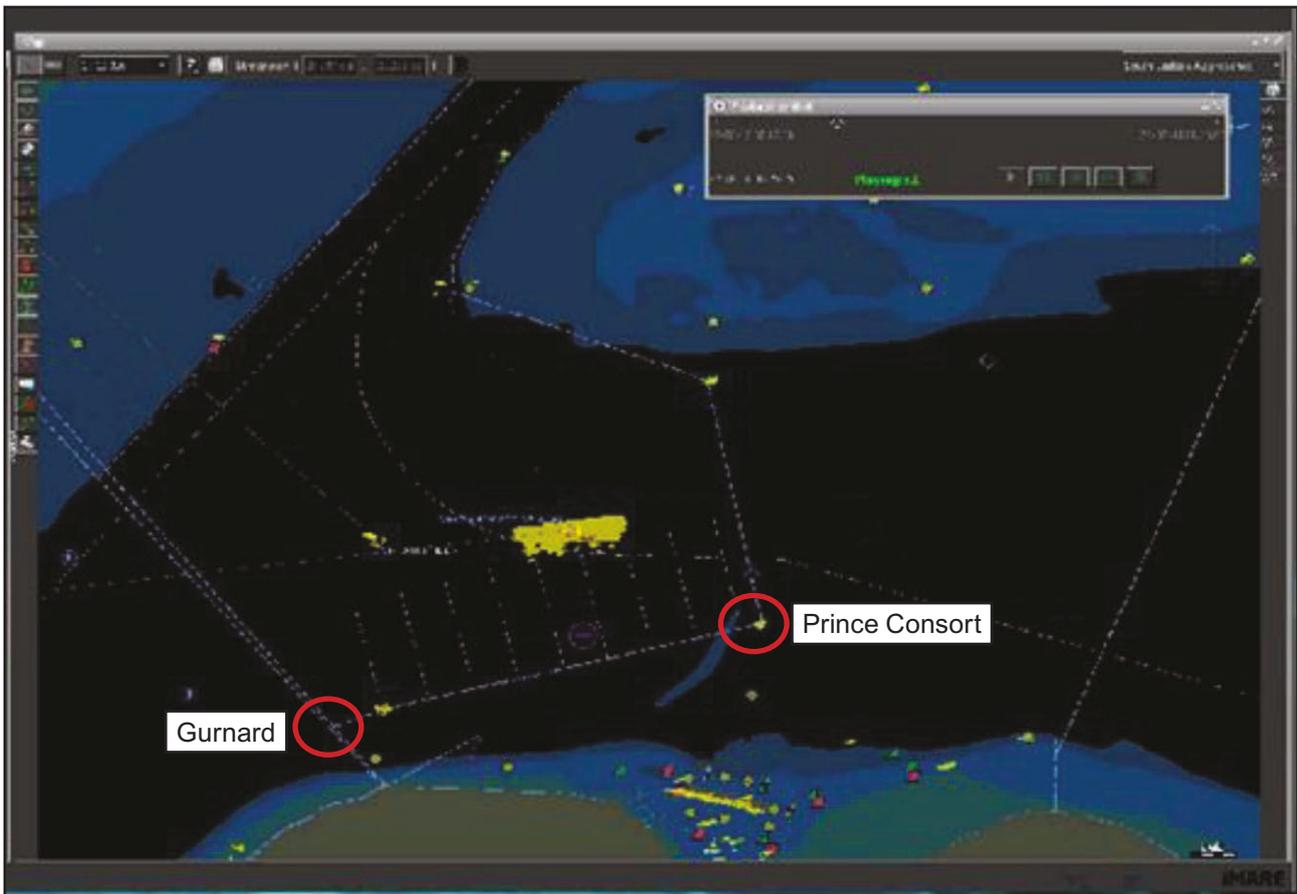
**Figure 7:** VTS officer's radar screenshot showing the countdown to the Gurnard buoy

At 0021, *CMA CGM Vasco de Gama* passed abeam of *Cap Hatteras* on a heading of 289° in a position 0.5nm to the east of the Prince Consort buoy. The lead pilot then gave the helmsman a series of courses to steer that, over the next 4 minutes, brought *CMA CGM Vasco de Gama* onto a heading of 260°. During the turn, the vessel passed 0.25nm north of the Prince Consort buoy (**Figure 6**) at a speed of 11.9kts. The VTS officer began his countdown on the VHF radio when the vessel was 6 cables away from the Gurnard buoy (**Figure 7**).

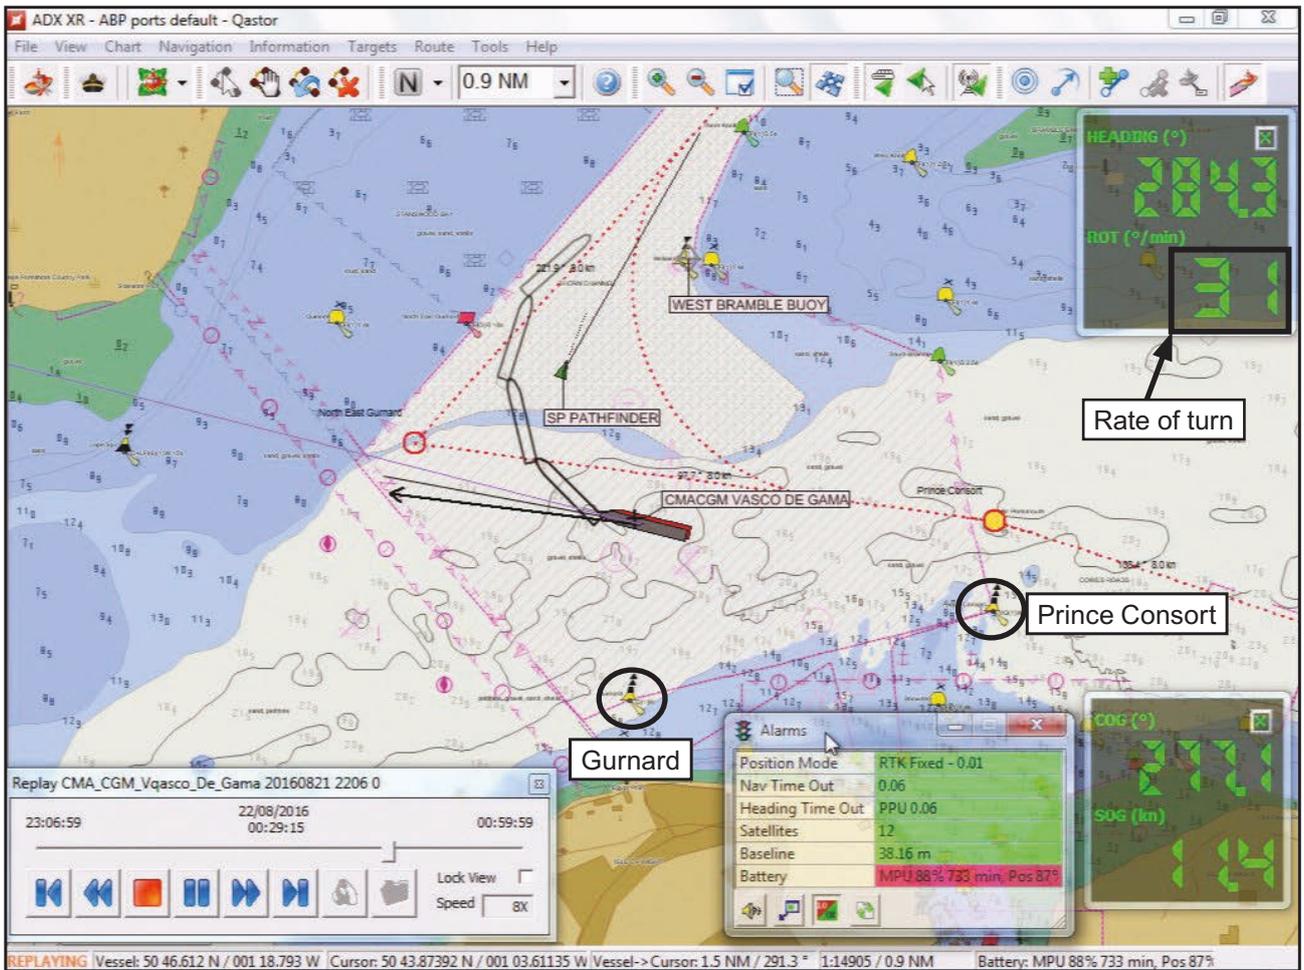
Figure 8: PPU screenshot showing the commencement of the turn

Initially, the vessel's rate of turn (ROT)<sup>3</sup> climbed to 31° per minute (**Figure 8**), but the pilots soon began to discuss their concerns about the effect of the vessel's stern coming into the wind. A few seconds later, as the ROT began to drop (**Figure 9**), the lead pilot asked "where is all this tide when you want it"? The lead pilot explained to the assistant pilot that he began his turn to starboard early and that the engine was set to full ahead. At the same time, the master expressed similar concern to the OOW in his native language, Romanian.

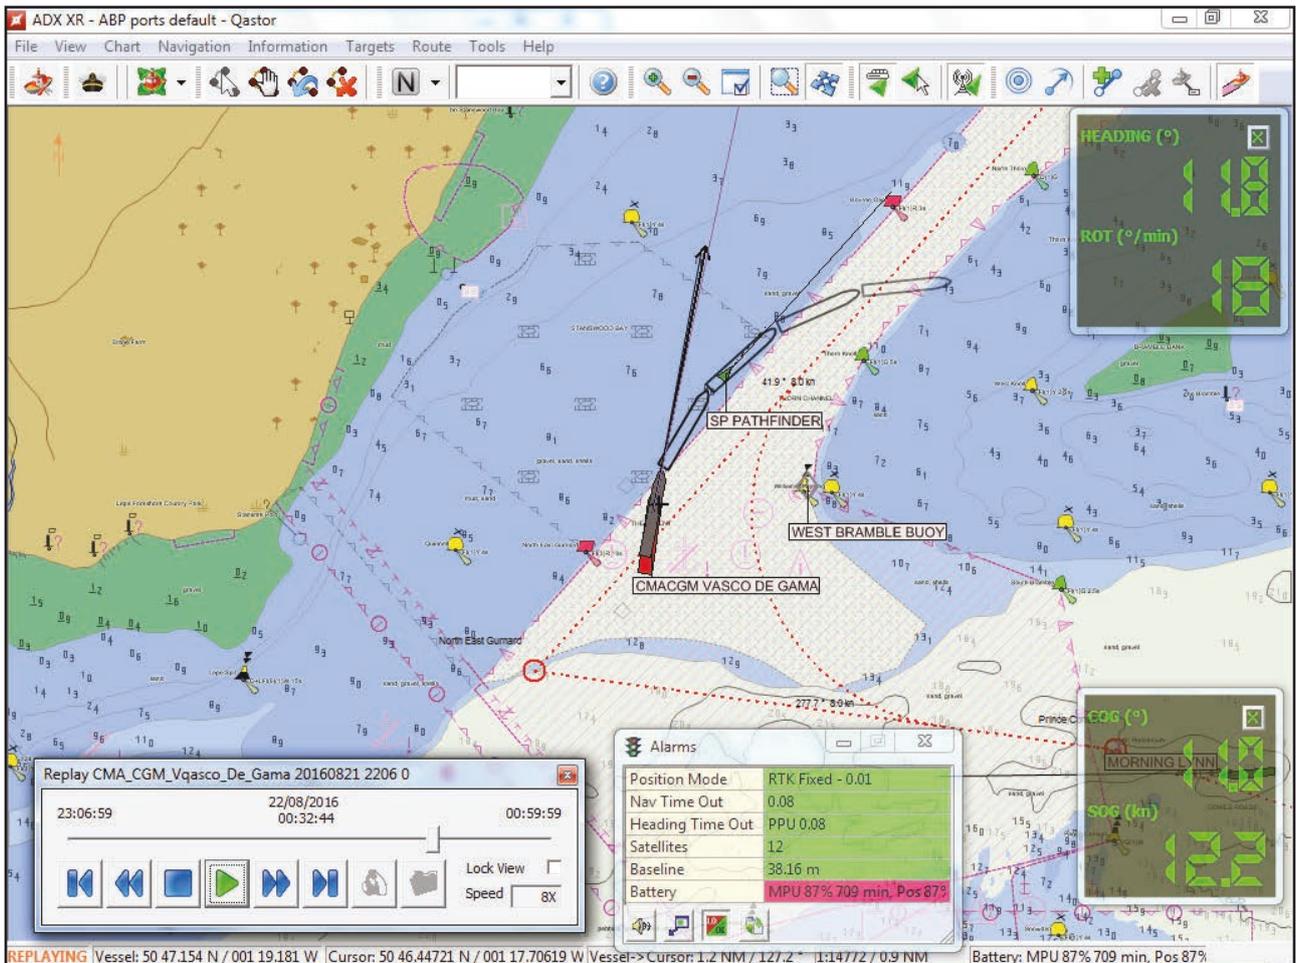
Figure 10: PPU screenshot showing CMA CGM Vasco de Gama departing the dredged channel

As the vessel approached the westward edge of the dredged channel and entered shallower water, the lead pilot told *CMA CGM Vasco de Gama's* master that they must keep going. At 0031, with the ROT continuing to drop, the VTS officer called the pilots on VHF channel 12 and advised them that the vessel appeared to be leaving the channel (**Figure 10**). The lead pilot acknowledged the VTS intervention. The VTS officer then alerted the local tug skippers and placed them on standby to provide rapid assistance if needed.

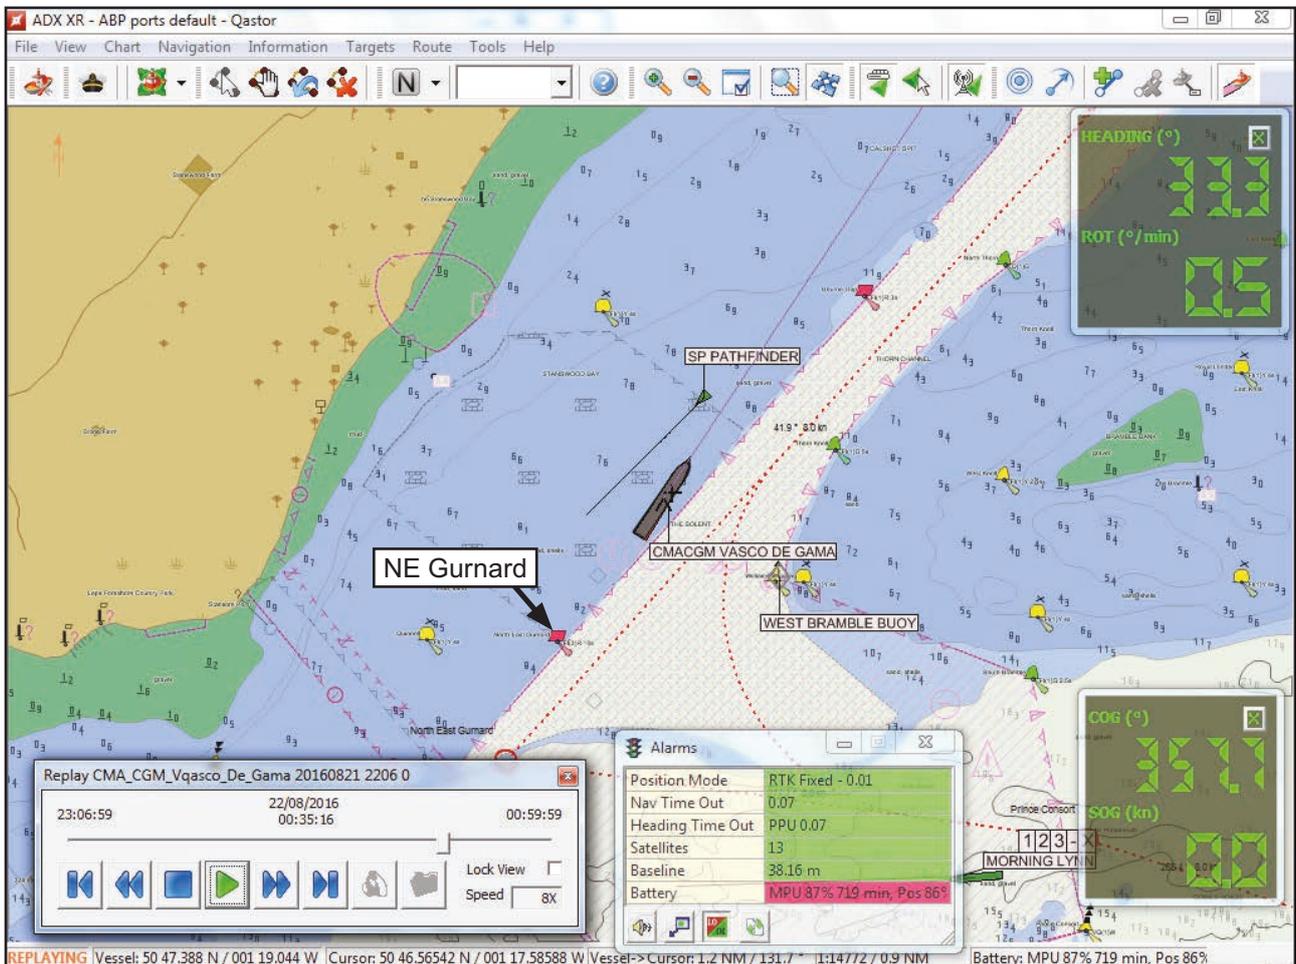
Figure 11: PPU screenshot showing the grounding position

At 0032, in position 50° 49.4'N 001° 19.02'W, about 0.4nm north-north-east of the north-east Gurnard buoy (**Figure 11**), *CMA CGM Vasco de Gama* grounded on the gently shelving seabed with the engine at full ahead. As *CMA CGM Vasco de Gama* slowed, the lead pilot tried to use the bow thrusters to drive the vessel back into the

While inbound to the Port of Southampton, *CMA CGM Vasco de Gama* grounded in position 50° 49.4'N 001° 19.02'W, about 0.4nm north-north-east of the north-east Gurnard buoy (**Figure 11**) while under pilotage through the Thorn Channel Precautionary Area. The grounding occurred on a flooding tide, about 2 hours before high water Portsmouth. The vessel had no propulsion or steering control defects, or power restrictions.

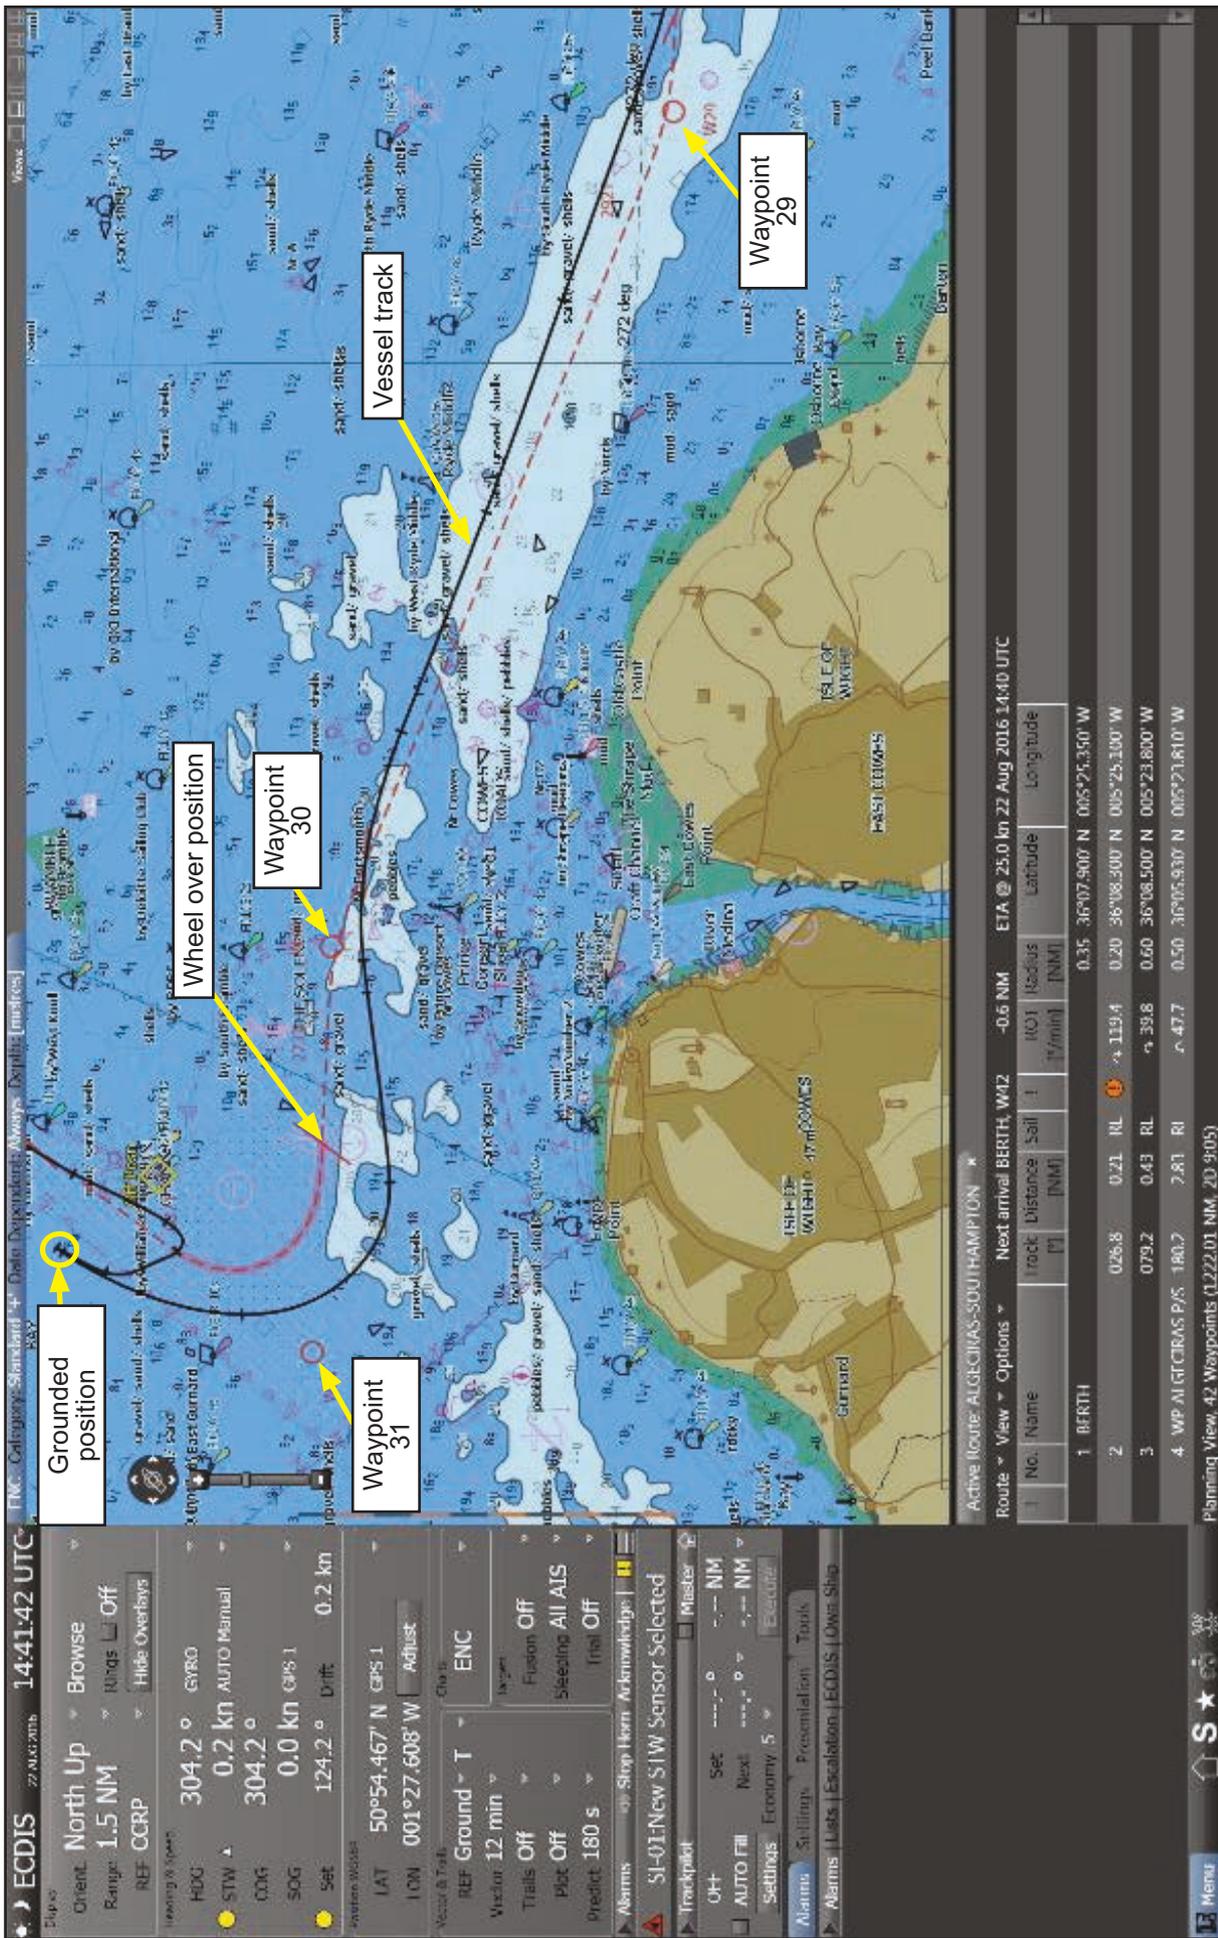
Figure 17: ECDIS screen display at time of grounding

The ECDIS units had three display modes: *base*, *standard* and *full*. When in *full* mode, the user was able to customise the display by application of user defined settings. This could reduce the amount of information presented. The bridge manual explained that the *base* mode provided the absolute minimum level of information and that the *full* mode displayed all the information contained in the electronic chart. The bridge manual warned that the amount of data contained in the *full* mode tended to overload the screen and recommended that the *standard* mode be used for navigation. CMA CGM Vasco de Gama's ECDIS units were set to the *full* mode with few user defined settings applied, and the two-colour option selected.

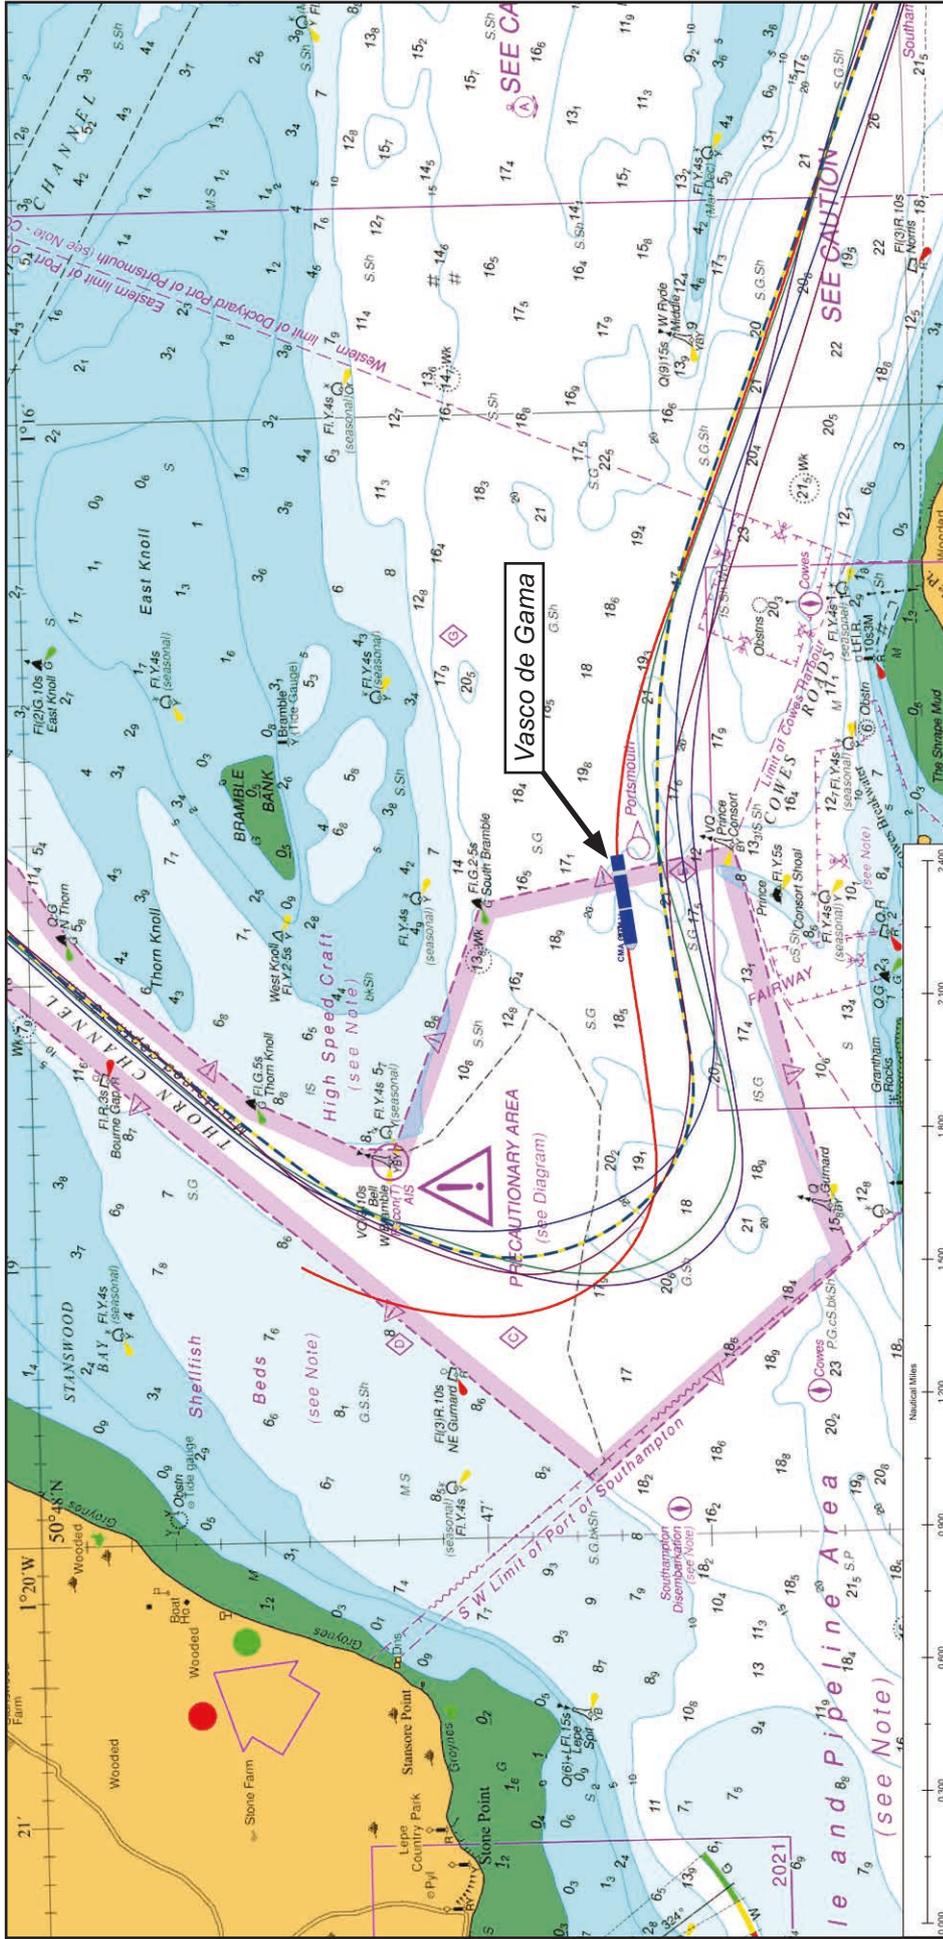
**Figure 20:** Tracks recorded on the PPU for the execution of the lead pilot's previous transits through the Precautionary Area on board Explorer class vessels

The lead pilot's execution of the Bramble Bank turn appeared in some ways to be similar to the majority of his previous inbound pilotage acts on board the Explorer class container vessels (**Figure 20**); he made a course alteration to port of about 30°, brought *CMA CGM Vasco de Gama* on to a heading of 260° and started his turn into the Thorn Channel 3 cables from the Gurnard buoy. However, the vessel's actual track into the Precautionary Area was much further north and more closely resembled that recommended for a strong ebbing tide.
