Report on the investigation of the collision between  
the high-speed passenger catamaran

***Typhoon Clipper***

***Alison***

adjacent to Tower Millennium Pier, River Thames, London

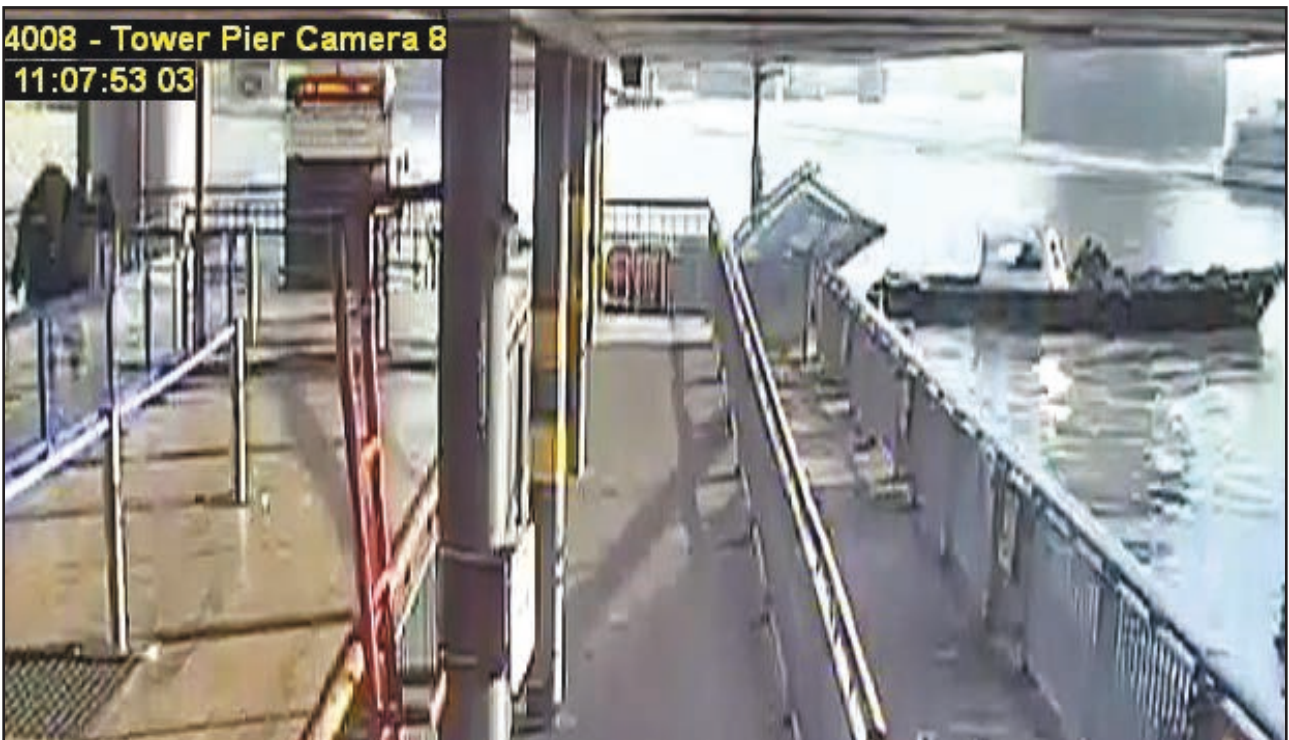
**Figure 4:** Tower Millennium Pier CCTV showing *Alison* emerging into the river close by the end of the pier

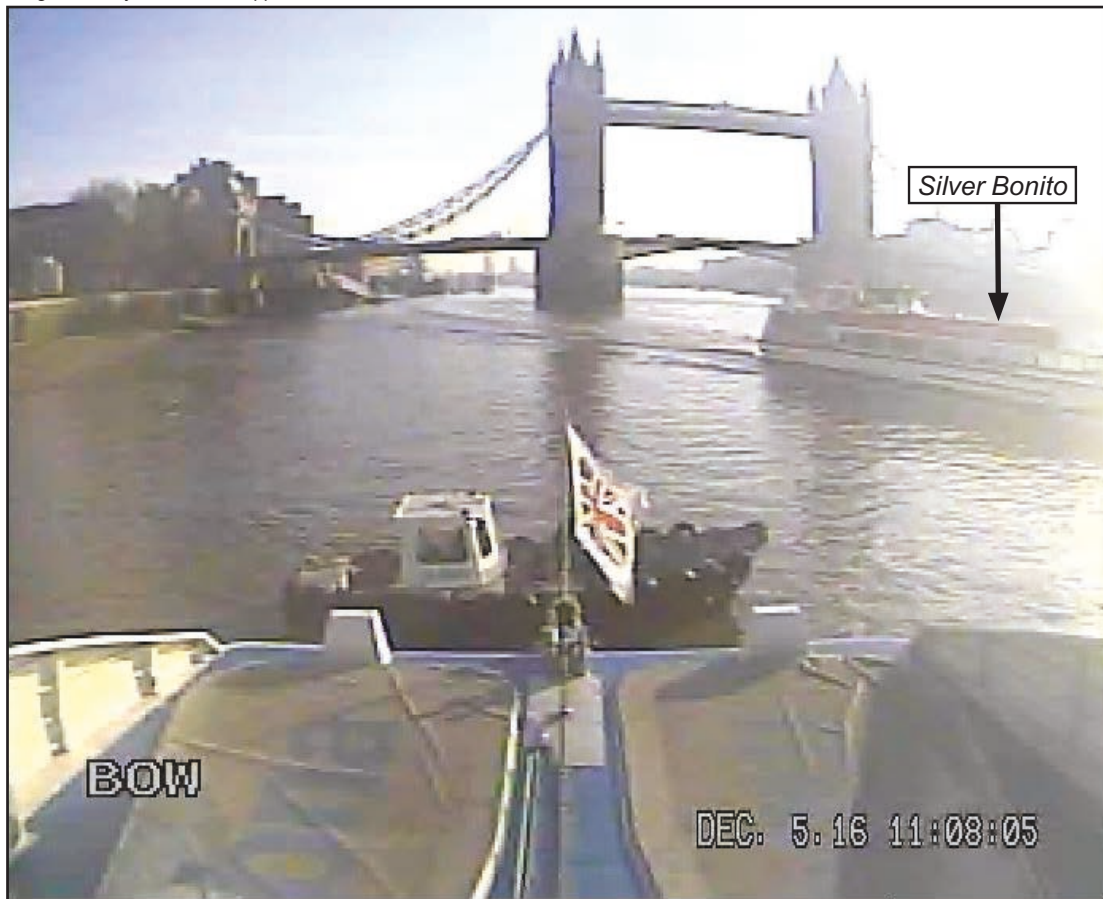
**Figure 6:** *Typhoon Clipper's* bow CCTV camera image immediately prior to collision

Post-accident analysis of CCTV recordings showed that the bow camera captured *Alison* directly ahead of *Typhoon Clipper* (**Figure 6**). However, the image from this camera, which provided good coverage of the forward blind spot, was not included in the split screen configuration adopted following the PLA's recommendation.

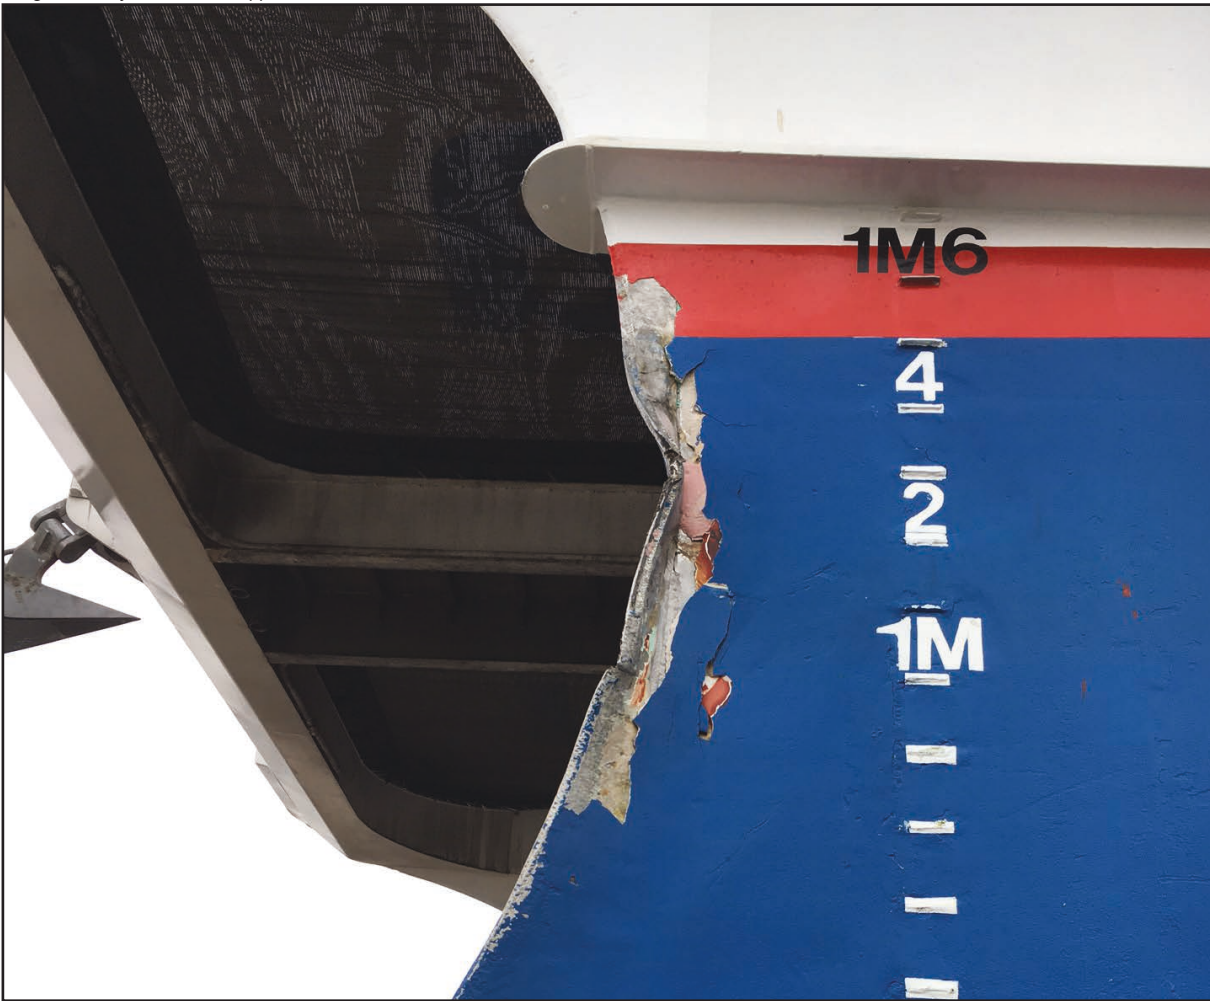
The stem of *Typhoon Clipper*'s port hull was dented where it had struck *Alison* (**Figure 10**). Port of London Marine Services Limited lifted *Alison* off the riverbed the day after the collision (**Figure 11**). *Alison*'s wheelhouse superstructure was distorted and the glass from the forward-looking window was missing (**Figure 11 inset**).

Figure 10: Damage to *Typhoon Clipper's* port stem

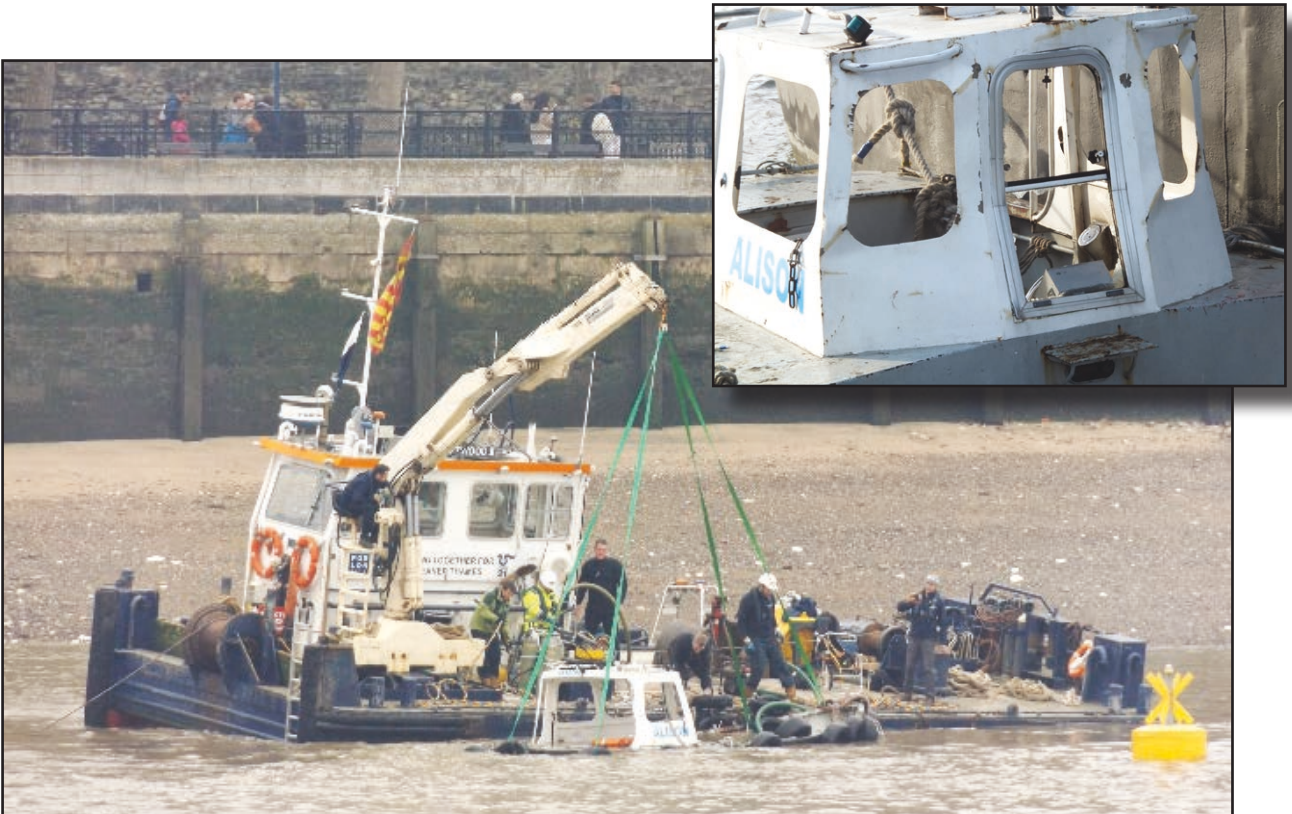
Figure 11: Recovery of *Alison* off the riverbed with inset detail of its superstructure damage

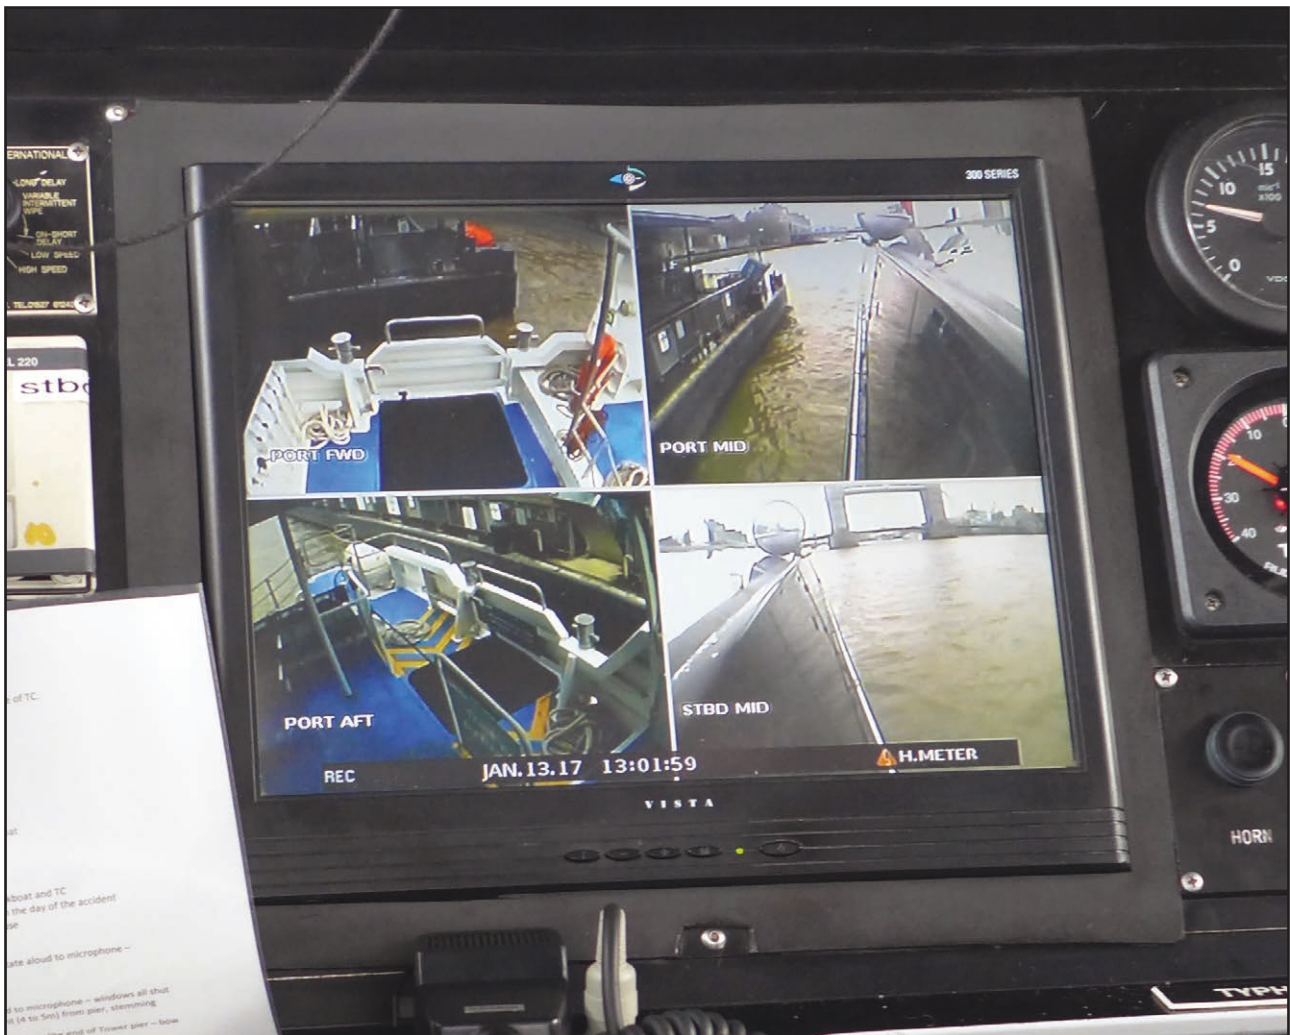
**Figure 15:** *Typhoon Clipper's* wheelhouse CCTV display (during the reconstruction) showing the display settings at the time of the accident

This display configuration was in accordance with Thames Clippers' direction to its masters, which followed a safety recommendation made by the PLA in 2009 after the collision between *Hurricane Clipper* and the cutter *George Williams*. The PLA's report into this accident recommended adoption of a 4-way split screen to improve visibility on the 'off' side when departing a pier (see Section 1.14.3).

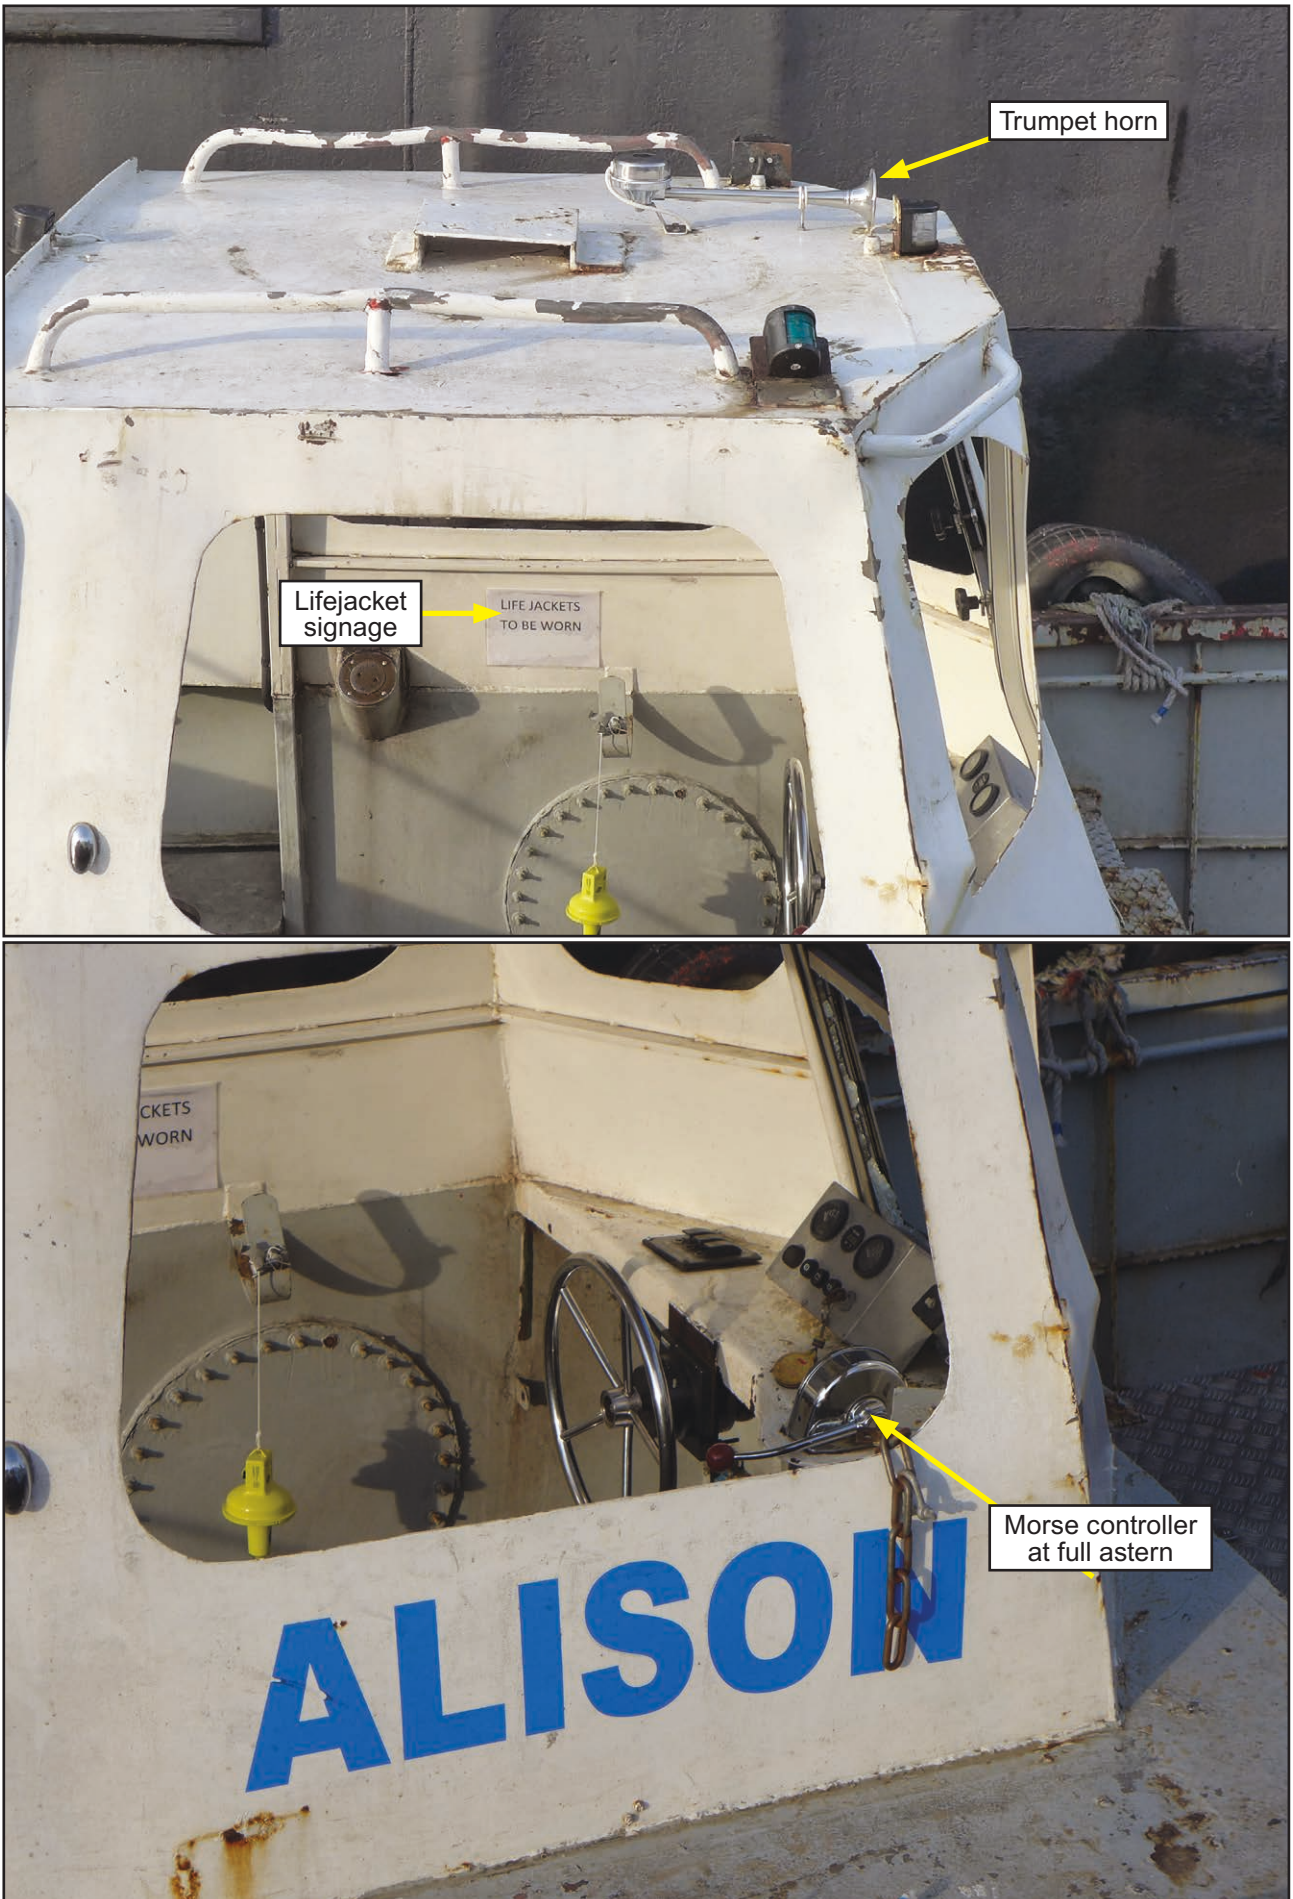
Figure 16: Alison - detail of trumpet horn, morse controller position and lifejacket signage

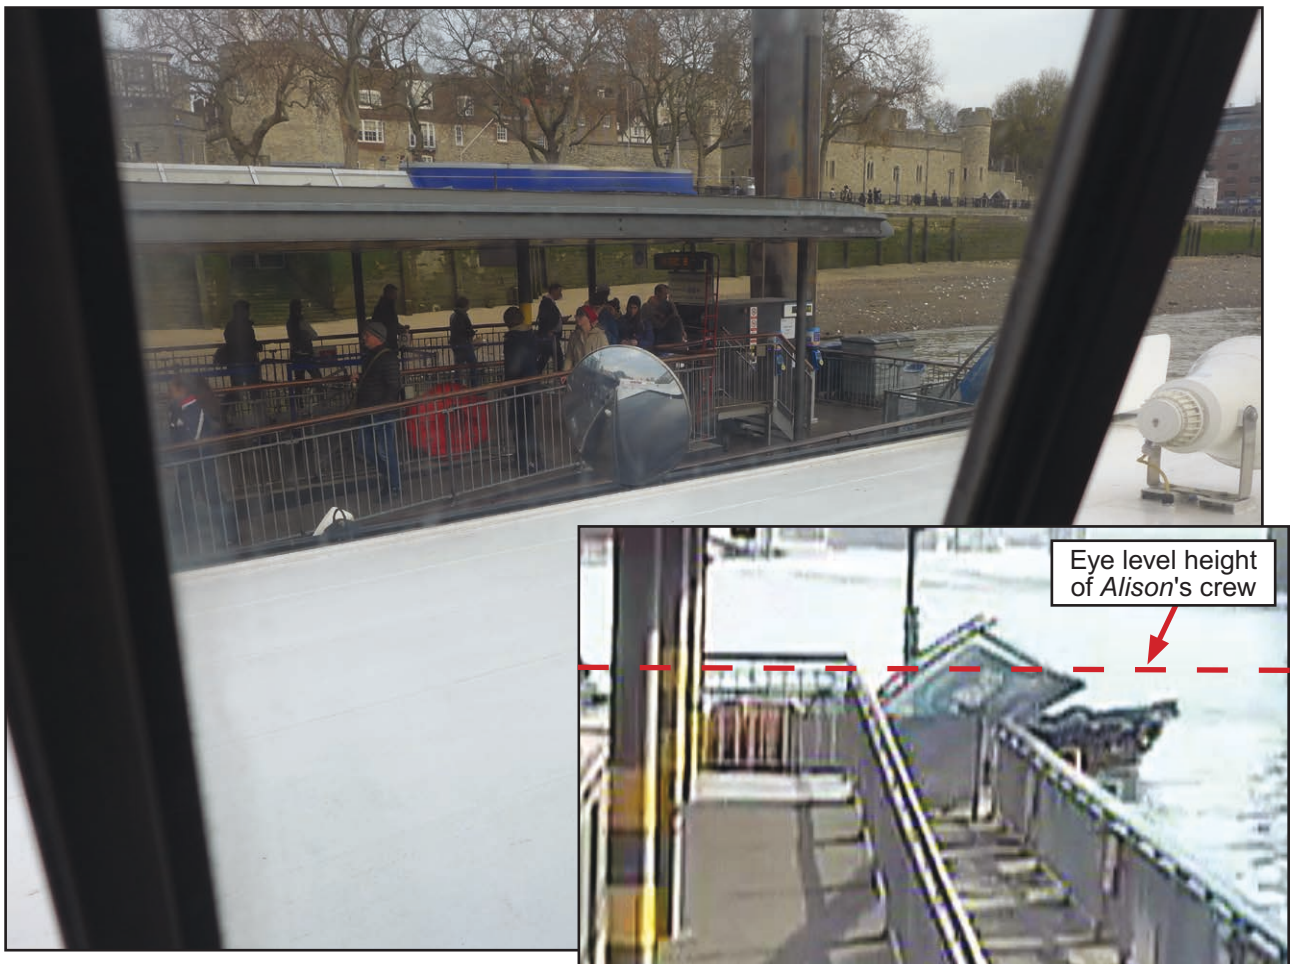
**Figure 21:** View of the pier from *Typhoon Clipper*'s wheelhouse (during reconstruction) and inset analysis of height of *Alison* when close by the pier

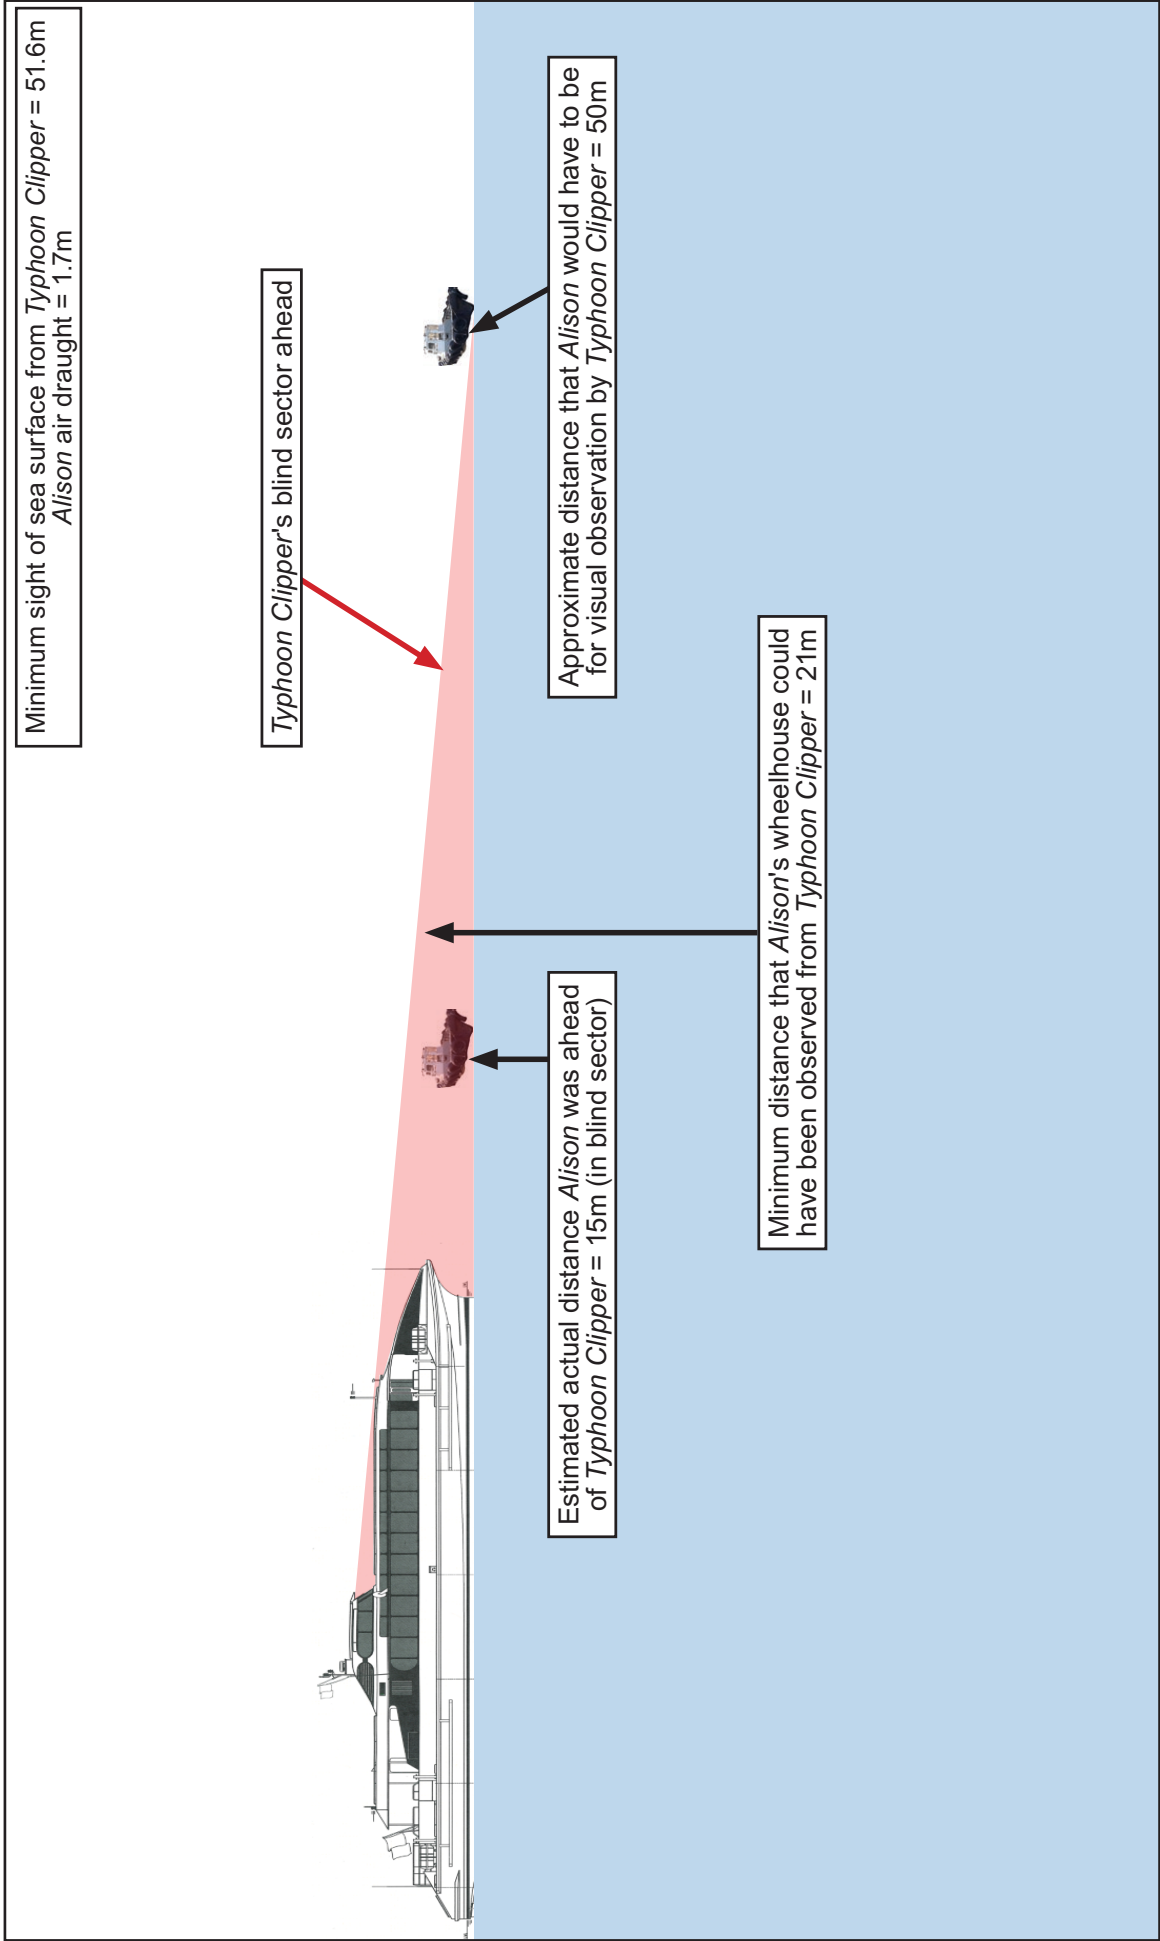
**Figure 22:** Analysis diagram showing *Typhoon Clipper*'s blind sector and *Alison*'s assessed relative position

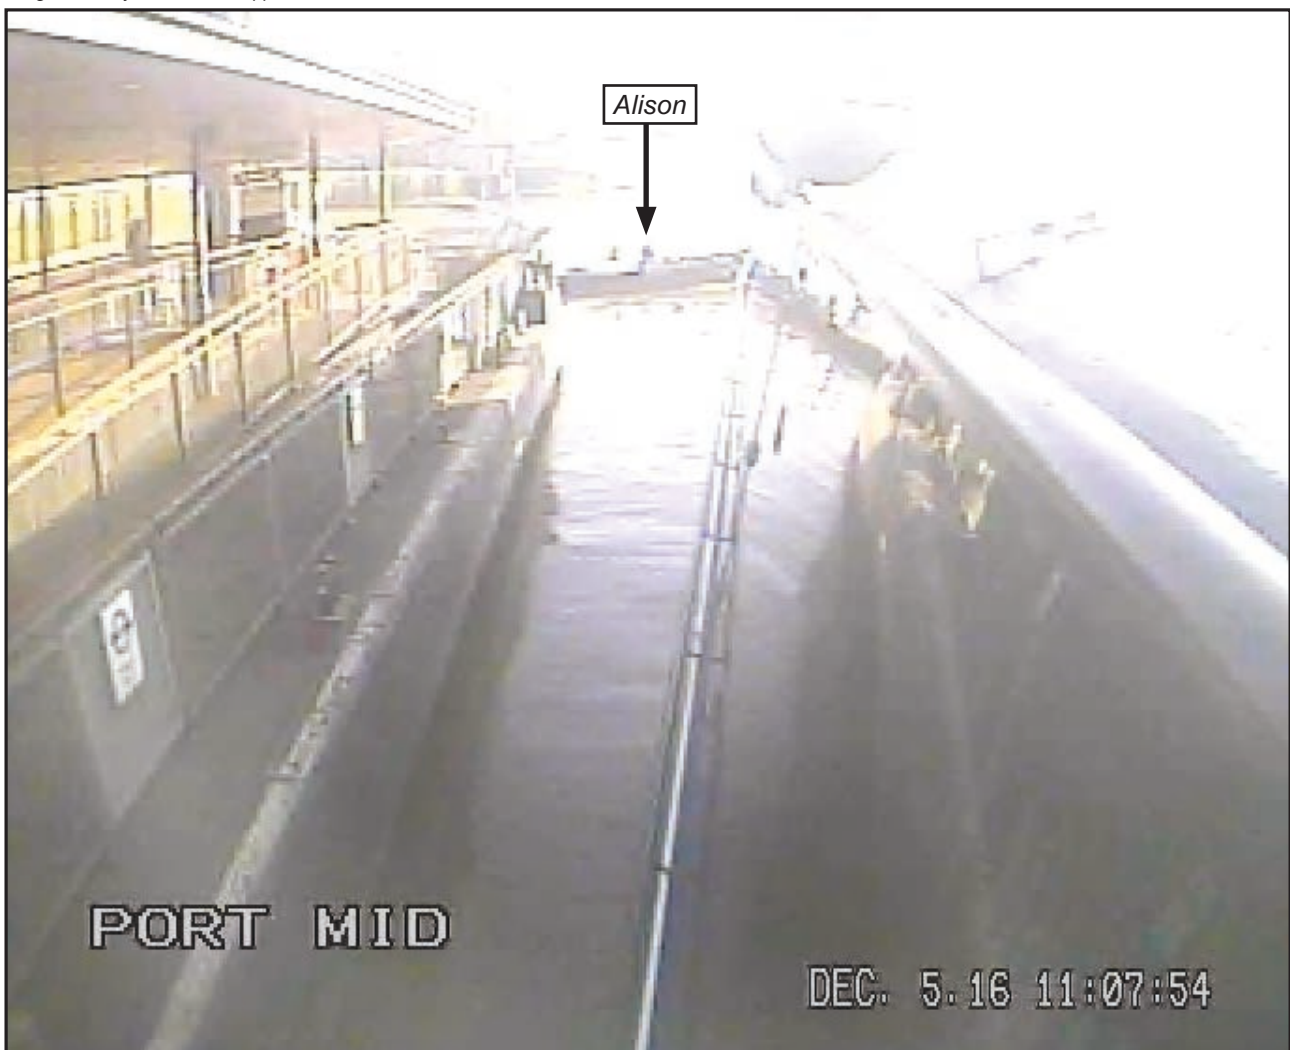
**Figure 23:** *Typhoon Clipper* CCTV port side outboard forward-looking camera's brief detection of *Alison* immediately prior to collision
