## ACCIDENT

<b>Aircraft Type and Registration:</b>	Airbus A320-214, G-EZTV
<b>No &amp; Type of Engines:</b>	2 CFM CFM56-5B4/3 turbofan engines
<b>Year of Manufacture:</b>	2010 (Serial no: 4234)
<b>Date &amp; Time (UTC):</b>	3 March 2017 at 1825 hrs
<b>Location:</b>	Stand 1, Manchester Airport
<b>Type of Flight:</b>	Commercial Air Transport (Passenger)
<b>Persons on Board:</b>	Crew - 6                      Passengers - 172
<b>Injuries:</b>	Crew - None                      Passengers - None
<b>Nature of Damage:</b>	Damage to forward lower fuselage and nose landing gear assembly
<b>Commander's Licence:</b>	Airline Transport Pilot's Licence
<b>Commander's Age:</b>	37 years
<b>Commander's Flying Experience:</b>	7,729 hours (of which 7,510 were on type) Last 90 days - 194 hours Last 28 days - 74 hours
<b>Information Source:</b>	Aircraft Accident Report Form submitted by the pilot and reports from: the ground handling company, the airfield operator, the aircraft operator and the manufacturer

## Synopsis

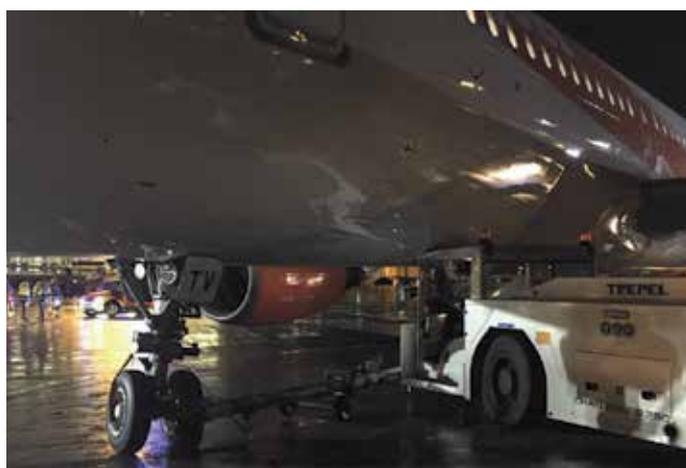
**Figure 1**

Ground crew from adjacent stands came to assist and found the towbar was still connected to both the tug and to the aircraft. The nose gear leg was rotated approximately 90° to the left and the tow bar was bent around the front corner of the tug (Figure 1). The shear pins on the towbar had fractured (Figure 2), and pieces were later found within the boundary of the stand, but the central retaining pin remained intact. The passengers and crew disembarked without injury from the rear right exit door.

Position of the tug and the towbar after the accident

When the pull forward manoeuvre commenced, the two sections of the towbar pivoted around the retaining pin, allowing the aircraft to turn right, possibly influenced by thrust from the idling left engine and a slight downslope. This was not noticed initially by the headset operator who was looking forwards in the intended direction of movement. When

the tug driver realised the aircraft was deviating from the intended path, he assumed the towbar sections had separated close to the aircraft's nosewheel, as designed, and tried to reverse the tug away. Because the towbar had not separated, the nose of the aircraft was pulled left, towards the tug. Although the headset operator had realised by this time that the aircraft was deviating from its intended route, he was unable to get the pilots to stop the aircraft before the collision occurred.

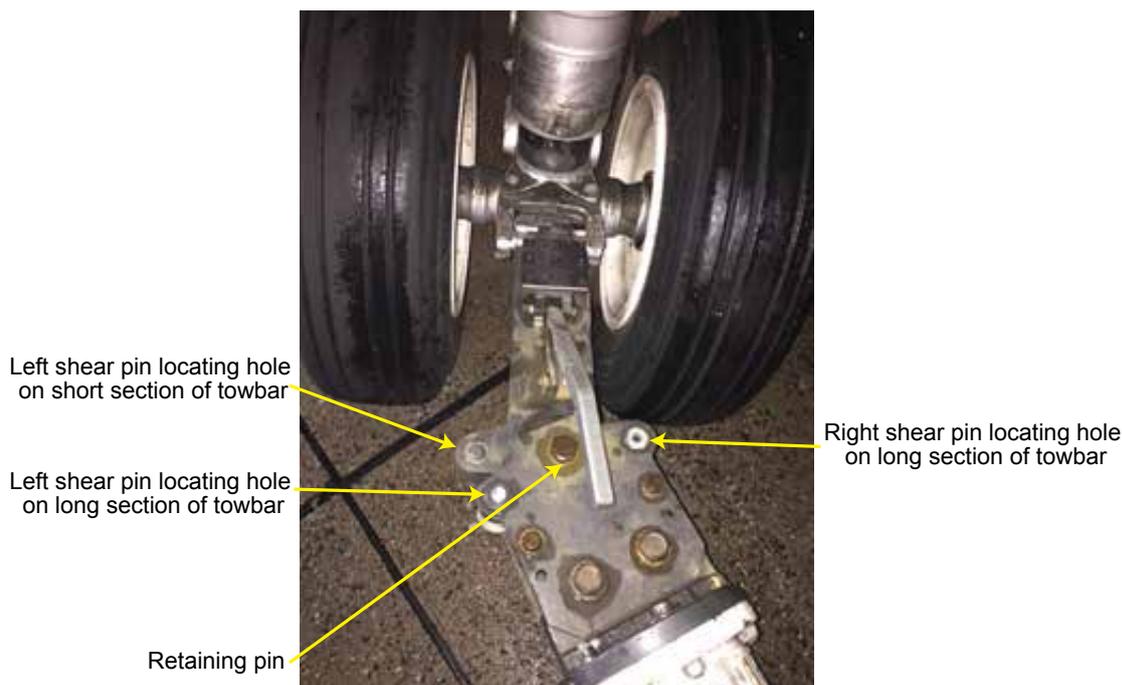
**Figure 2**

Image showing head of retaining pin and locating holes for failed shear pins

Examination of a number of towbars and their servicing records identified that past failures of a single shear pin had been resolved by replacement of that pin only, whereas they both need to be replaced because the unbroken pin may have been subjected to extra stress. One of the pins on this towbar had failed 16 days before the accident and only that pin had been replaced. It was also established that other maintenance procedures for the shear pins had not been followed. They had not been lubricated correctly and the training given to ground crews did not prepare them for conducting adequate serviceability checks on the pins. Additionally, the retaining pin (fitted between the two shear pins) was found to have been over-tightened and this might, over time, have contributed to the failure of the shear pins. The towbar comprised two sections, a short, forward section that connects to the aircraft and a longer section that connects to the tug. The shear pins and the retaining pin join the two sections through locating holes. The retaining pin that was fitted was intact and was found not to have the correct part number. However the loads in this event were probably not sufficiently high to cause a correctly fitted retaining pin with the correct part number to fail.

The aircraft manufacturer studied the accident and noted that the towbar used was not fitted with a damping system as recommended in the '*Aircraft Characteristics Manual*'<sup>3</sup>. This damping device is aimed at reducing the impulse loads generated at the connection interface between the towbar and the tug. Such a damping device is also requested by the latest industry standards for towbar design (eg SAE ARP1915E and ISO 9667).

Tables are provided in the *Aircraft Characteristics Manual* to enable operators to calculate the minimum weight of tug required to move an aircraft, depending on the aircraft's weight and local conditions. In this instance the aircraft manufacturer calculated that an 8 tonne tug would have been adequate, but the tug used was approximately three times heavier than this and consequently it was capable of loading the towbar above the minimum required load. The aircraft manufacturer stated that when the tug used is heavier than the minimum required, larger forces will be transmitted to the shear pins and this can increase the possibility of the pins breaking.

- Improvements to towbar maintenance and inspection procedures.
- A training aid has been developed to help ground crew recognise when shear pins are unserviceable.
- A standard fault-finding procedure has been introduced for ground crews when they hear an unusual sound or suspect a shear pin has broken while pushing or pulling an aircraft.
- Improvements have been made to ground crew training to ensure that correct procedures for aircraft engine start are followed for each stand at Manchester.
