ACCIDENT

Aircraft Type and Registration:	Cessna 510 Citation Mustang, OE-FHK	
No & Type of Engines:	2 PW 615F turbofan engines	
Year of Manufacture:	2010 (Serial no: 510-0315)	
Date & Time (UTC):	15 June 2017 at 1128 hrs	
Location:	London Biggin Hill Airport	
Type of Flight:	Training	
Persons on Board:	Crew - 2	Passengers - None
Injuries:	Crew - None	Passengers - N/A
Nature of Damage:	Leading edge of left wing and forward fuselage dented, and cabin access door hinge distorted	
Commander's Licence:	Air Transport Pilot's Licence	
Commander's Age:	50 years	
Commander's Flying Experience:	2,658 hours (of which 450 were on type) Last 90 days - 81 hours Last 28 days - 37 hours	
Information Source:	Aircraft Accident Report Form submitted by the pilot and enquiries made by the AAIB

Synopsis

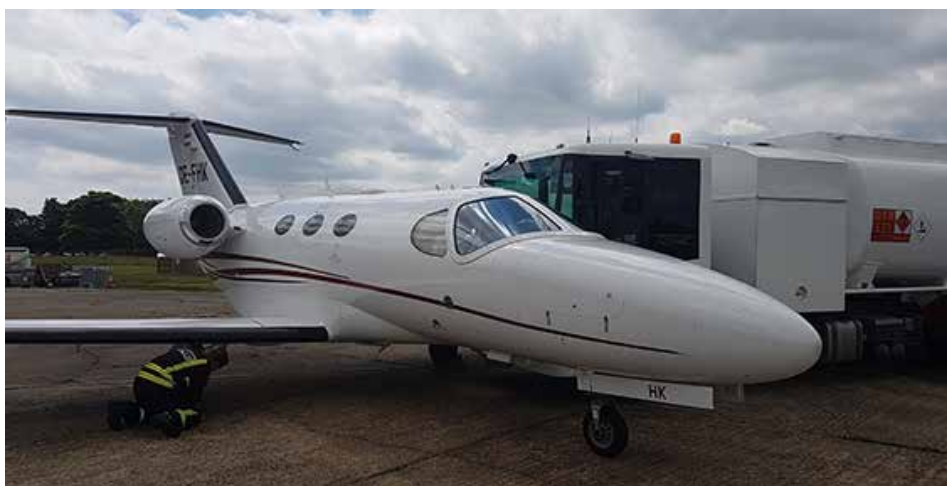
Figure 1

The aircraft rolled forward from its parked position and struck a fuel bowser when the chocks were removed without hydraulic pressure in the brake system.

OE-FHK after colliding with the fuel bowser

The electric hydraulic pump is turned on when the battery controller switch is moved to the BATT position but the trainee co-pilot stated that he had not been instructed to ensure this was done before applying the parking brake. The normal brake system functioned correctly when it was checked after the accident.

The commander was surprised to discover after the accident that it is not unusual for the hydraulic system pressure to dissipate within 30 minutes of electric power being disconnected. He had anticipated that there would be pressure available to actuate the brakes without turning on the battery.

A '*Safety Bulletin*' to flight crew was circulated which stated that the parking brake is only to be set with the battery switch in the BATT position and that the appropriate checklists are always to be followed. This notice also warns crew not to remove chocks if there are obstacles such as a fuel bowser nearby and states that trainee pilots are always to be accompanied by an experienced crew member while operating the aircraft.

The SOPs were modified and additional guidance on operation of the parking brake and the use of wheel chocks was placed in the OM.

Pilot training was revised to try to ensure a comprehensive understanding of the hydraulic system and the aircraft brakes.
