ACCIDENT

Aircraft Type and Registration:	Cessna 152, G-BIDH
No & Type of Engines:	1 Lycoming O-235-L2C piston engine
Year of Manufacture:	1981 (Serial no: 152-80546)
Date & Time (UTC):	27 August 2017 at 1425 hrs
Location:	Beverley Airfield, East Riding of Yorkshire
Type of Flight:	Training
Persons on Board:	Crew - 1 Passengers - None
Injuries:	Crew - None Passengers - N/A
Nature of Damage:	Damage to nose landing gear, engine cowling and propeller, and engine shock-loaded. Windsock pole knocked down
Commander's Licence:	Student Pilot
Commander's Age:	27 years
Commander's Flying Experience:	22 hours (of which 22 were on type) Last 90 days - 5 hours Last 28 days - 4 hours
Information Source:	Aircraft Accident Report Form submitted by the pilot

Synopsis

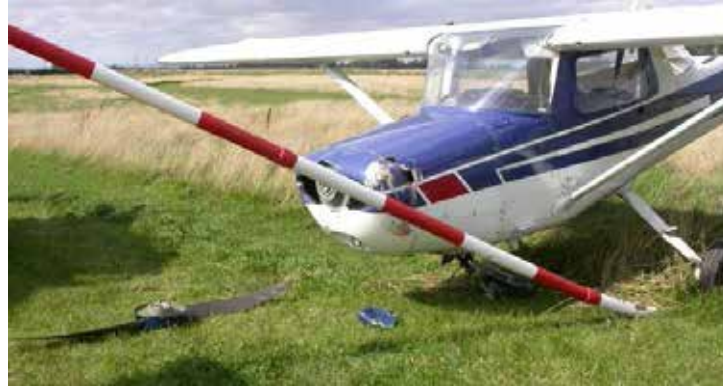
Figure 1

The aircraft was being flown by a student pilot who had earlier completed three satisfactory landings accompanied by an instructor and then one satisfactory, solo 'full-stop' landing. Following a further takeoff and circuit the student made an into-wind approach for a touch-and-go landing on the dry, grass runway. He judged his approach and touchdown to be better than those he had previously completed but, once all three wheels were on the ground, the aircraft veered left. The student reported that he responded by applying right rudder and increasing power; in preparation for takeoff. However, he could not prevent the aircraft from departing the runway to the left and travelling across an adjacent area of long grass. He applied the brakes and thought that he reduced power but the aircraft did not stop until it collided with a windsock pole and the propeller detached. The student turned off the fuel and the electric master switch before exiting the aircraft, which had pitched nose-down (Figure 1).

The aircraft in its resting place with the detached propeller on the ground to the left (photograph courtesy of Hull Aero Club Ltd)

The operator discovered that the left nose leg support strut had broken and suggested this may have caused the pilot to lose directional control. However, it is also possible that this occurred when the aircraft collided with the pole. The right arm of the nosewheel fork had fractured and this appeared to be a direct result of the impact. The operator reported that the throttle was found to be fully open, while the damage to the pole was consistent with the propeller striking the pole at a high power setting, causing all six threaded inserts on the crankshaft flange to be torn out as the propeller detached.
