SERIOUS INCIDENT

Aircraft Type and Registration:	Sling 4, G-LDSA	
No & Type of Engines:	1 Rotax 914-UL piston engine	
Year of Manufacture:	2017 (Serial no: LAA 400-15412)	
Date & Time (UTC):	27 July 2017 at 1355 hrs	
Location:	Near Hailsham, East Sussex	
Type of Flight:	Private	
Persons on Board:	Crew - 1	Passengers - 1
Injuries:	Crew - None	Passengers - None
Nature of Damage:	Right canopy door detached in flight	
Commander's Licence:	Private Pilot's Licence	
Commander's Age:	72 years	
Commander's Flying Experience:	865 hours (of which 31 were on type) Last 90 days - 12 hours Last 28 days - 4 hours	
Information Source:	Aircraft Accident Report Form submitted by the pilot

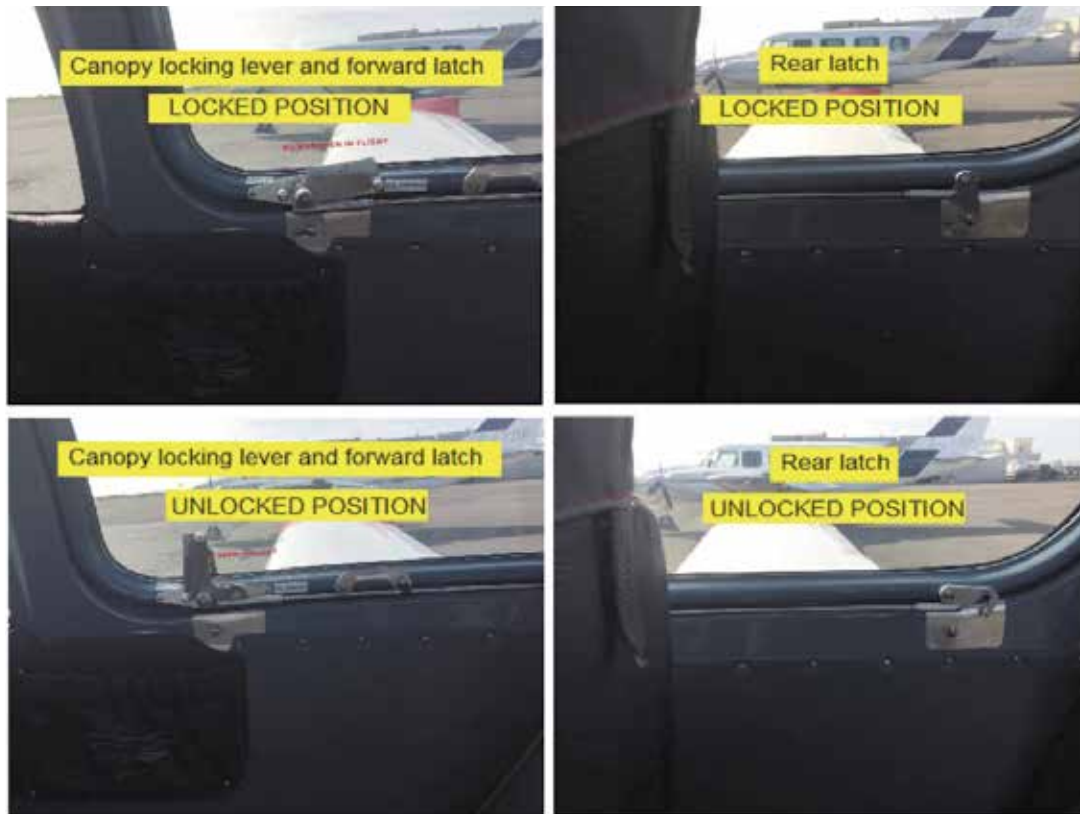
Figure 1

Passenger canopy locking lever and latches

The LAA inspected the aircraft and contacted the aircraft manufacturer. Analysis of damage to the forward and aft hinge fuselage attachment points indicate that both hinges failed in overload. Both forward and aft latch pins remained attached to the fuselage and were both intact. The canopy was not recovered and so it was not possible for the canopy locking lever and mechanism to be examined.

The pilot stated that the passenger had advised him that the lever had remained in the closed position until the canopy detached from the aircraft. However, the LAA found that it was possible to partially lock the canopy with the lever not fully in the closed 'over-centre' position.

There have been no other reported incidents for this aircraft type of a canopy opening in flight. The LAA is to publish a safety article reminding pilots to check that canopies are fully locked prior to flight.

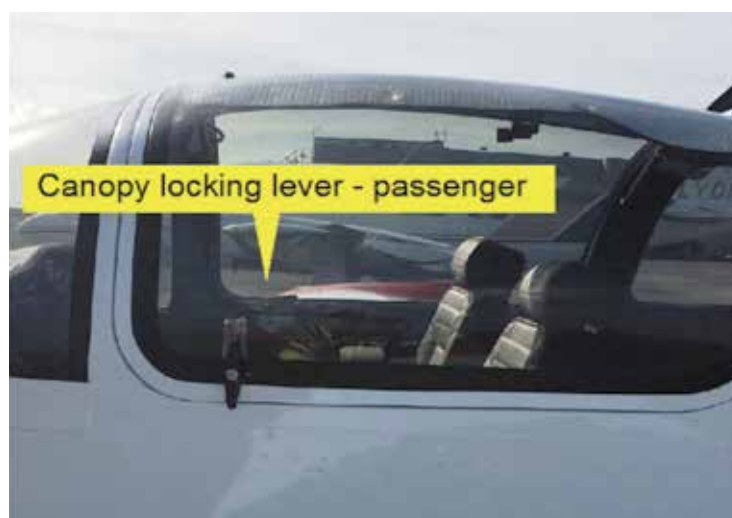
Figure 2

Passenger canopy locking lever position

The inspection of the aircraft by the LAA indicates that the canopy opened in flight because the passenger door lever was not in the fully closed position. It is possible that the lever may not have been in the fully closed position prior to the commencement of the flight, or that the lever was inadvertently moved at some point during the flight.
