ACCIDENT

Aircraft Type and Registration:	Skyranger 912(2), G-CCDH	
No & Type of Engines:	1 Rotax 912-UL DCDI piston engine	
Year of Manufacture:	2003 (Serial no: BMAA/HB/233)	
Date & Time (UTC):	5 July 2017 at 1716 hrs	
Location:	Filey, North Yorkshire	
Type of Flight:	Private	
Persons on Board:	Crew - 1	Passengers - 1
Injuries:	Crew - None	Passengers - None
Nature of Damage:	Nosewheel, propeller, wing	
Commander's Licence:	National Private Pilot's Licence	
Commander's Age:	51 years	
Commander's Flying Experience:	110 hours (of which 85 were on type) Last 90 days - 26 hours Last 28 days - 26 hours	
Information Source:	Aircraft Accident Report Form submitted by the pilot

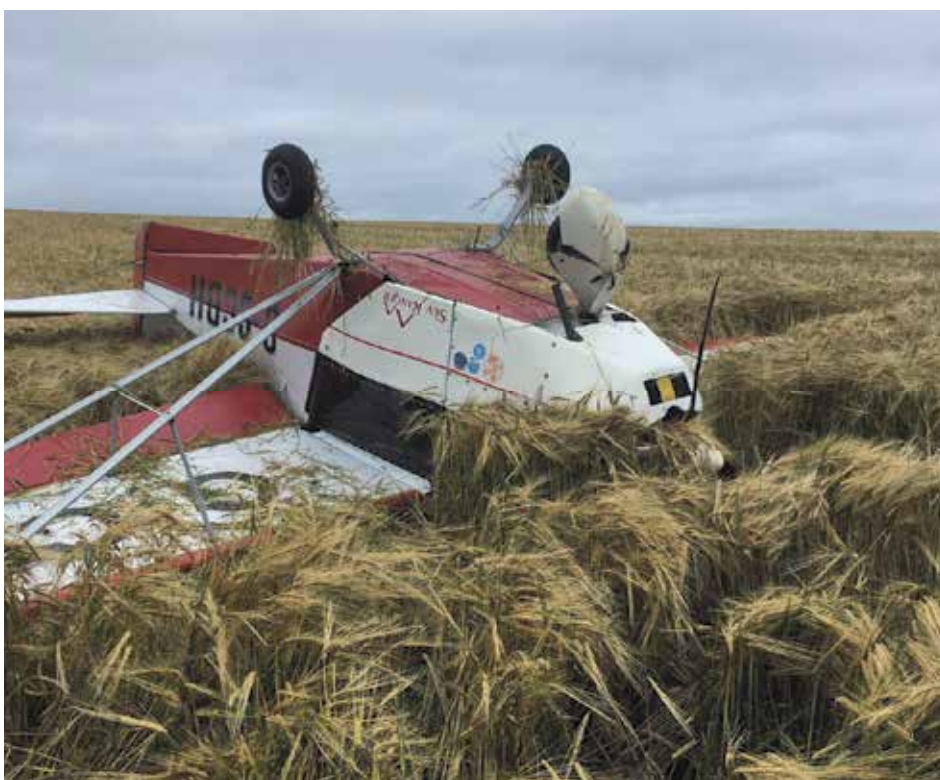
Figure 1

The pilot decided to turn around and head towards Durham but the cloud to the north had also descended. At this stage he decided to divert immediately but the available airfields were not appropriate due to their elevation and the cloud base. He decided to perform a precautionary landing in a field and after considering all options chose what he perceived to be a stubble field. This was in fact a standing crop and, on landing, the aircraft sank into the crop, causing it to roll over. Both occupants were suspended by their full harnesses but then escaped uninjured.

G-CCDH after impact
