SERIOUS INCIDENT

Aircraft Type and Registration:	Boeing 737-36E Freighter, TF-BBF	
No & Type of Engines:	2 CFM International CFM56-3B2 turbofan engines	
Year of Manufacture:	1992 (Serial no: 25264)	
Date & Time (UTC):	3 February 2017 at 0015 hrs	
Location:	East Midlands Airport, Leicestershire	
Type of Flight:	Commercial Air Transport (Cargo)	
Persons on Board:	Crew - 2	Passengers - None
Injuries:	Crew - None	Passengers - N/A
Nature of Damage:	Overheating of rear equipment bay	
Commander's Licence:	Airline Transport Pilot's Licence	
Commander's Age:	50 years	
Commander's Flying Experience:	9,889 hours (of which 8,087 were on type) Last 90 days - 94 hours Last 28 days - 26 hours	
Information Source:	AAIB Field Investigation

Synopsis

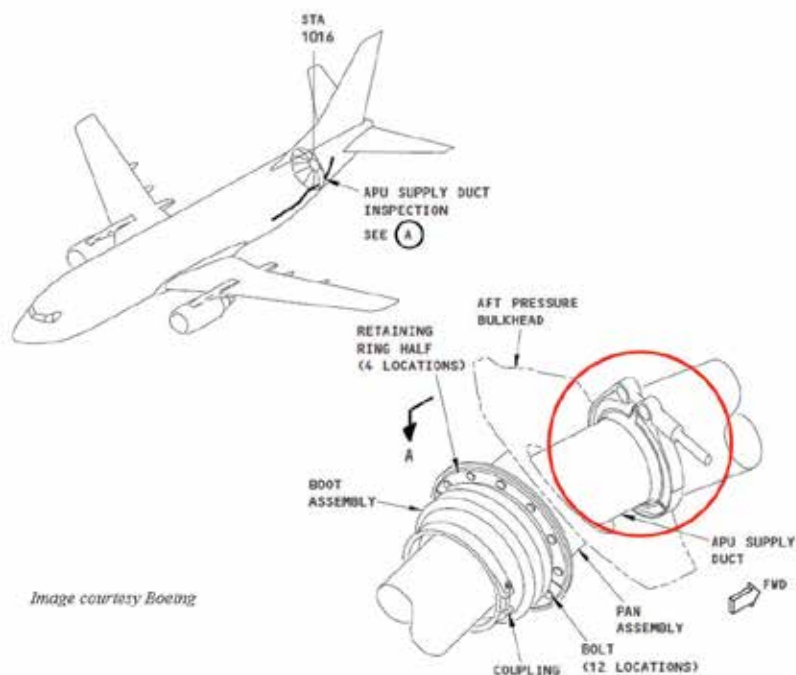
Figure 4

Investigation by the operator's engineering personnel revealed that a V-band clamp⁴ had separated from a joint on the APU bleed air duct in the rear equipment bay, immediately forward of the aft pressure bulkhead, beneath the main deck cargo floor in the vicinity of fuselage station (STA) 1016, Figure 4.

Location of the APU bleed air duct leak and failed V-band clamp

The operator is replacing the V-band clamps at the failure location on TF-BBF across its fleet of 737-300 and 737-400 aircraft. This is being carried out on a rolling programme, as the aircraft undergo scheduled C-check maintenance inspections. The operator is also considering replacement of other V-band clamps on their aircraft where the release of bleed air may create a hazard.

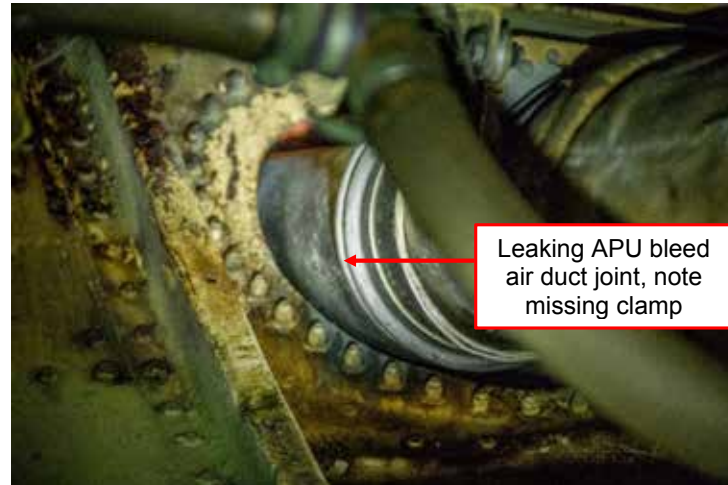
Figure 5

The aft pressure bulkhead adjacent to the leaking APU bleed air duct joint showed evidence of overheating and scorching due to ignition of the Ardrox AV8 corrosion-inhibitor coating on the aircraft's internal structure in this location, Figure 5.

Overheating damage to the aircraft's structure adjacent to the APU bleed air duct leak

The aircraft manufacturer stated that, when the aircraft's APU is running, the air within the APU bleed air duct, at the point of rupture, can reach a maximum temperature of 376°C. The material safety data sheet for Ardrox AV8 states that the material has an auto-ignition temperature of 200°C.

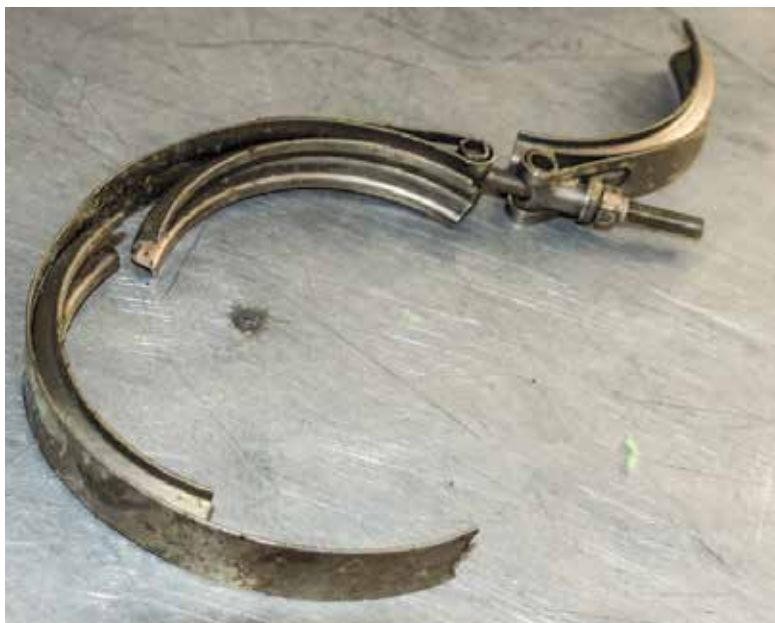
The broken clamp was recovered from the rear equipment bay, Figure 6 and subjected to detailed examination.

Broken V-band clamp

The fracture surface was heavily corroded, indicating that the crack had been present for a considerable period of time and that the clamp had been exposed to a corrosive environment. After cleaning, scanning electron microscopy analysis of the fracture surface revealed small areas of ductile overload at the outer edges of the crack, and large areas of intergranular cracking, which is consistent with stress corrosion cracking (SCC). SCC is a progressive crack growth mechanism that occurs in certain metals that are subjected to tensile loading in a corrosive environment. The presence of intergranular cracking was further confirmed by a metallographic section of the fracture face, Figure 9, which showed a branching crack path that is typical of SCC. It was not possible to determine exactly when the cracks had formed, and whether they would have been large enough to detect visually when the 1C maintenance inspection was performed in July 2015.

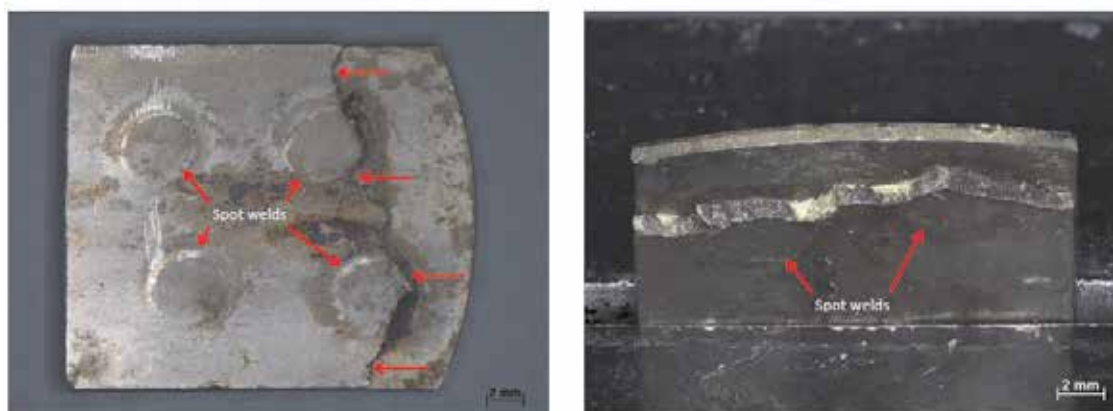
Figure 7

The clamp's tension band had fractured at the point where the upper folded part of the band is attached to the main lower part of the band by two staggered rows of spot welds, Figure 7.

V-band clamp fracture location at spot welds

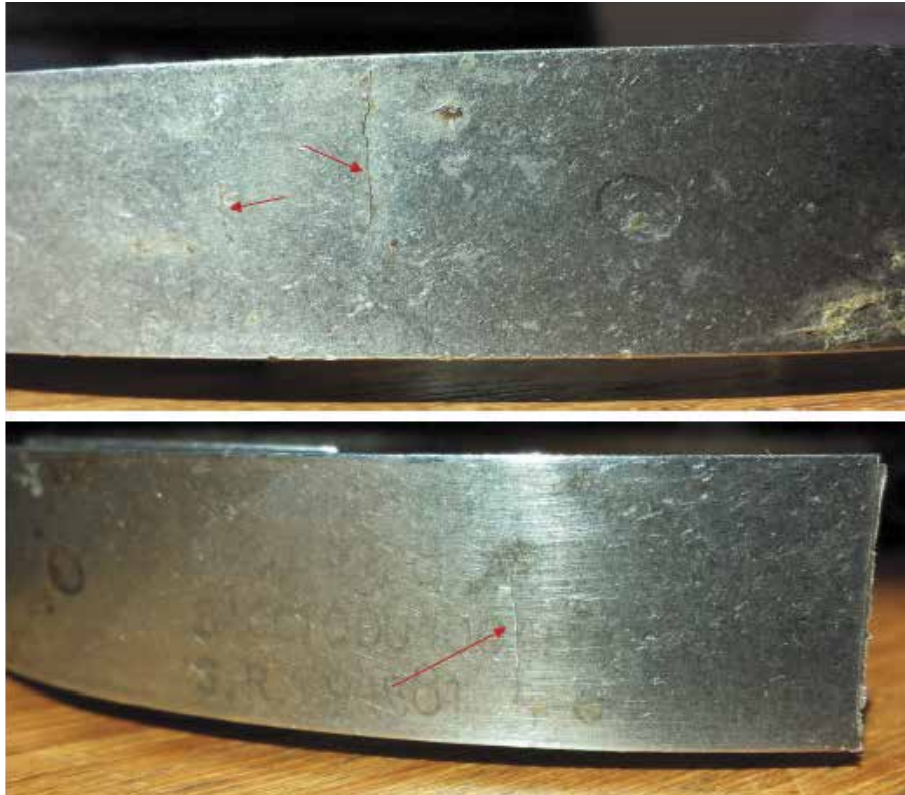
Figure 8

In addition to the main fracture, three further cracks in the clamp's band were identified, Figure 8. These additional cracks were located at points on the band between where the inner profiled segments were attached, at points where the band bending loads were highest.

Other cracks identified in the V-band clamp band

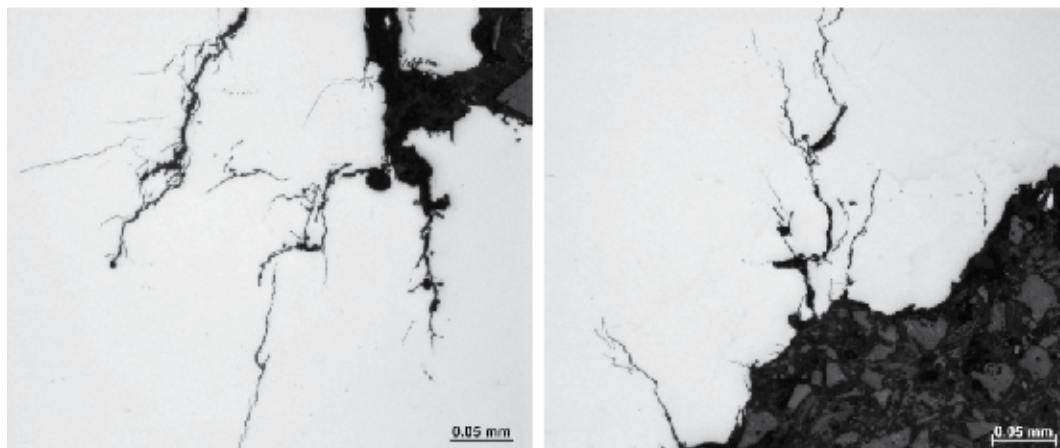
Figure 9

Metallographic section of band fracture face, showing branching crack paths

The metallurgical evidence shows that the V-band clamp failed as a result of stress corrosion cracking, and that the crack propagation had taken place over a considerable period of time. The tensile loading in the clamp's outer band, necessary for securing the duct joint, is applied by tightening the clamp's locking nut. Whilst the projection of the clamp's bolt beyond the locking nut as found after the incident did not indicate over-tightening of the clamp, it was not possible to eliminate previous over-tightening of the clamp as a contributory factor in the clamp's eventual failure. The position of the clamp in the rear of the rear equipment bay, in close proximity to the aft pressure bulkhead, renders visual examination for cracking difficult. Furthermore it was not possible to determine exactly when the cracks had formed in the clamp's outer band and it is possible that they were below the size detectable by visual inspection when the aircraft underwent its most recent 1C maintenance inspection.
