Rail Accident Investigation Branch

Rail Accident Report

Serious irregularity at Cardiff East Junction 29 December 2016

Report 15/2017
October 2017

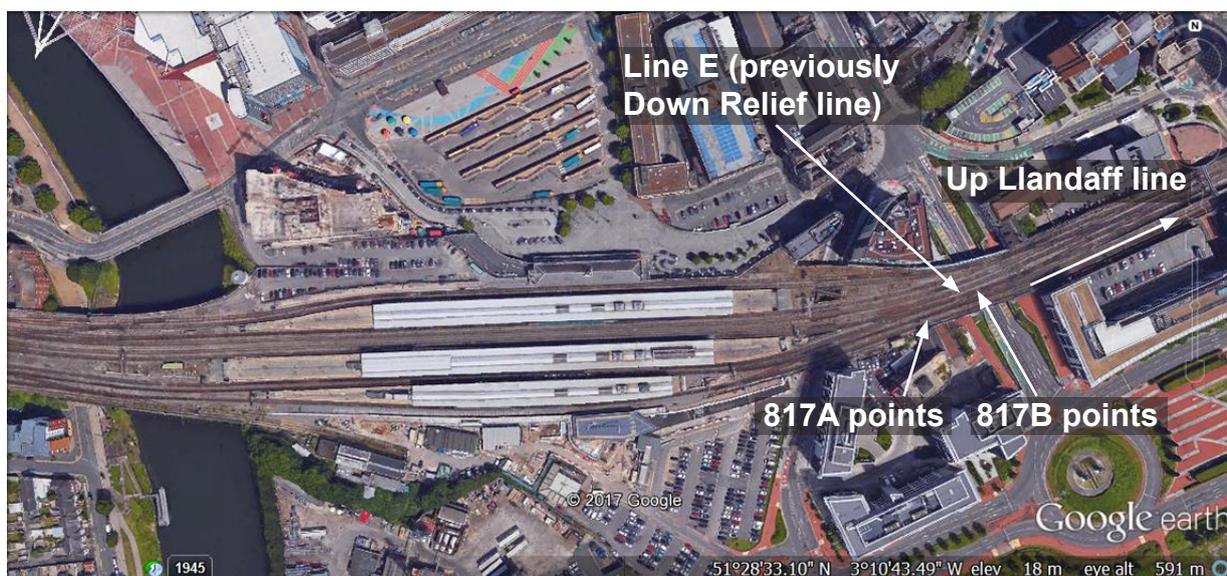
Figure 2: Overview of the lines out of Cardiff Central station showing the location of 817 points

- 7 817A points had been left unsecured, *undetected* and in the wrong position at the end of the works, earlier on the same day. They were due to be removed as part of final project works taking place during the Easter period in 2017. In the position in which the points were lying, train 2T08 would have been routed onto the former down relief line, which became line E as part of the works, and will be referred to as line E throughout this report.

- 8 817B points at the other end of the same *crossover* (figure 3) had also been left unsecured and undetected in the layout. However, this end of the crossover had been left set in the correct position for trains to pass along line E. 817B points were to be removed as part of the works carried out by 3 January 2017.

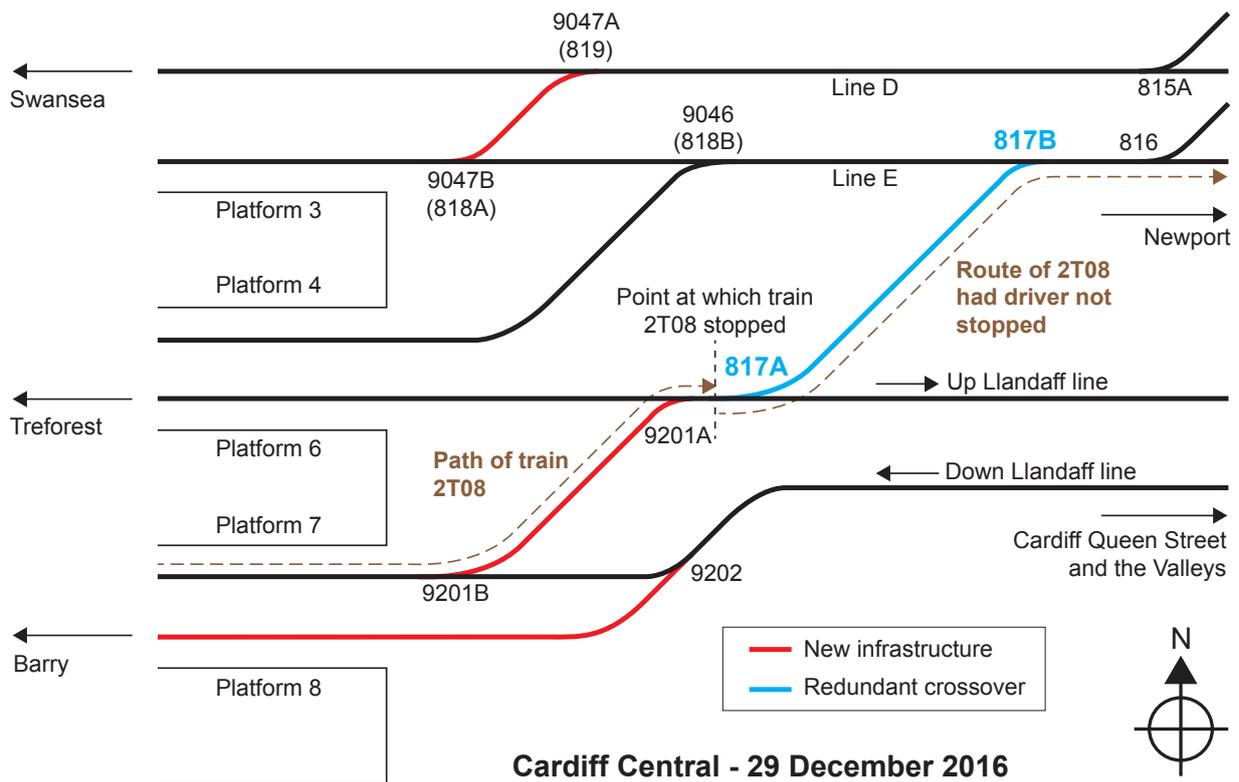
Figure 3: Simplified track layout showing the area and the location of 817 points

- 11 The train stopped approximately three metres west of 817A points on the *Up Llandaff* line, a location which is measured as 170 miles and 18 chains² from Paddington (via Gloucester).
