INCIDENT

Aircraft Type and Registration:	Agusta AW139, G-CIPW	
No & Type of Engines:	2 Pratt & Whitney Canada PT6C-67C turboshaft engines	
Year of Manufacture:	2013 (Serial no: 41344)	
Date & Time (UTC):	9 June 2017 at 1625 hrs	
Location:	Viscount Platform, North Sea	
Type of Flight:	Commercial Air Transport (Passenger)	
Persons on Board:	Crew - 2	Passengers - None
Injuries:	Crew - None	Passengers - N/A
Nature of Damage:	None	
Commander's Licence:	Airline Transport Pilot's Licence	
Commander's Age:	61 years	
Commander's Flying Experience:	13,840 hours (of which 444 were on type) Last 90 days - 70 hours Last 28 days - 24 hours	
Information Source:	Aircraft Accident Report Form submitted by the pilot plus operator's internal investigation and subsequent AAIB enquiries

Synopsis

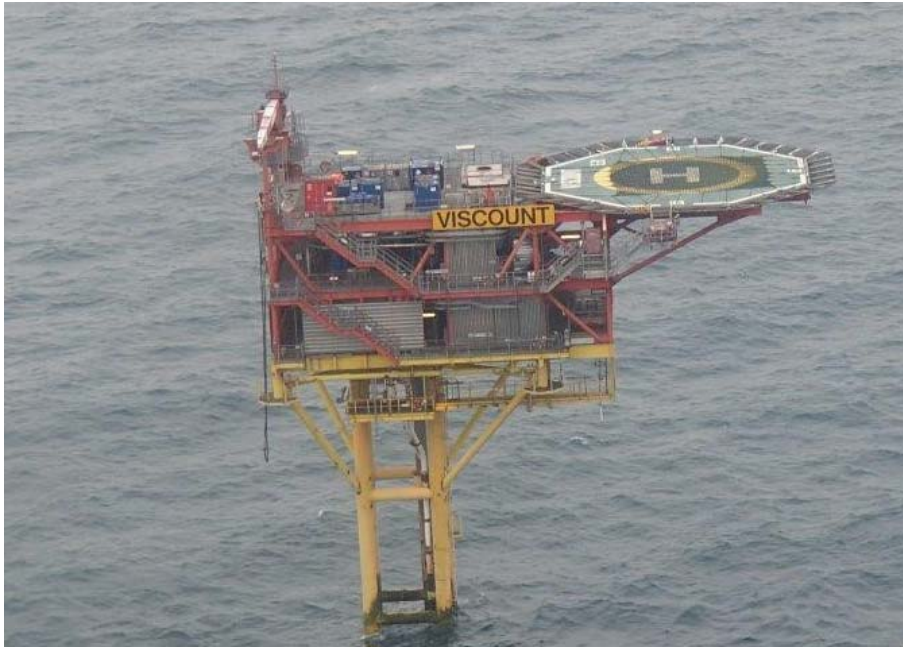
Figure 1

After completing their landing checks the crew confirmed the name painted on the platform was '*VISCOUNT*' and then landed normally (Figure 1). Once on the helideck they realised there were no passengers for them and consequently they discovered they should have flown to the Vampire platform. They subsequently lifted from Viscount flew to Vampire and then completed the remainder of their task without further incident.

The Normally Unmanned Installation (NUI) known as Viscount

The crew of this helicopter proceeded to the wrong offshore platform because the operator's flight planning system had not been updated to reflect a change of destination and because different platform identifiers were used by the operator and the chartering company.
