Rail Accident Investigation Branch

Rail Accident Report

Freight train derailment at East Somerset Junction 20 March 2017

Report 19/2017
December 2017

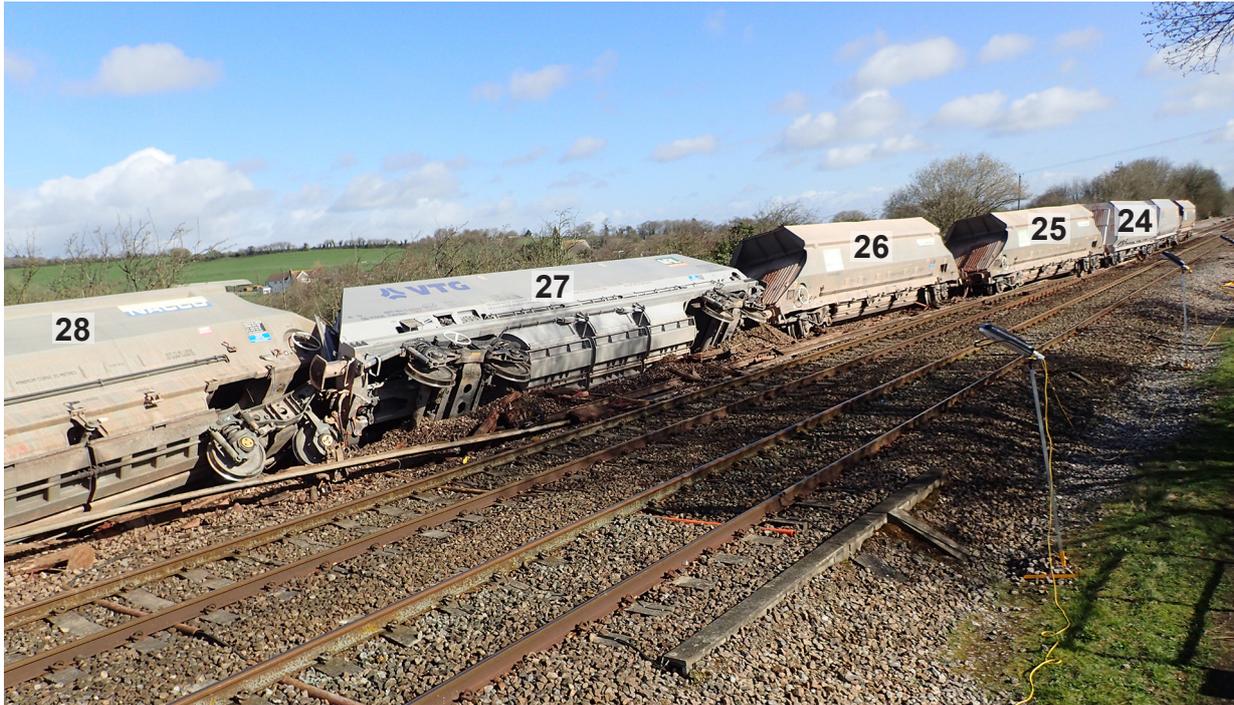
- 5 Six wagons, the 24th to 29th from the front of the train, derailed on the approach to the junction. The 27th and 28th wagons tipped onto their sides (figure 2) and the train divided between the 21st and 22nd wagons. The brakes applied automatically and the front part of the train stopped on the Up Westbury line. There were no injuries.
- 6 Although the Down Westbury line was not directly affected by the derailment, it was blocked to allow the recovery of the wagons and reinstatement of the damaged track. The Up and Down Westbury lines reopened at 23:01 hrs on 24 March, with trains able to access the East Somerset Branch from 04:49 hrs on 25 March.

Figure 2: General view of accident site, showing the numbering of the wagons from the front of the train

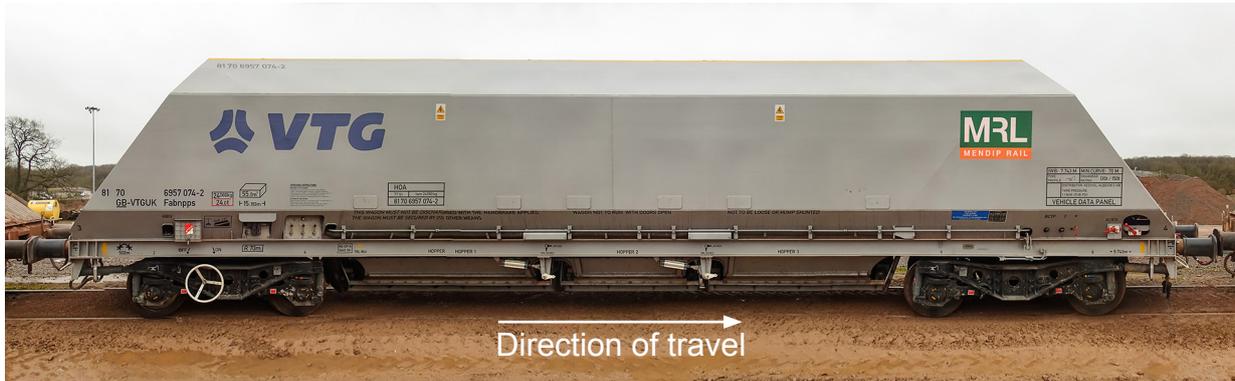
- 16 The first wagon to derail was the 24th from the front of the train; this was a type HOA hopper wagon, no. 706957074-2 (figure 4). The wagon is owned by VTG; it had been manufactured by Astra Rail and was only a few months old at the time of the derailment. It was carrying approximately 77 tonnes of washed sand; weighbridge data from Mendip Rail indicates this was offset so that the load on the left-hand wheels of the leading bogie was 4% higher than the load on the right-hand wheels. This offset is not likely to have been a significant factor in the derailment of the wagon (refer to paragraph 47).

Figure 4: Wagon 706957074-2 (number 24 in train 7Z15) at Merehead Quarry after the derailment

- 17 Subsequent examination of the wagon identified defects consistent with impact damage caused during the derailment:
- the spacing between the wheels on the wagon's leading axle was 4 mm less than when it was assembled (recorded on 4 April 2016), and 3 mm less than the minimum given in Railway Group Standard GM/RT2466, 'Railway Wheelsets';
 - the frame of the leading bogie was twisted by 7.8 mm, compared with 0.9 mm when it was assembled³ (recorded on 29 April 2016); and
 - the frame of the trailing bogie was twisted by 4.1 mm, compared with 0.8 mm when it was assembled (recorded on 28 April 2016).
- 18 The RAIB has found no evidence that the design or condition of the wagon, or the loading or operation of the train, caused or contributed to the accident.

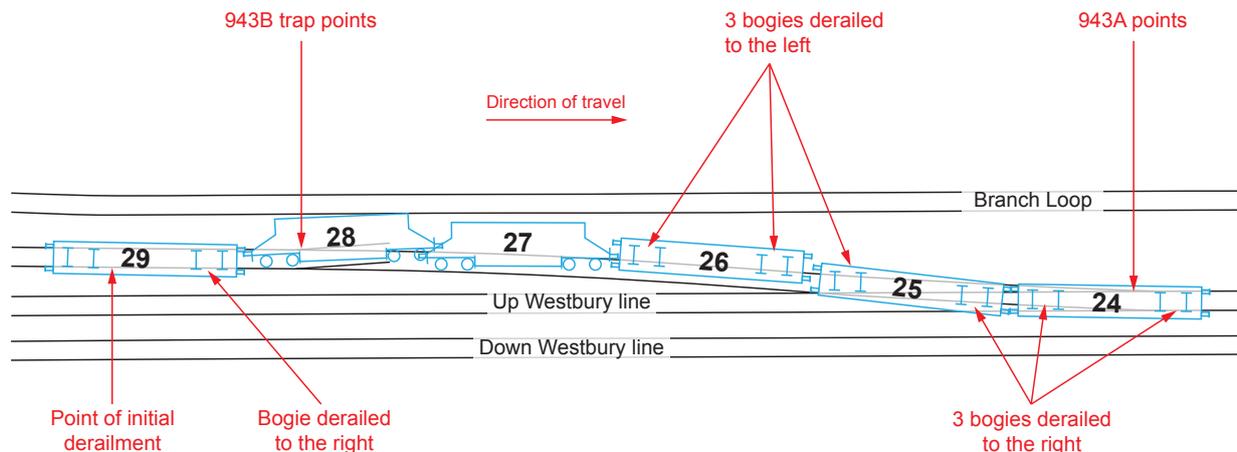
- 30 At around 17:48 hrs, the 24th to 29th wagons derailed as the train passed over the site of the former 945 points, which had connected Witham Sidings to the Link Line; the 27th and 28th wagons turned onto their sides (figure 5). The drag from the derailed wagons caused the coupling between the 21st and 22nd wagons to fail. In turn, this caused the brake pipe to part and the brakes to be applied automatically, stopping the train. The derailed wagons had travelled 79 metres before coming to rest.

Figure 5: Overview of accident site, showing final resting point of derailed wagons

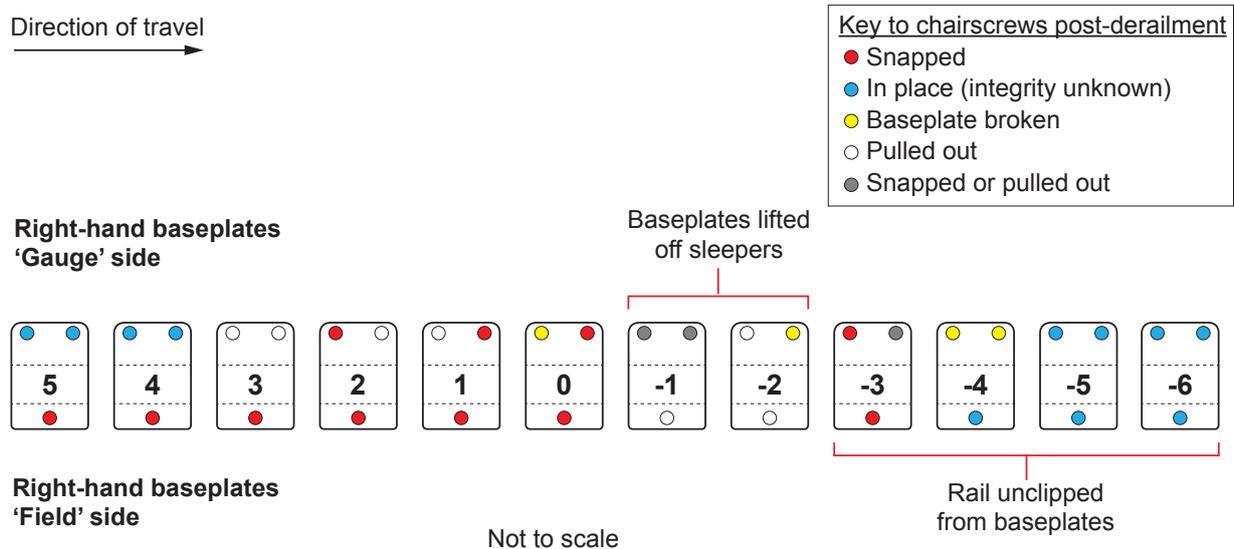
39 Examination of the track components after the derailment on 20 March 2017, revealed that *chairscrews* on the right-hand rail had failed to secure the rail, either because they had snapped or because they had been pulled out of their timber *bearers* (figure 6).

Figure 6: Right-hand baseplate fixings post-derailment

- 57 The RAIB considers that the geometry of the curve at the site of 945 points (paragraph 51), coupled with the relative rigidity of the field side chairscrews, probably led to these being subjected to disproportionately high lateral forces as trains traversed the curve. Examination of the sheared field side chairscrews from bearer numbers 5 to 1 indicated that they had all failed some time prior to the derailment on 20 March 2017. The field side chairscrew from bearer 0 had fatigue *beach marks* and a final fracture surface consistent with failure having occurred immediately before or during the derailment.

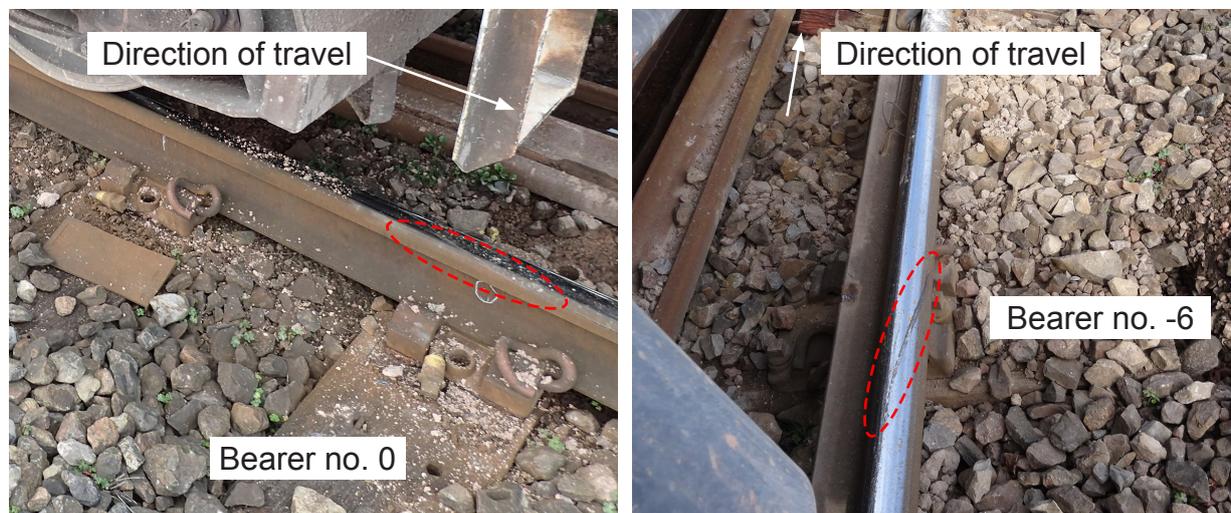
- 40 The bearers were numbered by the site investigation team: bearer no. 0 coincided with a short *flange mark* where the right-hand wheel flange had crossed from the *gauge side* of the rail to the *field side* (figure 7). The left-hand baseplate was also broken at bearer no. 0. Another short flange mark was present close to bearer no. -6, approximately four metres beyond bearer no. 0.

Figure 7: Flange marks on right-hand rail head at bearer nos. 0 and -6

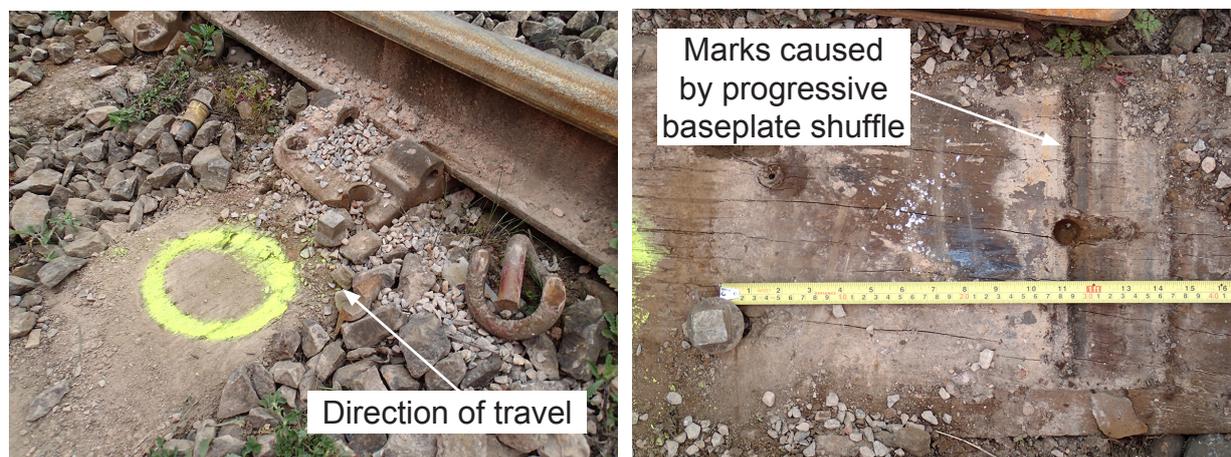
- 41 Evidence of *baseplate shuffle* was visible at all of the baseplates shown at figure 6, causing an increase in track gauge. Some of the shuffle would have occurred dynamically due to the loading from passing trains and some would have remained as static gauge spread (approximately 40 mm at bearer no. 0, figure 8). Further movement of the baseplates occurred during the course of the derailment.

Figure 8: Views before and after removal of right-hand baseplate at bearer no. 0

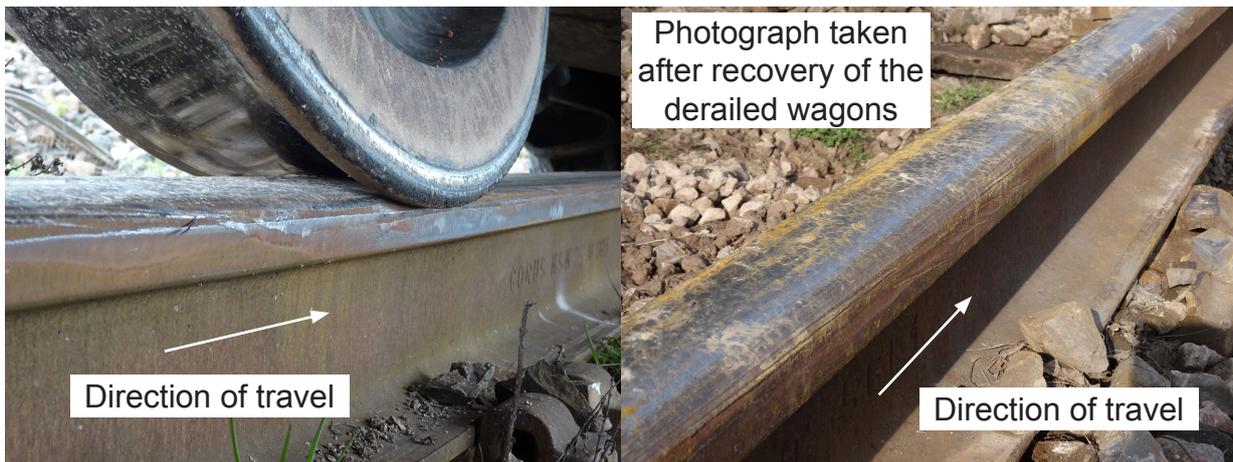
- 42 Witness marks from wheel flanges riding along the gauge corner of the right-hand rail were found at bearer no. -2. Multiple marks from the wheels of the derailed wagons dropping into the *four foot* were present on the left-hand rail in the vicinity of bearer nos. -2 and -4 (figure 9).

Figure 9: Drop-in marks on the gauge corner of the left-hand rail at bearer nos. -2 and -4 (courtesy Network Rail)

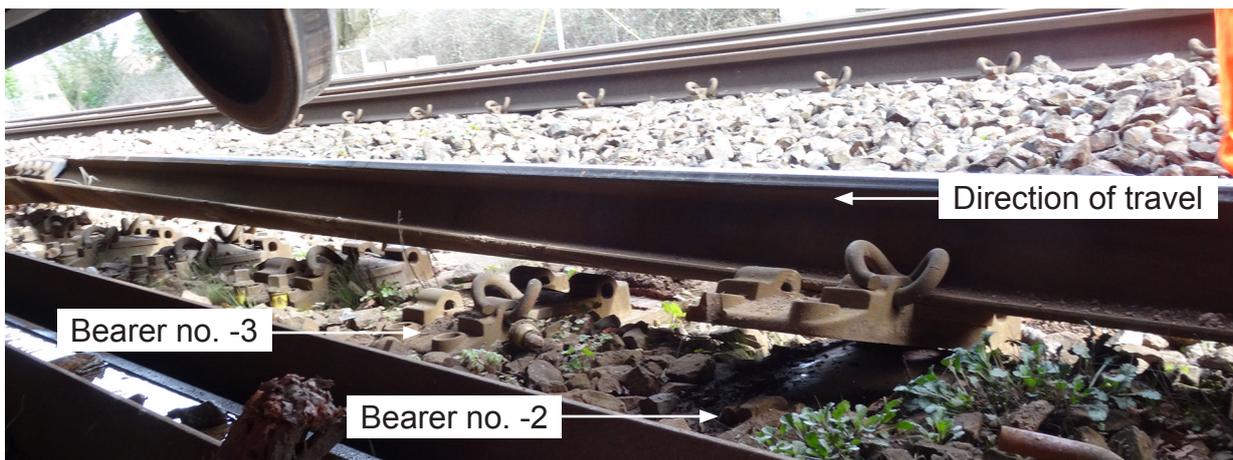
- 43 The right-hand baseplates at bearer nos. 3 through to -2 had lifted and pivoted around the edge on the field side of the rail. From bearer no. -3 onwards the rail had become unclipped from the baseplates, which remained in place on the bearers (figure 10).

Figure 10: View showing outwards rotation of the right-hand rail

- 46 The right-hand rail, already loosened, was moved further by the forces resulting from the derailment. It rotated outwards and became unclipped from the baseplates from bearer no. -3 onwards. Because of this, subsequent axles of the train derailed progressively earlier (closer to bearer no. 0).

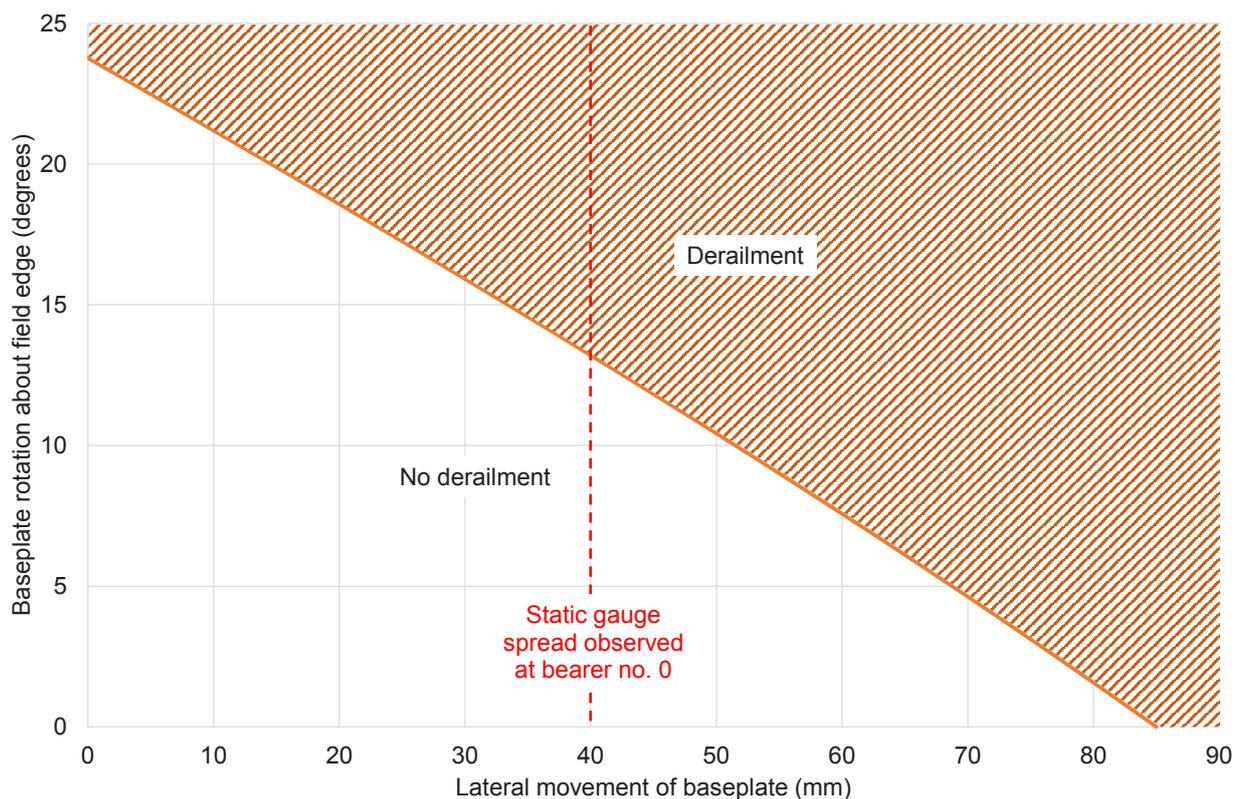
- 44 Although it is not possible to be certain about the exact sequence, the RAIB has concluded that the derailment was probably initiated when the leading left-hand wheel of the 24th wagon dropped into the four foot close to bearer no. -4 as a result of gauge spread. The forces exerted on the outer (right-hand) rail, in conjunction with its lack of fixity (paragraph 39), caused it to move laterally and also to rotate outwards, pivoting about the field side edge of the baseplates. The derailment occurred once the track gauge had increased to approximately 1520 mm; figure 11 shows the relationship between lateral displacement of the right-hand rail and its outwards rotation at which this threshold is reached.

Figure 11: Conditions required for gauge spread derailment (gauge ≥ 1520 mm)

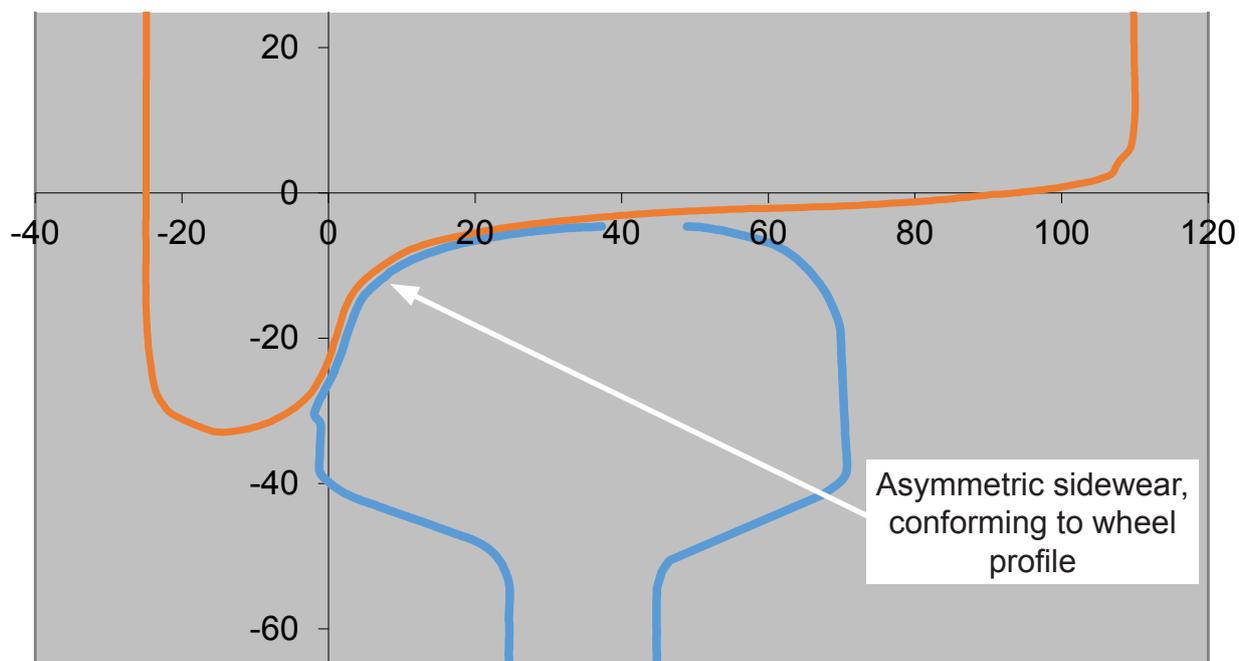
- 58 The failure of chairscrews allowed the outer rail on the curve to move, leading to dynamic gauge spread. This enlarged the clearance between the wheel flange and gauge face allowing an increased 'angle of attack' (the angle of the wheel relative to the rail) of the leading outer wheel on each bogie, and hence the lateral force on the rail, leading to further chairscrew failures and ultimately to the derailment. The *sidewear* that was evident on the outer rail approaching the point of derailment⁸ (figure 12), was consistent with wheels traversing the curve with high lateral contact forces acting between the flange and rail.

Figure 12: Cross-section of right-hand rail head and leading wheel of the 24th wagon at bearer no. 0 (view towards front of train)

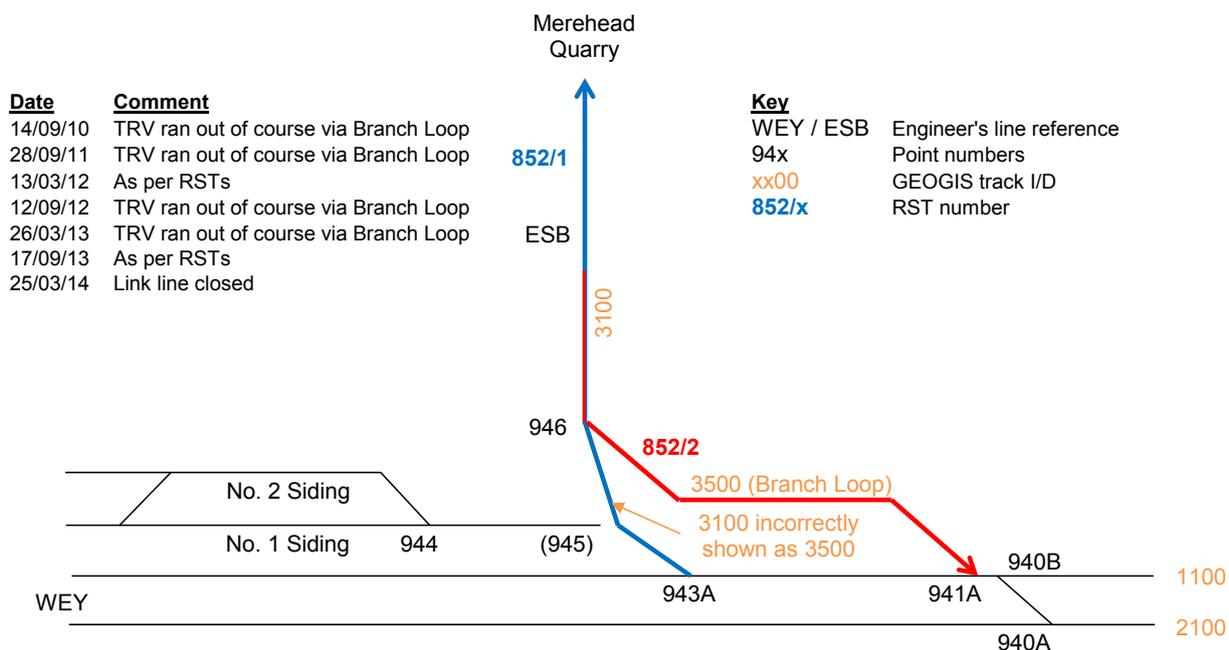
D2 Figure 17 shows the RSTs for the East Somerset Branch before they were changed to optimise the routing of the TRV in the Westbury area. RST 852/1 recorded the geometry of the Link Line (which had an incorrect GEOGIS track I/D in the RST), leading onto the Branch. RST 852/2 covered the Branch Loop.

Figure 17: East Somerset Branch RSTs prior to August 2014

D3 The TRV was planned to run using both RSTs. However, four of the six runs that took place in the three years from September 2010 ran in both directions over the Branch Loop and therefore did not measure the geometry of the Link Line.

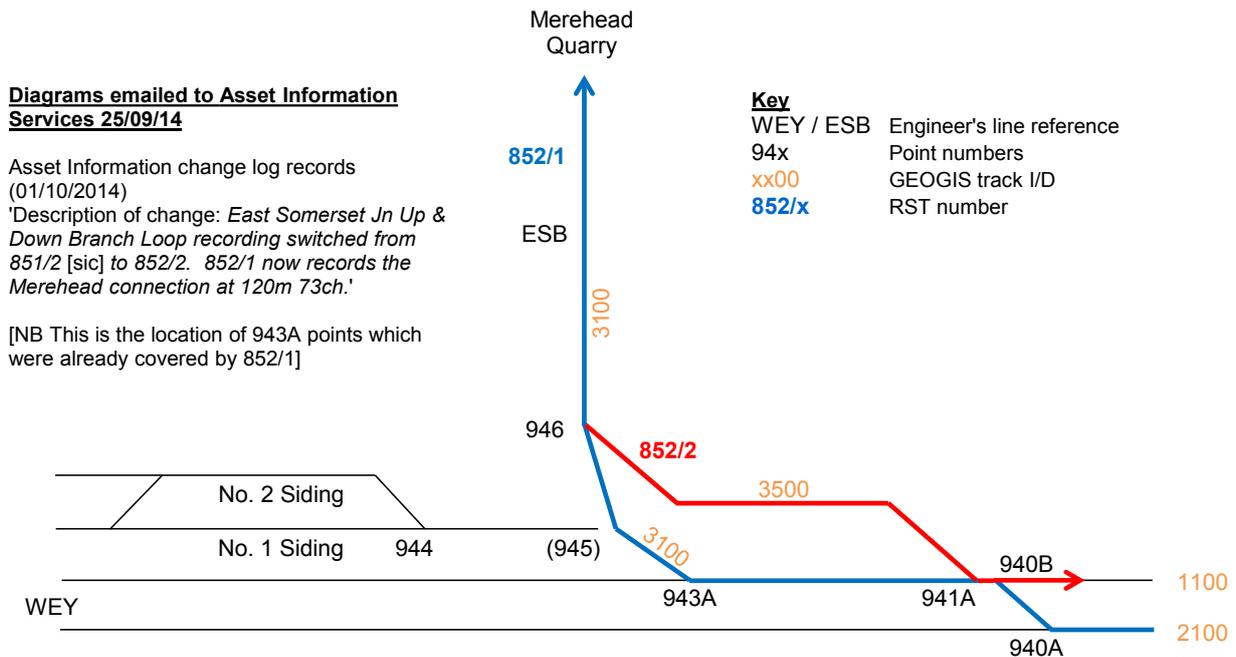
D4 Figure 18 shows the changes requested diagrammatically by the principal technical officer following the meeting at Westbury during August 2014. In practice, the only significant change was to include the crossover from the Down to Up Westbury lines (940 points). The principal technical officer believed the changes to the RSTs were more significant than the diagrams show: he believed the Link Line was not previously included (paragraph 68), possibly because of the incorrect track I/D in RST 852/1. On receipt of the principal technical officer's diagram, AIS translated the change into text and recorded it in their change log, incorrectly transposing the RSTs.

Figure 18: East Somerset Branch RSTs as requested by the PTO September 2014

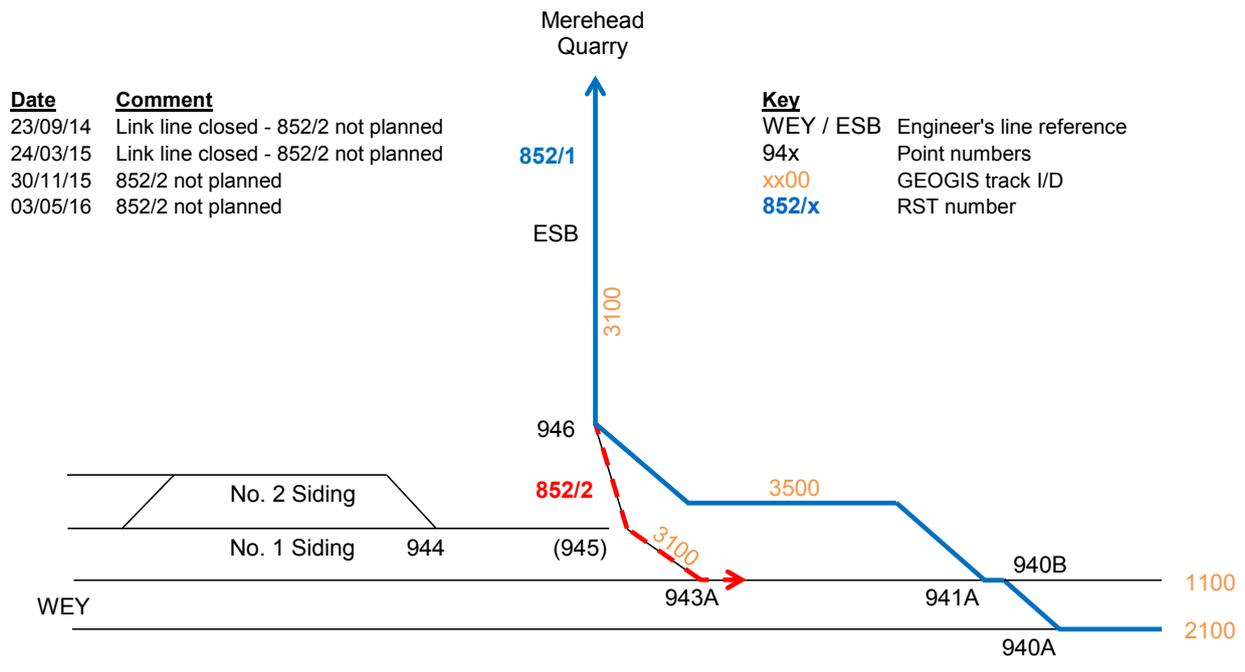
D5 Figure 19 shows the RSTs as amended by AIS in September 2014; these do not reflect the change log record as shown in figure 18 (the Link Line was now covered by RST 852/2 not 852/1).

Figure 19: East Somerset Branch RSTs as at March 2017

- 3 *The purpose of this recommendation is to reduce the probability that sections of track might inadvertently be missed from train-based track inspections.*
 Network Rail should improve its processes for specifying and controlling the configuration of the route definitions used by its track measurement trains. The improved arrangements should take account of the needs of all relevant stakeholders and clarify ownership of the data. Where temporary closures of sections of line are necessary, the steps to reactivate train-based measurement should be clearly defined (paragraph 90d).
