SERIOUS INCIDENT

Aircraft Type and Registration:	Bombardier BD-700-1A11 (Global 5000), VP-CKM	
No & Type of Engines:	2 Rolls-Royce BR700-710A2-20 turbofan engines	
Year of Manufacture:	2012	
Date & Time (UTC):	15 November 2016 at 0138 hrs	
Location:	On approach to Hong Kong International Airport	
Type of Flight:	Private	
Persons on Board:	Crew - 3	Passengers - None
Injuries:	Crew - None	Passengers - N/A
Nature of Damage:	None	
Commander's Licence:	Airline Transport Pilot's Licence	
Commander's Age:	56 years	
Commander's Flying Experience:	6,820 hours (of which 623 were on type) Last 90 days - 58 hours Last 28 days - 22 hours	
Information Source:	AAIB Field Investigation

Synopsis

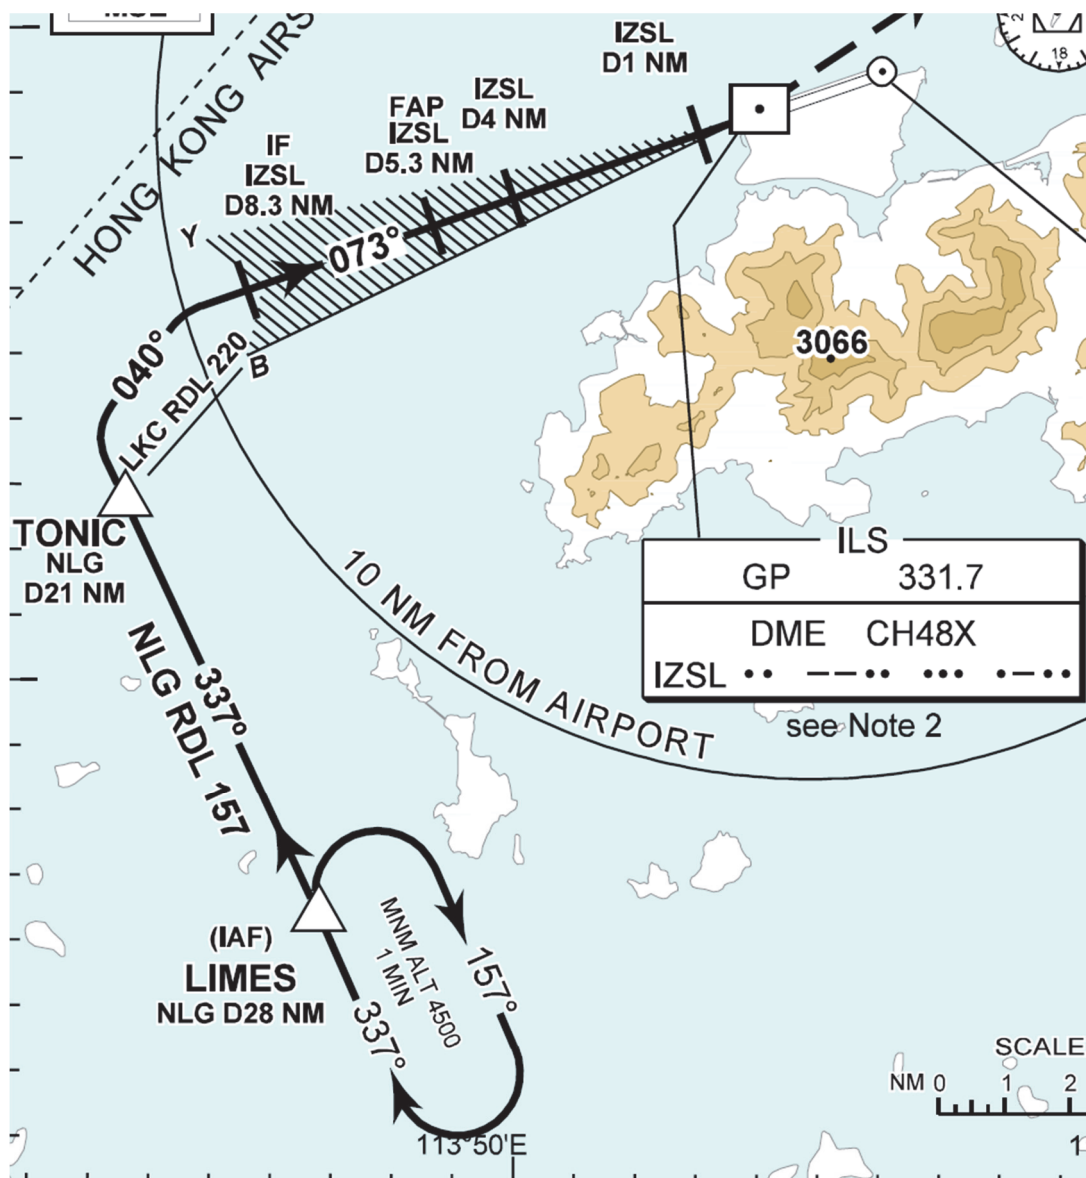
Figure 1

Plan view of the ILS for Runway 07L from the Hong Kong Airport
(valid at the time of the incident)

The aircraft was cleared for the ILS approach to Runway 07L while approaching TONIC and was expected to follow the lateral path shown in Figure 1, and descend not below 1,700 ft amsl until intercepting the glideslope as shown in Figure 2. The autopilot was engaged and the flightpath was being controlled laterally by the FMS, which was in navigation (NAV) mode. The aircraft was flying level at 3,000 ft amsl in altitude hold (ALT) mode. In this configuration, the aircraft would have automatically followed the lateral path of the procedure and remained at 3,000 ft amsl.

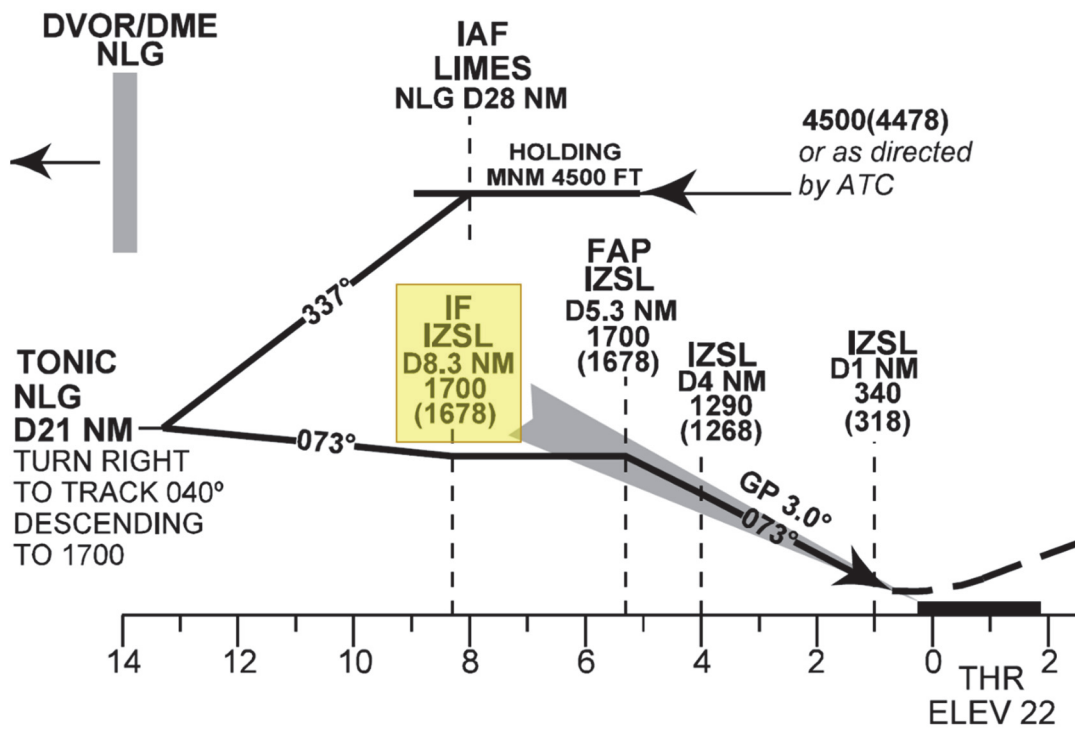
Figure 2, showing the vertical profile of the ILS 07L approach, indicates that, once cleared for the ILS approach and past LIMES, VP-CKM was permitted to descend to not below 1,700 ft amsl (shown in yellow). The aircraft was then expected to fly not below 1,700 ft amsl until intercepting the glideslope, which would provide vertical guidance towards the runway (shown in Figure 2 by the black line marked 'GP 3.0°').

Vertical profile of the ILS for Runway 07L from the Hong Kong AIP

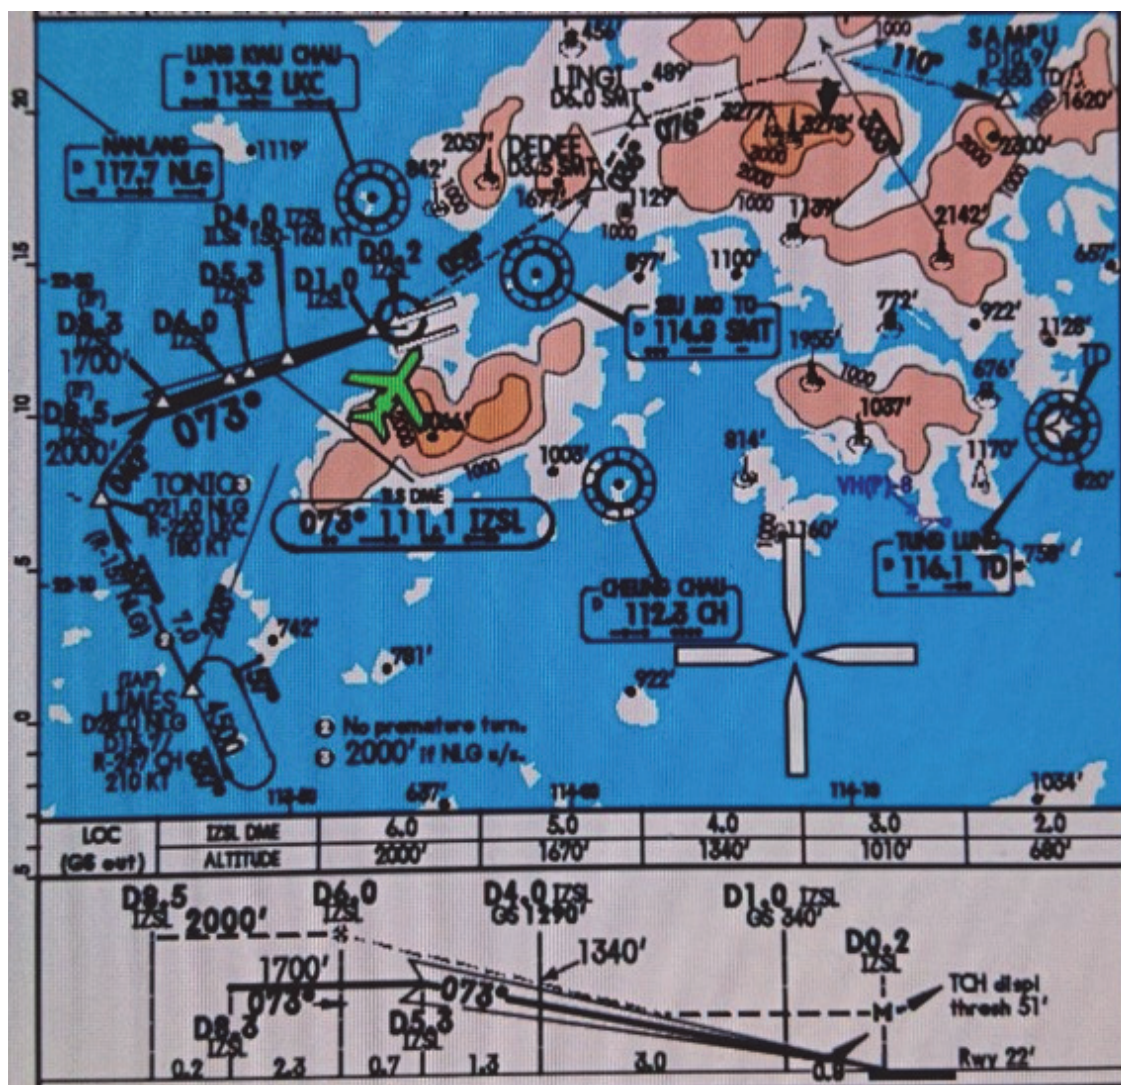
Figure 3

A section of the ILS or LOC 07L approach chart shown on the electronic flight display

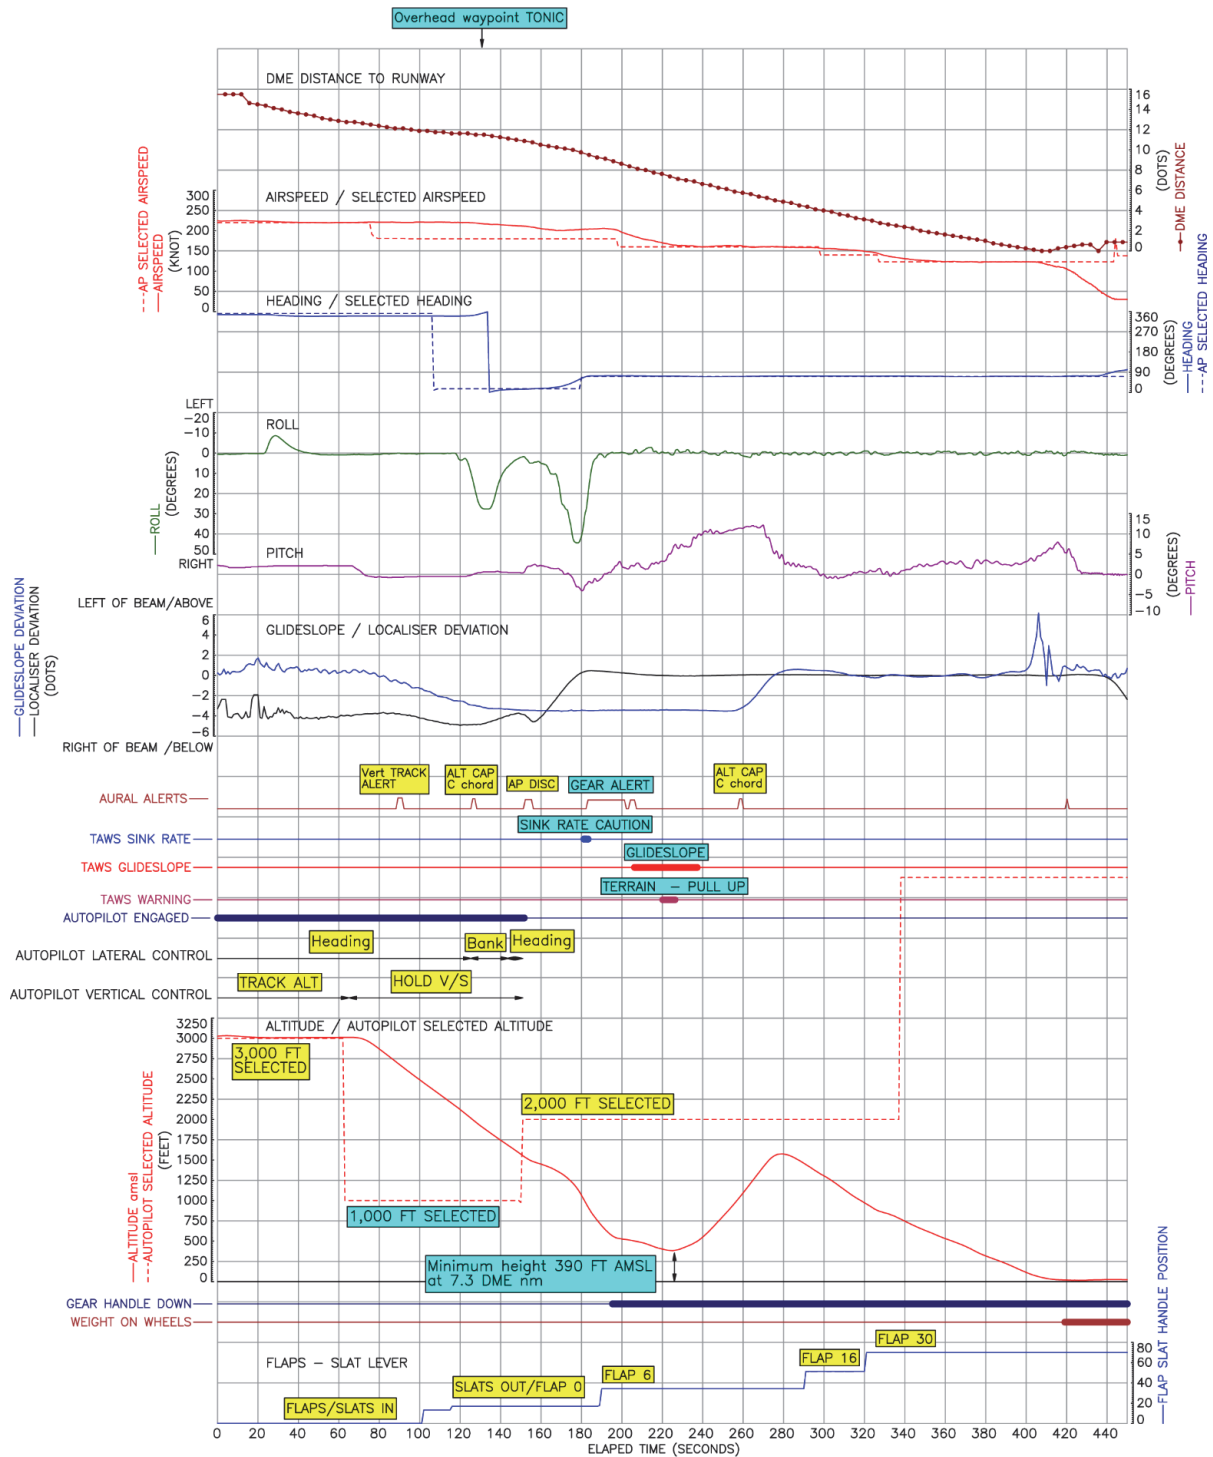
Figure 4

Selected data from the FDR are presented in Figure 4.

FDR data during the approach to Hong Kong Airport – Runway 07L
