SERIOUS INCIDENT

Aircraft Type and Registration:	ATR 72-212 A, 500 Version, G-COBO	
No & Type of Engines:	2 Pratt & Whitney Canada PW127M turboprop engines	
Year of Manufacture:	2009 (Serial no: 0852)	
Date & Time (UTC):	21 December 2016 at 1733 hrs	
Location:	5 nm north of reporting point ORTAC	
Type of Flight:	Commercial Air Transport (Passenger)	
Persons on Board:	Crew - 4	Passengers - 61
Injuries:	Crew - None	Passengers - None
Nature of Damage:	None	
Commander's Licence:	Airline Transport Pilot's Licence	
Commander's Age:	46 years	
Commander's Flying Experience:	6,040 hours (of which 1,401 were on type) Last 90 days - 152 hours Last 28 days - 51 hours	
Information Source:	AAIB Field Investigation

Synopsis

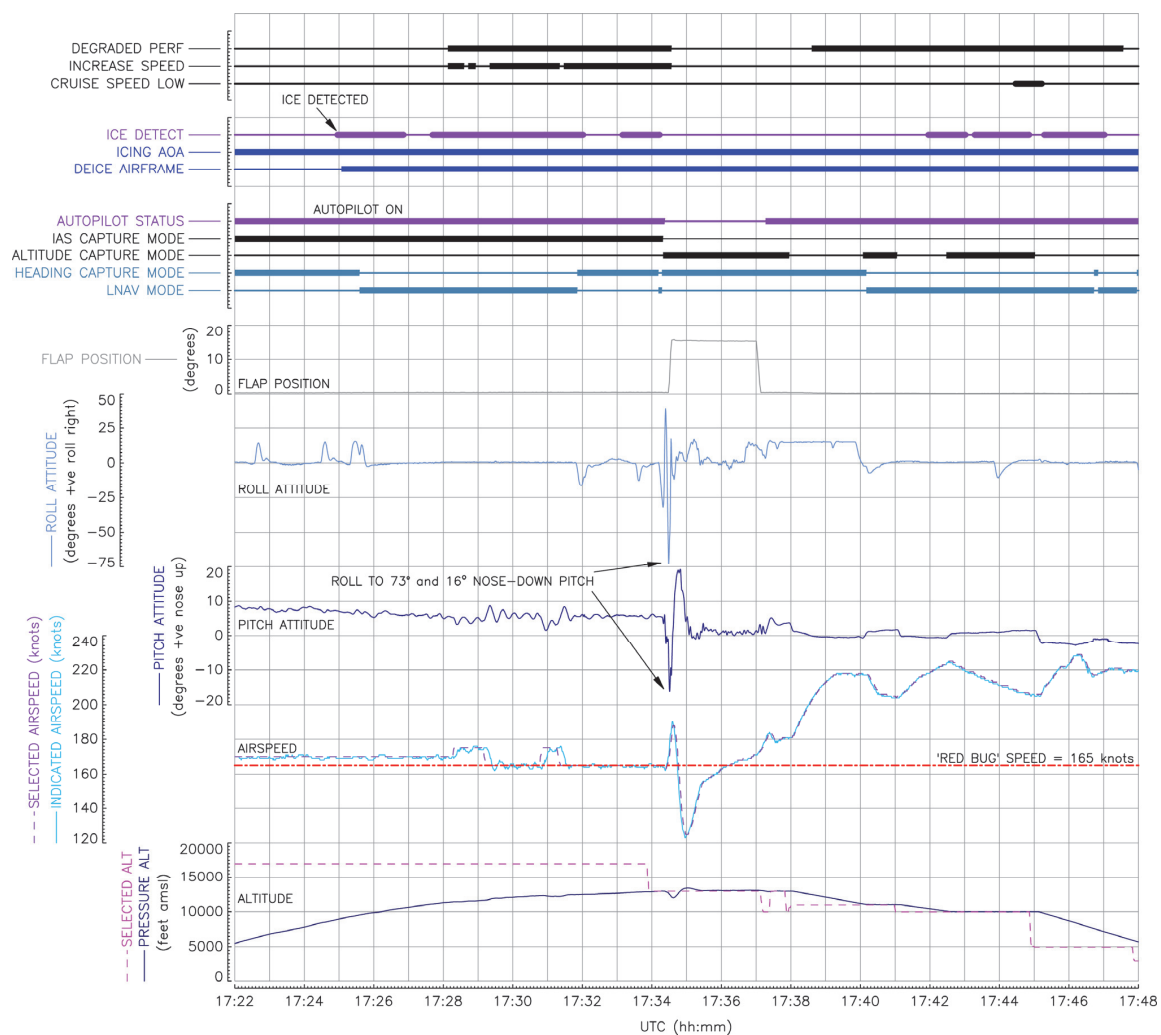
Figure 1
Salient data from the FDR and DAR

Recorded data⁶ showed that at the point of the upset the aircraft initially rolled left to 32° the autopilot disengaged, before rolling right to 38°. It then rolled left again, reaching attitudes of 73° in roll and 16° nose-down in pitch.

- ⁵ Lateral Navigation. Selecting LNAV from heading mode deactivates the HI bank protection, if it had been selected.
- ⁶ Although not recorded on the FDR, the manufacture confirmed that the stick shaker would have activated during the event (resulting in the autopilot disengagement), and also the stick pusher. The crew had no recollection of these inputs, and neither of these was discussed or audible on the CVR.

Upon the commander's instructions the co-pilot actioned the upset recovery items when instructed to do so by the commander. These included extending the flaps to Flap 15⁷. The commander recovered the aircraft to controlled flight at FL130, having descended through about 1,000 ft. During the recovery, pitch increased from nose-down to a nose-up attitude of 19°, before reducing to a normal value. During these pitch and roll oscillations, the IAS varied between 190 kt and 123 kt.

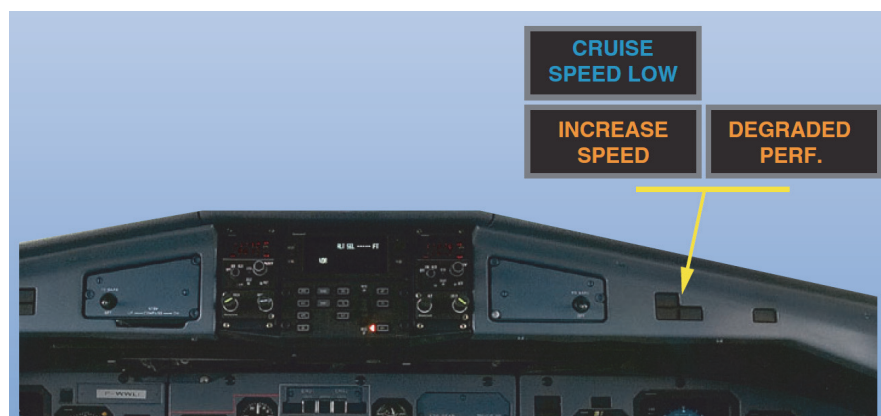
Figure 2

The APM function was active in icing conditions (based on the status of the airframe de-icing system and ice detection, i.e. active when airframe anti icing was switched ON by the pilot or by automatic ice detection by the aircraft). It compared theoretical aircraft drag with actual in-flight drag, and MSIS with actual IAS. A **DEGRADED PERF** caution (a steady amber light with a single audio chime and a master caution on the attention getter) would illuminate when the actual drag was higher than the theoretical drag and the IAS greater than the MSIS. An **INCREASE SPEED** caution (an amber flashing light with audio chime and a master caution on the attention getter) would illuminate when actual drag was higher than theoretical one and IAS less than MSIS, within a threshold (Figure 2).

APM messages.
(Similar layout on left side of the cockpit)
