**ACCIDENT**

<b>Aircraft Type and Registration:</b>	Yak-52, G-YAKB	
<b>No &amp; Type of Engines:</b>	1 Ivchenko Vedeneyev M-14P radial piston engine	
<b>Year of Manufacture:</b>	1992 (Serial no: 9211517)	
<b>Date &amp; Time (UTC):</b>	8 July 2016 at 0934 hrs	
<b>Location:</b>	1 nm north of Dinton, Wiltshire	
<b>Type of Flight:</b>	Aerial work	
<b>Persons on Board:</b>	Crew - 2	Passengers - None
<b>Injuries:</b>	Crew - 1 (Fatal) 1 (Serious)	Passengers - N/A
<b>Nature of Damage:</b>	Aircraft destroyed	
<b>Commander's Licence:</b>	Commercial Pilot's Licence	
<b>Commander's Age:</b>	60 years	
<b>Commander's Flying Experience:</b>	2,953 hours (of which 446 were on type) Last 90 days - 18 hours Last 28 days - 15 hours	
<b>Information Source:</b>	AAIB Field Investigation

**Synopsis**

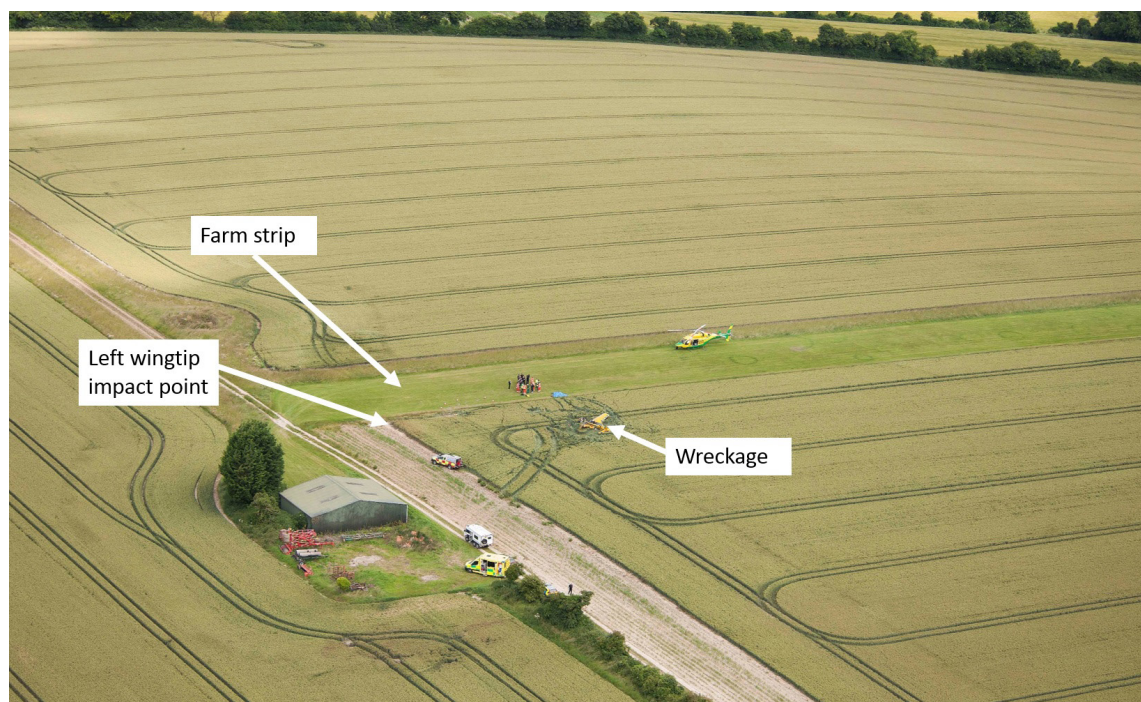
**Figure 3**

The aircraft wreckage was located in a wheat field on the southern edge of a private farm strip, 1 nm north of Dinton, at an elevation of 436 ft amsl (Figure 3). The private strip was not shown on any aeronautical chart or in any airfield guide and, according to its owner, was not easily visible from the air. The strip was 473 m long, 20 m wide and orientated in the direction 080°(M).

Aerial view of accident site (looking north) and private farm strip  
(Photograph courtesy QinetiQ)

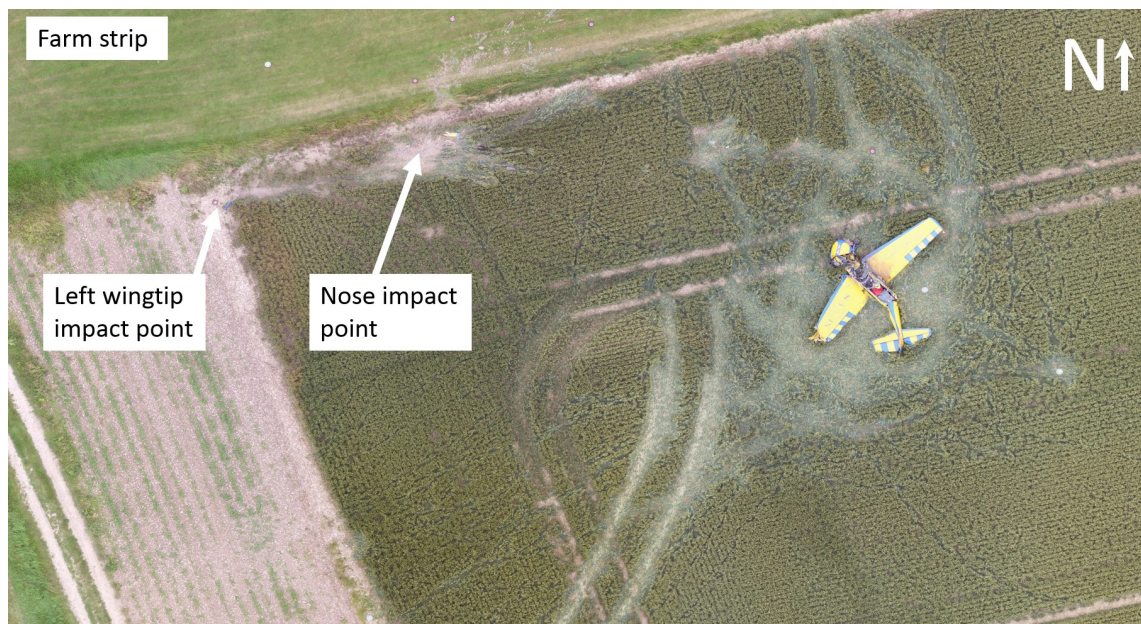
**Figure 4**

The ground impact marks showed that the aircraft had struck the ground left wingtip first, in a steep left bank; this was followed by a heavy nose impact (Figure 4). The aircraft had then bounced backwards, probably striking its tail, before bouncing again into the location where it was found, resting upright, 35 m from the initial impact point.

Aerial view of accident site (North up)

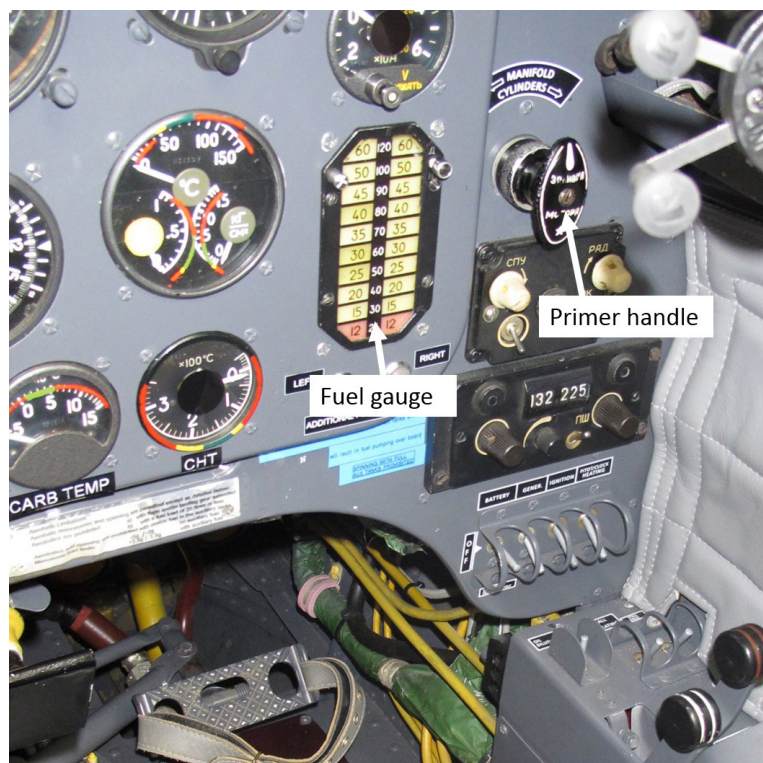
**Figure 8**

The light bulbs inside the fuel gauge (Figure 8) were also examined and three of the bulbs were found to be stretched. These were for the left tank quantities 40 and 45, and for the right tank quantity 40. During transition from one indicated level to the next, the two quantities can be flickering on and off. This indicated that the left fuel tank quantity was probably between 40 and 45 litres and the right fuel tank quantity was probably about 40 litres.

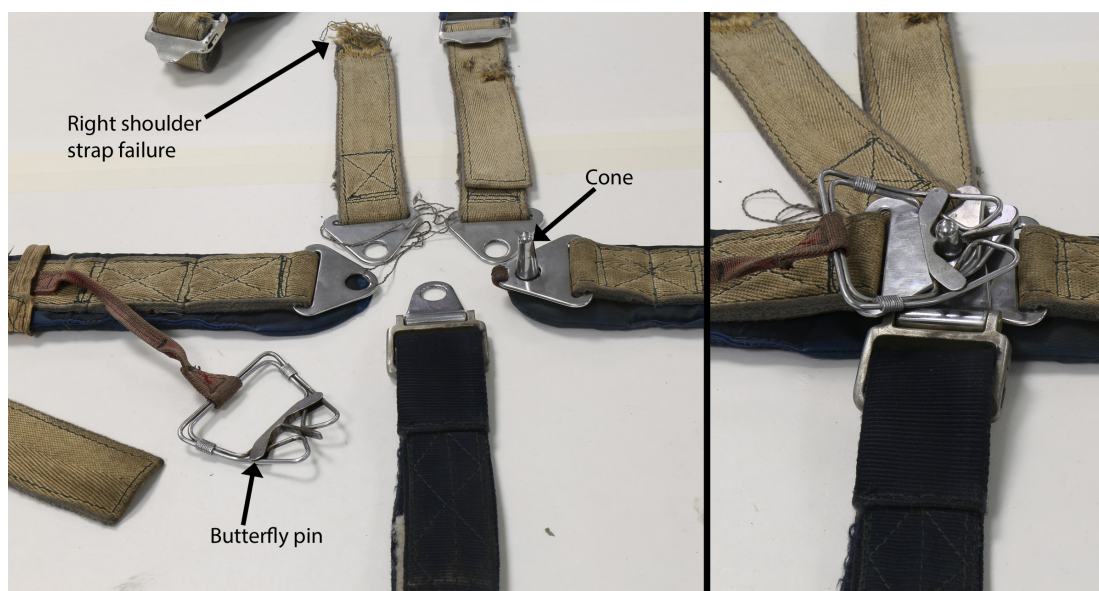
**Figure 10**

Front seat 5-point harness as found (left); all straps secured (right)

The front seat right lower shoulder strap had failed in overload at the adjustable buckle (Figure 10) and the crotch strap had failed at its lower fuselage fitting. This lower fitting failure was probably caused by distortion of the floor and seat structure which resulted in the seat pan moving forwards against the crotch strap. The front seat lap straps had not failed but the butterfly pin had come out, so the straps were no longer connected. If the butterfly pin had not been inserted at the time of impact it is unlikely that the shoulder strap or crotch strap fitting would have failed. It appeared most likely that the pin came out during the impact sequence which allowed the FSP to be thrown from his seat. There were no witness marks on the pin or on its tether to help explain how it came out.

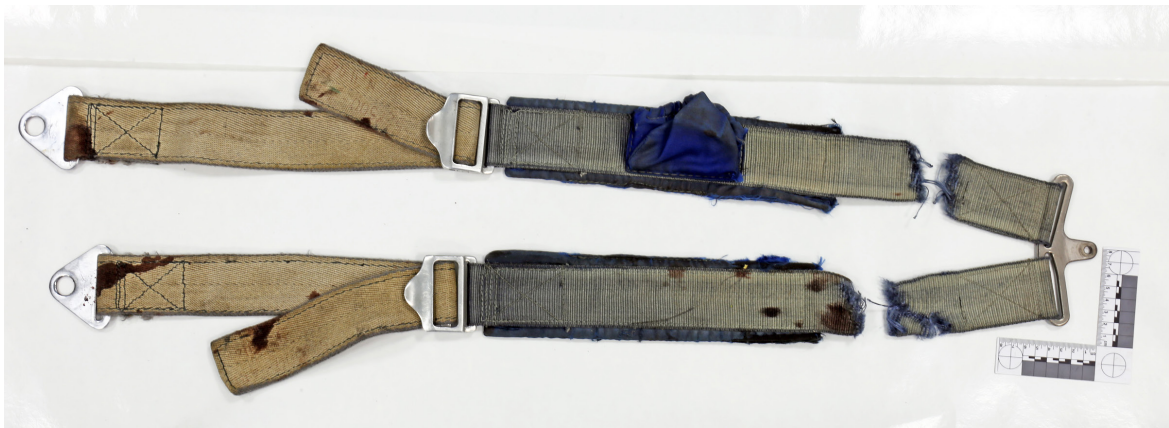
**Figure 11**

The rear seat upper shoulder straps had both failed in overload above the adjustable buckles (Figure 11), and the rear seat left lap strap had failed at the adjustable buckle (Figure 12). The butterfly pin was also out, but one witness who attended the scene believes he removed it to help the commander out of his seat.

Rear seat shoulder harnesses (both failed at upper strap)

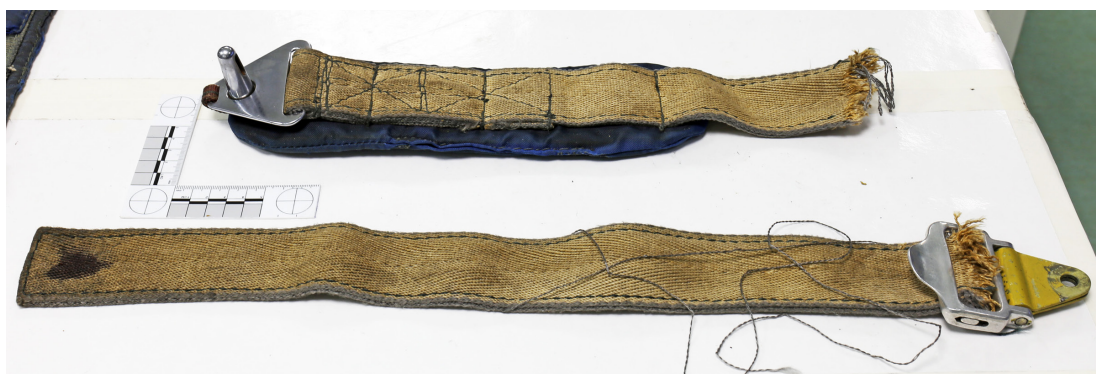
**Figure 12**

Rear seat left lap strap (failed at adjustable buckle)
