ACCIDENT

Aircraft Type and Registration:	Cessna 182T, N60554
No & Type of Engines:	1 Lycoming IO-540-AB1A5 Piston Engine
Year of Manufacture:	2006
Date & Time (UTC):	28 August 2017 at 1640 hrs
Location:	Private airstrip, near Stockbridge, Hampshire
Type of Flight:	Private
Persons on Board:	Crew - 1 Passengers - None
Injuries:	Crew - None Passengers - N/A
Nature of Damage:	Damaged beyond economic repair
Commander's Licence:	Private Pilot's Licence (Federal Aviation Administration, USA)
Commander's Age:	64 years
Commander's Flying Experience:	1,329 hours (of which 950 were on type) Last 90 days - 27 hours Last 28 days - 5 hours
Information Source:	Aircraft Accident Report Form submitted by the pilot and further enquires by the AAIB

Synopsis

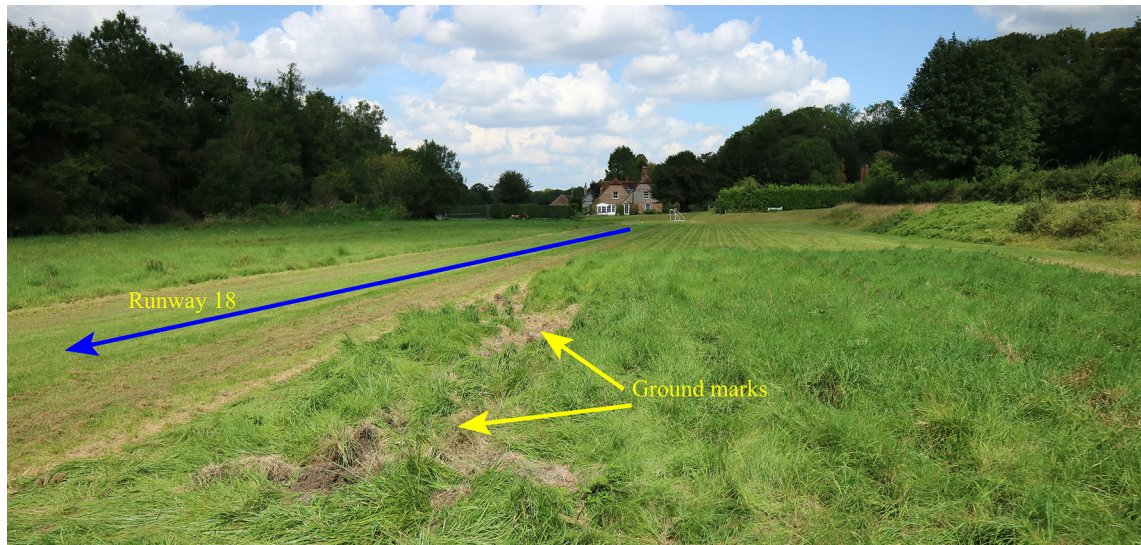
Figure 1

A northerly view of Runway 18.
Note the trees and buildings to the north of the airstrip, on the approach to Runway 18
