## ACCIDENT

<b>Aircraft Type and Registration:</b>	Piper PA-32R-301T, N414AG	
<b>No &amp; Type of Engines:</b>	1 Lycoming T10-540-AH1A piston engine	
<b>Year of Manufacture:</b>	2000 (Serial no: 3257184)	
<b>Date &amp; Time (UTC):</b>	23 August 2017 at 0827 hrs	
<b>Location:</b>	5 miles south of Linton-on-Ouse Airfield	
<b>Type of Flight:</b>	Private	
<b>Persons on Board:</b>	Crew - 1	Passengers - None
<b>Injuries:</b>	Crew - None	Passengers - N/A
<b>Nature of Damage:</b>	Extensive	
<b>Commander's Licence:</b>	Commercial Pilot's Licence	
<b>Commander's Age:</b>	63 years	
<b>Commander's Flying Experience:</b>	3,088 hours (of which 1,904 were on type) Last 90 days - 188 hours Last 28 days - 56 hours	
<b>Information Source:</b>	Aircraft Accident Report Form submitted by the pilot

## Synopsis

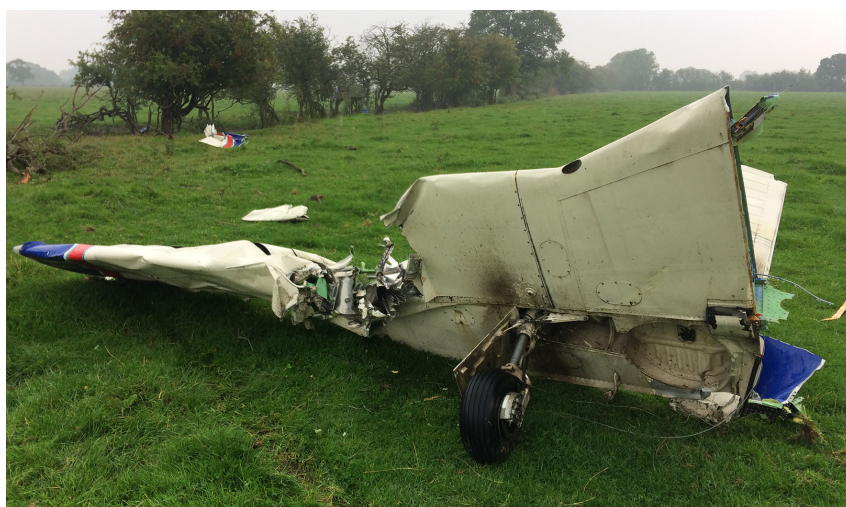
**Figure 1**

As the pilot flared the aircraft he retracted the flaps to try to improve the braking action on wet grass, and he turned off the master switch. The touchdown and ground roll felt relatively gentle and it became apparent that the aircraft was going to pass through an old hedge line consisting of numerous trees and bushes. The pilot steered towards a gap between two trees but the right wing and associated landing gear detached upon impact with one of the trees (Figure 1). The outboard section of the left wing also hit a tree and sustained damage, but without detaching from the fuselage. The aircraft then skidded across the adjoining field, losing the left main landing gear leg in the process. However, the nosewheel steering was still effective and the pilot used this to direct the aircraft between two ponds which he spotted ahead.

Detached right wing with trees which the aircraft hit in the background

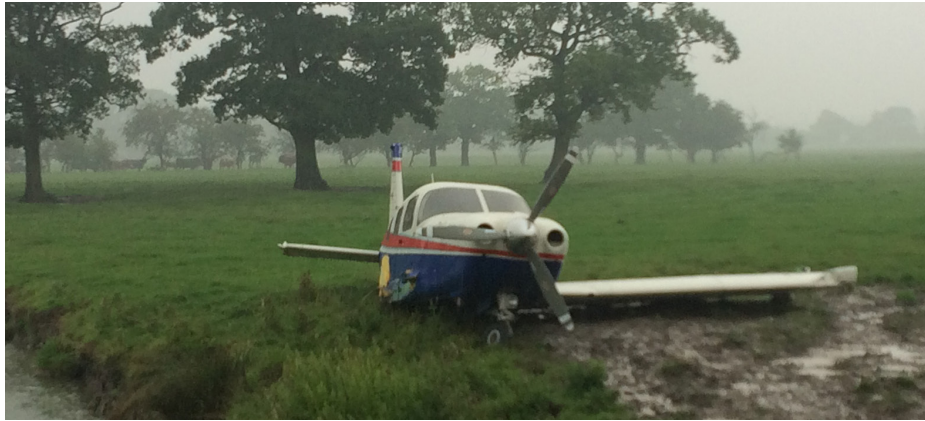
**Figure 2**

The aircraft came to a halt approximately one metre from the edge of one of the ponds (Figure 2) and the pilot, who was uninjured, escaped through the door without difficulty. He checked the left wing tank and estimated it still held 25 gallons of fuel but the tank in the right wing had burst and he was unable to determine how much fuel it contained at touchdown.

Final position of N414AG close to the pond
