**ACCIDENT**

<b>Aircraft Type and Registration:</b>	Titan T-51 Mustang, G-DHYS	
<b>No &amp; Type of Engines:</b>	1 Suzuki V6 Mini Merlin piston engine	
<b>Year of Manufacture:</b>	2015 (Serial no: LAA 355-15190)	
<b>Date &amp; Time (UTC):</b>	31 May 2017 at 1433 hrs	
<b>Location:</b>	Gloucestershire Airport, Gloucestershire	
<b>Type of Flight:</b>	Private	
<b>Persons on Board:</b>	Crew - 1	Passengers - None
<b>Injuries:</b>	Crew - None	Passengers - N/A
<b>Nature of Damage:</b>	Main landing gear, propeller and right wing damaged	
<b>Commander's Licence:</b>	Commercial Pilot's Licence	
<b>Commander's Age:</b>	60 years	
<b>Commander's Flying Experience:</b>	2,462 hours (of which 51 were on type) Last 90 days - 95 hours Last 28 days - 24 hours	
<b>Information Source:</b>	Aircraft Accident Report Form submitted by the pilot

**Synopsis**

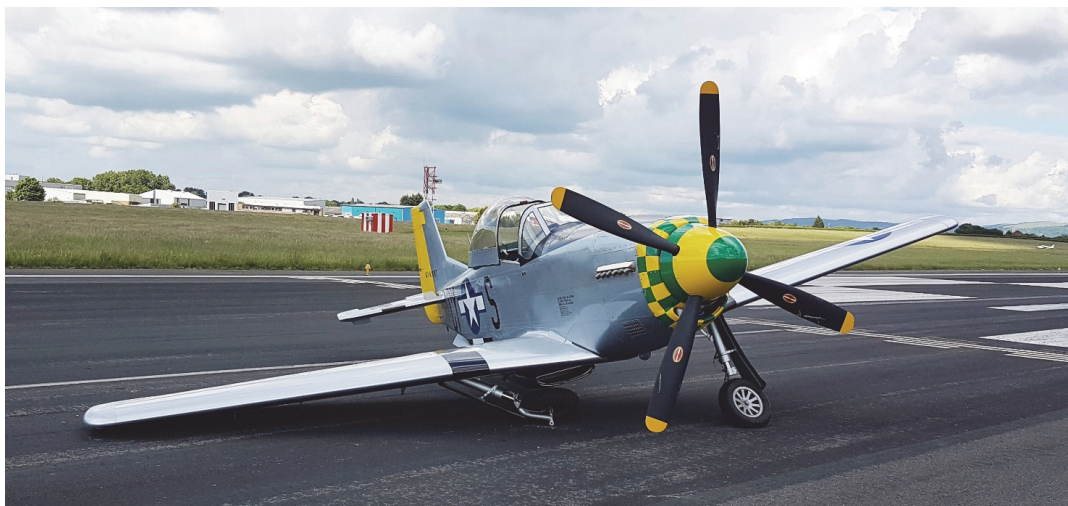
**Figure 1**

Following a local flight in good weather conditions, with light winds, the pilot landed the aircraft normally on Runway 27. As the aircraft slowed to approximately 10-15 mph at the end of the landing roll the pilot gently applied the brakes, but as he did so the aircraft yawed to the left which he could not control using right rudder and right brake. The pilot reported that the wings remained level as the aircraft yawed to the left. The weight transferred to the right main landing gear leg, which collapsed inwards, causing the propeller and right wingtip to contact the runway as the aircraft came to a stop, Figure 1.

G-DHYS following the collapse of the right main landing gear

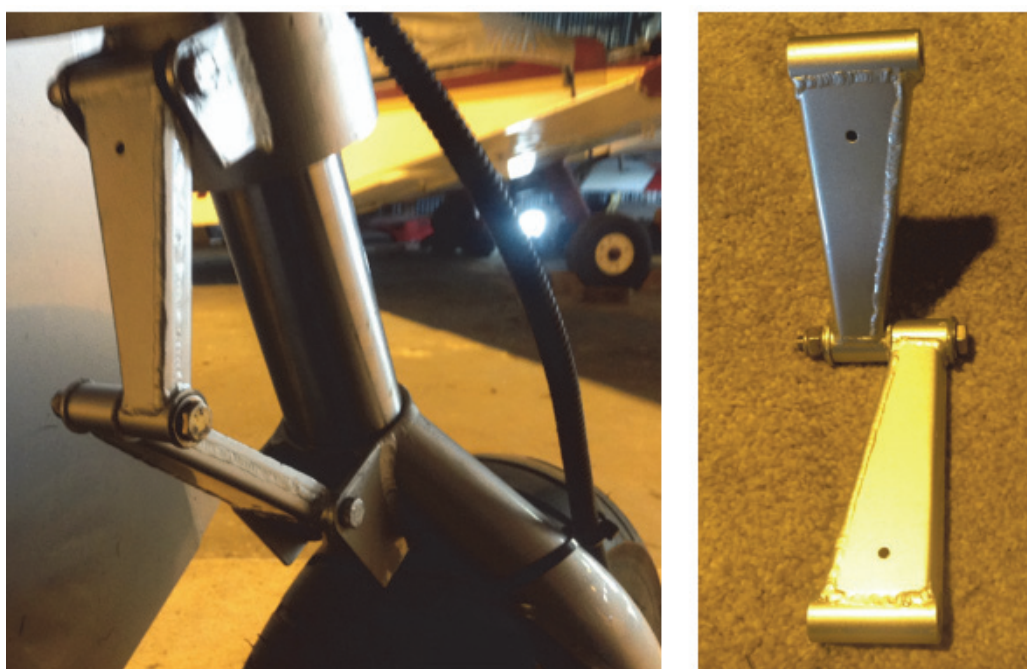
**Figure 4**

Strengthened MLG torque links installed on G-FION

The LAA has approved a set of modified torque links, Figure 4, for installation on G-FION, another T-51 Mustang aircraft that is currently under construction. The modified stronger torque links were developed as an LAA modification as a result of concerns raised by the accident with G-DHYS. If this modification is successful, the LAA will require that T-51 Mustang aircraft, powered by the Suzuki V6 engine and operating on an LAA Permit to Fly, are modified in this manner.

The aircraft's right MLG leg collapsed during the latter stages of a normal landing rollout, whilst the aircraft was travelling at low speed. Inspection of the damaged MLG components did not positively identify the cause of the right MLG leg collapse. The LAA have approved a modification for strengthened MLG torque links for the T-51 Mustang aircraft and pending flight trials, may mandate this modification for certain T-51 Mustang aircraft<sup>1</sup> operating on an LAA Permit to Fly.
