**ACCIDENT**

<b>Aircraft Type and Registration:</b>	Vans RV-6A, G-CCVS	
<b>No &amp; Type of Engines:</b>	1 Superior XP-IO-360-B1A2 piston engine	
<b>Year of Manufacture:</b>	2010 (Serial no: PFA 181A-13413)	
<b>Date &amp; Time (UTC):</b>	15 August 2017 at 1530 hrs	
<b>Location:</b>	Old Sarum Airfield, Wiltshire	
<b>Type of Flight:</b>	Private	
<b>Persons on Board:</b>	Crew - 1	Passengers - None
<b>Injuries:</b>	Crew - 1 (Minor)	Passengers - N/A
<b>Nature of Damage:</b>	Extensive	
<b>Commander's Licence:</b>	Private Pilot's Licence	
<b>Commander's Age:</b>	46 years	
<b>Commander's Flying Experience:</b>	496 hours (of which 65 were on type) Last 90 days - 19 hours Last 28 days - 3 hours	
<b>Information Source:</b>	Aircraft Accident Report Form submitted by the pilot

**Synopsis**

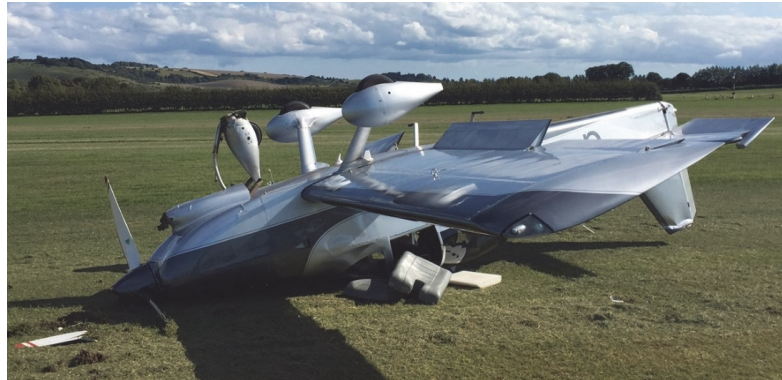
**Figure 1**

The aircraft's nose landing gear struck the ground and was damaged when the pilot initiated a go-around, after experiencing turbulence on final approach. During the subsequent landing the nose landing gear collapsed and the aircraft inverted.

G-CCVS after the accident

The pilot assessed that he should have increased his airspeed on the fourth approach to allow for the gusty crosswind, and that his speed had reduced by the time he crossed the threshold, leaving little energy in reserve to help cope with the unexpected downdraught. Consequently the aircraft struck the ground hard and a subsequent study of an observer's video footage later showed that this deformed the nose landing gear leg. The pilot judged that he should have initiated a go-around earlier in his fourth approach, once he appreciated the intensity of the turbulence.

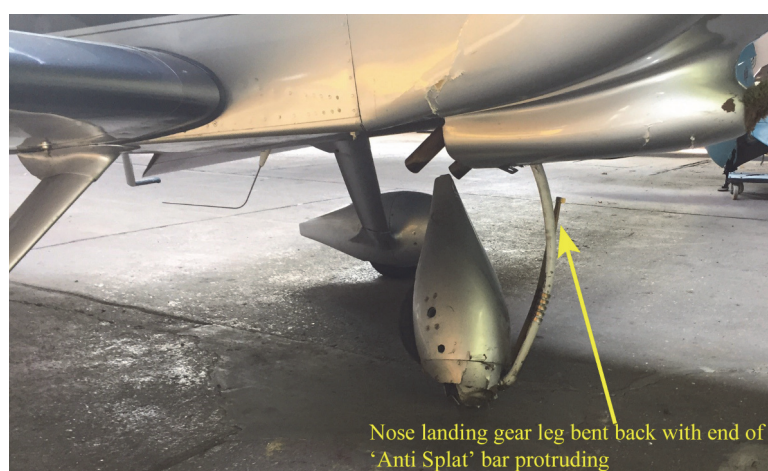
**Figure 2**

The AAIB has reported on several previous accidents in which the nose landing gear leg of a Vans RV series aircraft has bent back or collapsed. AAIB Bulletin 3/2017 contains a report concerning G-RPRV, an RV-9A that flipped upside down, and a list of other recorded instances in the UK during which the nose landing gear leg bent back. The report also mentions an 'Anti Splat' kit (Figure 2) which is intended to restrain the nose landing gear leg from tucking under.

An 'Anti-Splat' kit was fitted to the nose landing gear
