ACCIDENT

Aircraft Type and Registration:	3DR Solo (UAS)	
No & Type of Engines:	4 3DR 22x16 mm 880 kv electric motors	
Year of Manufacture:	2016 (Serial no: VUE003)	
Date & Time (UTC):	13 June 2017 at 0930 hrs	
Location:	Kemsley Mill, Kent	
Type of Flight:	Aerial Work	
Persons on Board:	Crew - None	Passengers - None
Injuries:	Crew - N/A	Passengers - N/A
Nature of Damage:	Propeller and motor damage, fuselage cracked, gimbal snapped off	
Commander's Licence:	BNUC-S	
Commander's Age:	43 years	
Commander's Flying Experience:	112 hours (of which 26 were on UAS types) Last 90 days - 5 hours UAS Last 28 days - 3 hours UAS	
Information Source:	Aircraft Accident Report Form submitted by the pilot

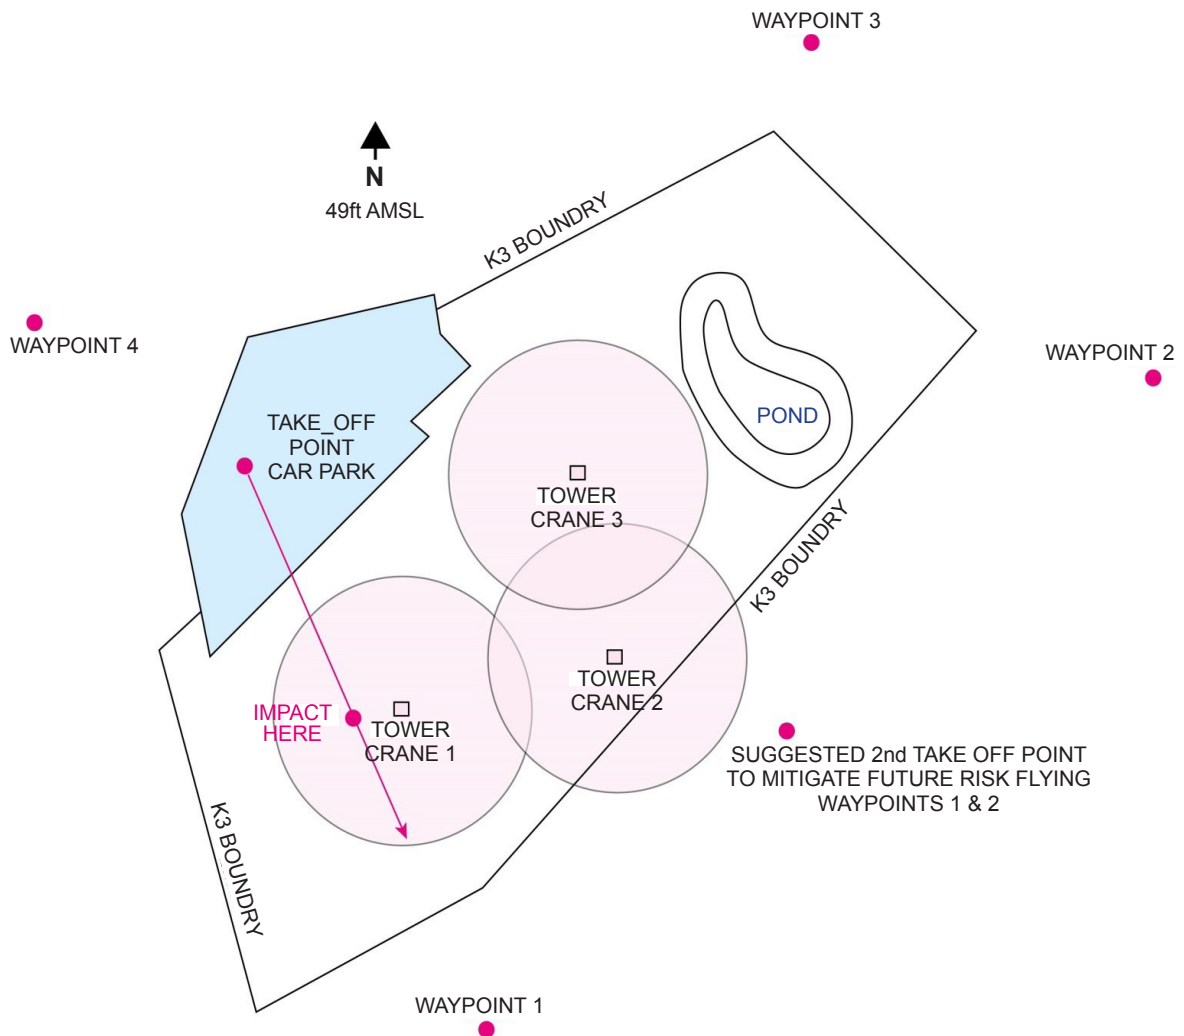
The unmanned aircraft struck a crane during an autonomous flight to survey a construction site. The pilot, who had previously flown the pre-programmed mission at the site, had not taken into account the addition of a new crane.

The pilot had flown the UA previously at the construction site using a pre-programmed mission profile with four waypoints. All waypoints were programmed to be flown at 400 ft agl, which was above the height of the three cranes at the site. The UA took off from a car park on the north side of the site and started climbing to its first waypoint at the south-western tip of the site (Figure 2). Before it reached 400 ft agl it collided with the jib of a crane. The crane had not been at the site during the previous flight, and from where the pilot was situated in the car park it was difficult for him or his observer to tell that it was about to strike the crane because of a lack of perspective. The UA fell to the ground and was damaged but there was no damage to the construction site.

Figure 2
The planned route and location of the collision

The pilot stated that the accident was caused by the incorrect programming of the autonomous waypoint mission which had not taken into account the new crane at the site. He stated that future missions would be planned such that the UA ascended vertically to 400 ft shortly after takeoff, in a safe corridor, before surveying the site and would avoid intersecting the working radius of any of the cranes. He also decided to split the mission in two and to survey the southern boundary by taking off from a new position on the south side. This would avoid flying directly across the site and would afford him a better view of the UA's relative location to the cranes.
