**ACCIDENT**

<b>Aircraft Type and Registration:</b>	Skyranger 912S(1), G-ZADA	
<b>No &amp; Type of Engines:</b>	1 Rotax 912ULS piston engine	
<b>Year of Manufacture:</b>	2006 (Serial no: BMAA/HB/446)	
<b>Date &amp; Time (UTC):</b>	18 June 2017 at 1800 hrs	
<b>Location:</b>	Ince Airfield, Merseyside	
<b>Type of Flight:</b>	Private	
<b>Persons on Board:</b>	Crew - 1	Passengers - 1
<b>Injuries:</b>	Crew - None	Passengers - 1 (Serious)
<b>Nature of Damage:</b>	Extensive damage, beyond economic repair	
<b>Commander's Licence:</b>	National Private Pilot's Licence	
<b>Commander's Age:</b>	68 years	
<b>Commander's Flying Experience:</b>	400 hours (of which 130 were on type) Last 90 days - 6 hours Last 28 days - 6 hours	
<b>Information Source:</b>	Aircraft Accident Report Form submitted by the pilot and further enquiries by the AAIB

**Synopsis**

Following a high and fast approach, the aircraft landed further along the runway than planned and ran off the end of the grass runway into a river.

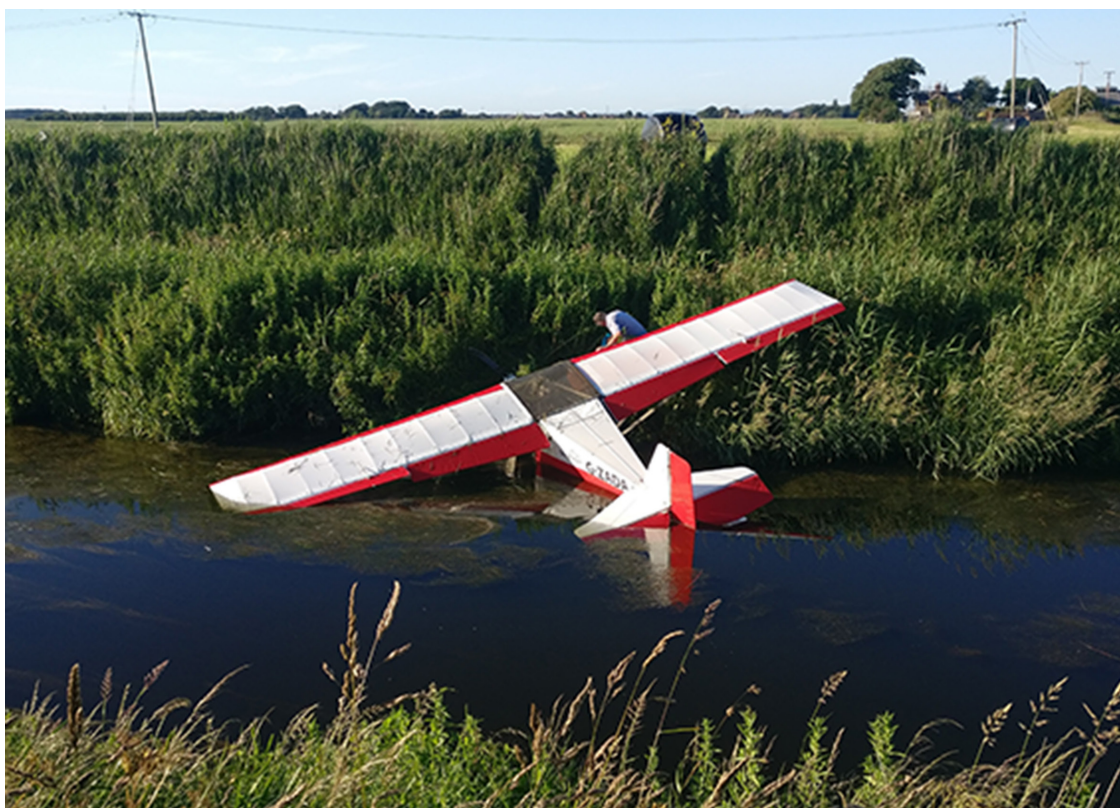
**Figure 1**

Once on the runway the pilot applied maximum braking but was unable to halt the aircraft before the end of the runway, where there is a steep river bank. The aircraft overran the runway and crossed over the shallow river, which was approximately 10 m wide, before hitting the far bank and coming to rest (Figure 1). The occupants had no difficulty escaping from the aircraft but the passenger subsequently experienced chest pains and was later diagnosed to have fractured a rib.

View of the aircraft in its resting place by the north bank of the River Alt.  
Note power lines which cross the extended centreline of Runway 36

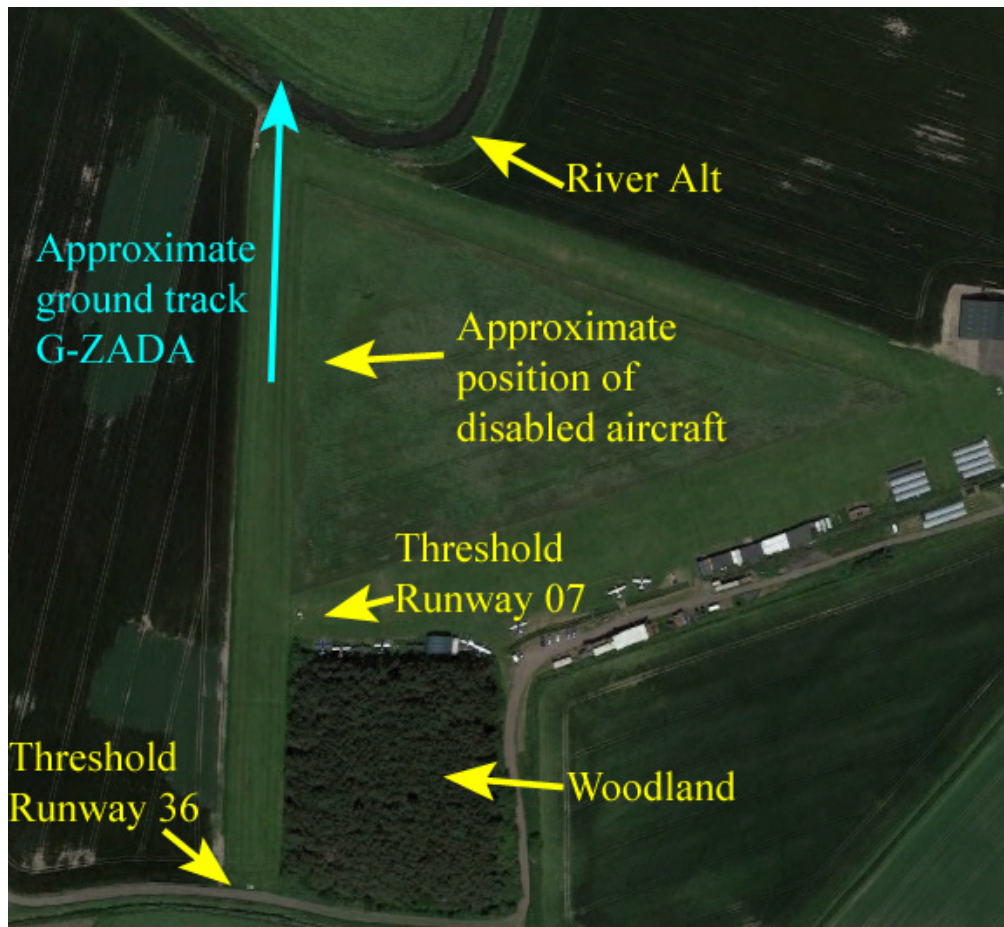
**Figure 2**

The pilot of the lead aircraft provided a GPS-derived plot of his aircraft's flight which indicated that it stopped approximately two-thirds of the way along Runway 36 (Figure 2) and this correlated with his recollection, as well as that of other witnesses. He did not see G-ZADA land but, after helping to push the disabled aircraft clear of the runway, his passenger glanced back and saw G-ZADA touchdown approximately in line with his own position and then lost sight of it.

Ince Airfield; Runway 36 and aircraft's approximate ground track after touchdown  
 ©2017Google, Image © DigitalGlobe

The pilot stated that, while circuiting to Runway 36, he was distracted by trying to avoid noise-sensitive areas and, as a result, he turned onto final approach high and fast. He also thought that woodland on the east side of Runway 36 (Figure 2), may have initially given him the impression that the threshold was north of the woodland, where Runway 36 passes the threshold of Runway 07. When he touched down he was confident there was still sufficient distance available to bring the aircraft to a halt. He did not consider initiating a baulked landing and later noticed power lines which run across the extended centreline, north of the river, and was glad he did not try to take off again from the upwind end of the runway.
