SERIOUS INCIDENT

Aircraft Type and Registration:	Boeing 767-36N, G-POWD	
No & Type of Engines:	2 General Electric Co CF6-80C2B7F turbofan engines	
Year of Manufacture:	2003 (Serial no: 30847)	
Date & Time (UTC):	19 March 2017 at 0900 hrs	
Location:	En route from London Stansted Airport to Rzeszow-Jasionka Airport, Poland	
Type of Flight:	Commercial Air Transport (Passenger)	
Persons on Board:	Crew - 9	Passengers - 262
Injuries:	Crew - None	Passengers - None
Nature of Damage:	None	
Commander's Licence:	Airline Transport Pilot's Licence	
Commander's Age:	52	
Commander's Flying Experience:	8,965 hours (of which 2,635 were on type) Last 90 days - 24 hours Last 28 days - 24 hours	
Information Source:	AAIB Field Investigation

Synopsis

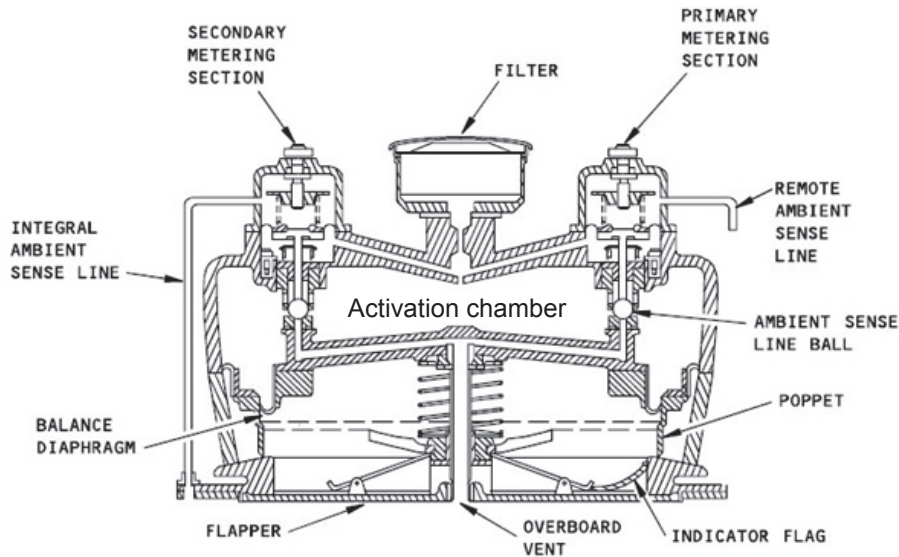
Figure 2

The PRPV uses two control metering sections, the primary and the secondary, which open at differential pressures of 8.95 and 9.42 psi, respectively. They are identical in construction, but the secondary unit is adjusted to the higher pressure so that it operates as a back-up in the event of a failure in the primary. One side of each metering section is supplied with an ambient pressure source: a remote line for the primary and an integral sense line for the secondary. Cabin pressure is applied to the opposite sides of the metering section and, at excess cabin pressures the ball valve attached to the metering section will lift, allowing air to pass into the activation chamber. This allows cabin pressure to open the poppet valve, which vents cabin air overboard. Associated movement of the flapper doors causes the spring-loaded indicator flags to pop out.
