**ACCIDENT**

<b>Aircraft Type and Registration:</b>	Schleicher ASW 24, G-CFNG	
<b>No &amp; Type of Engines:</b>	None	
<b>Year of Manufacture:</b>	1988 (Serial no: 24015)	
<b>Date &amp; Time (UTC):</b>	4 December 2016 at 1235 hrs	
<b>Location:</b>	Brentor Airfield, Devon	
<b>Type of Flight:</b>	Private	
<b>Persons on Board:</b>	Crew - 1	Passengers - None
<b>Injuries:</b>	Crew - 1 (Fatal)	Passengers - N/A
<b>Nature of Damage:</b>	Destroyed	
<b>Commander's Licence:</b>	Sailplane Pilot's Licence (SPL) and Airline Transport Pilot's Licence	
<b>Commander's Age:</b>	47 years	
<b>Commander's Gliding Experience:</b>	1,500 glider hours 130 hours in the last 12 months (Approximate figures as it was not possible to access pilot's electronic logs)	
<b>Information Source:</b>	AAIB Field Investigation

**Synopsis**

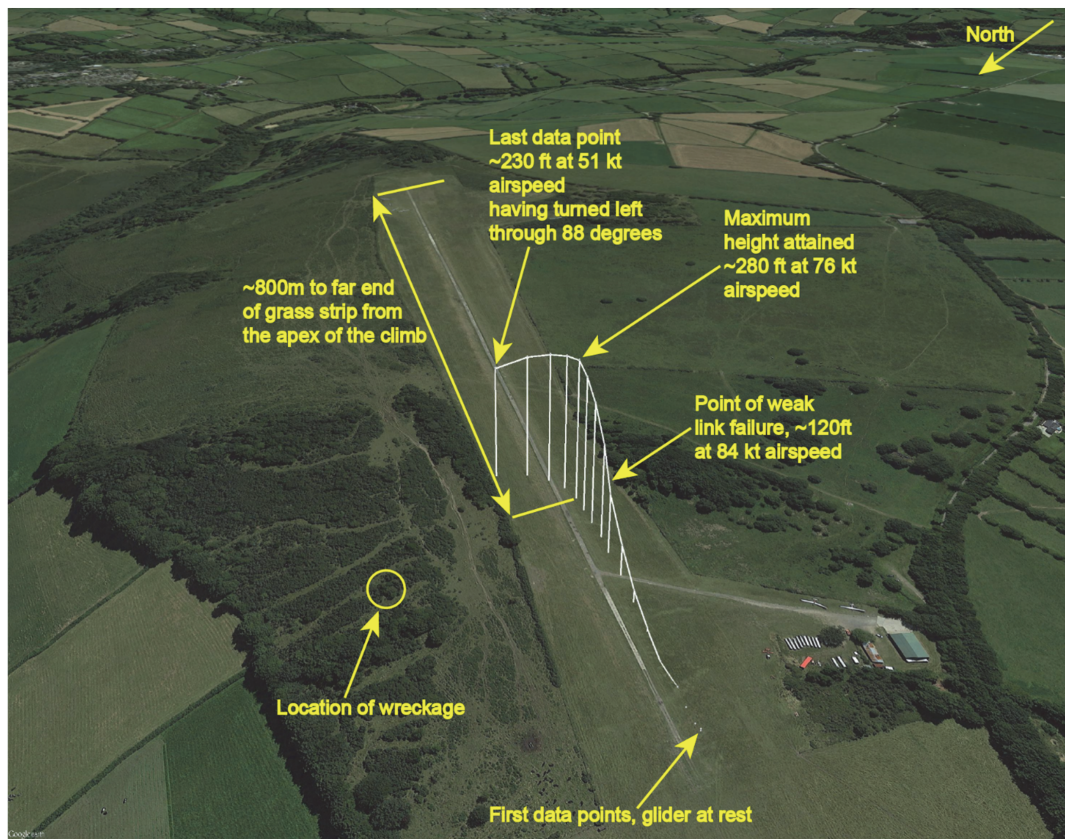
**Figure 1**

On the day of the accident the winch was located at the eastern end of the site. The ground beyond the winch point drops off steeply, making an overrun an unattractive proposition. However, to the south of the site there is a series of fields offering a reasonable prospect of an off-airfield landing. The surface immediately to the north of airfield is soft moorland and high gorse (Figure 1).

The aircraft wreckage was located 86 m north of the runway edge in an area of gorse-covered moorland (Figure 1). The impact marks and wreckage distribution were consistent with the aircraft having struck the ground in a 90° left bank with the nose down. The left wing had separated at the root and the cockpit area was destroyed.

Vertical profile (ft aal<sup>7</sup>), ground track and true airspeed data for the accident flight

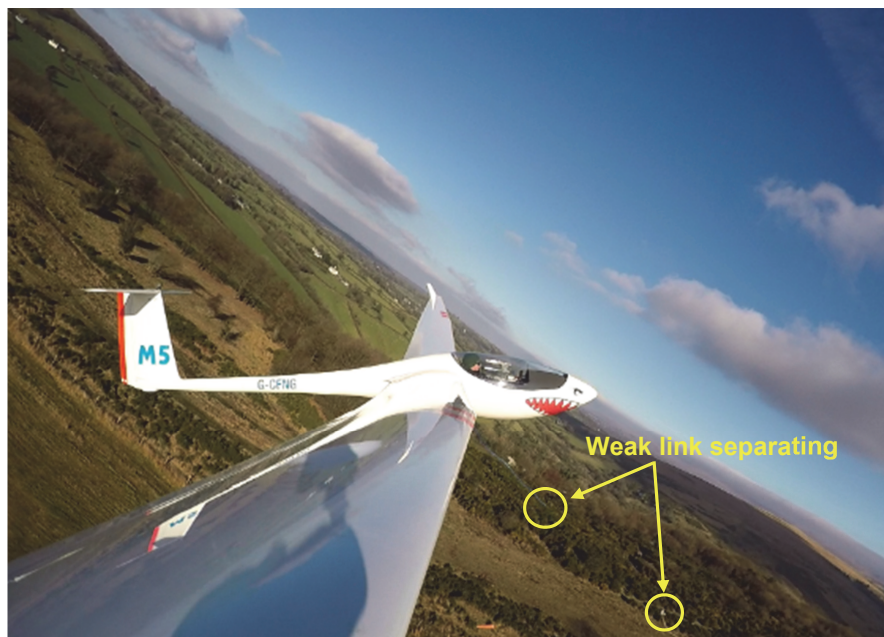
**Figure 2**

The initial launch appeared normal with the glider becoming airborne at about 53 KIAS, five seconds after the launch started. Three seconds after the glider became airborne it was at 78 KIAS, and about 100 ft aal, when the weak link parted (Figure 2). The pilot immediately looked left and looked left repeatedly from this point on. At no time did the pilot look to the right.

Glider at the moment of launch failure

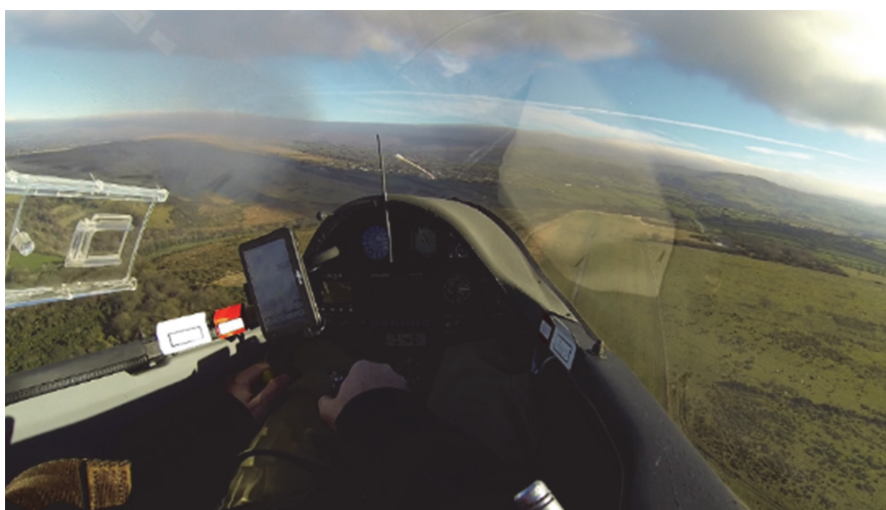
**Figure 3**

Over the next four seconds the glider pitched gently nose down, gaining height while slowing to 60 KIAS<sup>8</sup>. This pitch-down manoeuvre brought the nose of the glider to approximately level with the horizon. The pilot then made an approximately half-to-two-thirds left roll input on the control stick, while sustaining a neutral to slightly forward pitch input. The glider rolled left, the nose dropped below the horizon and began to turn to the north during which the speed reduced to 51 KIAS (Figure 3).

Cockpit view as left roll input is being made

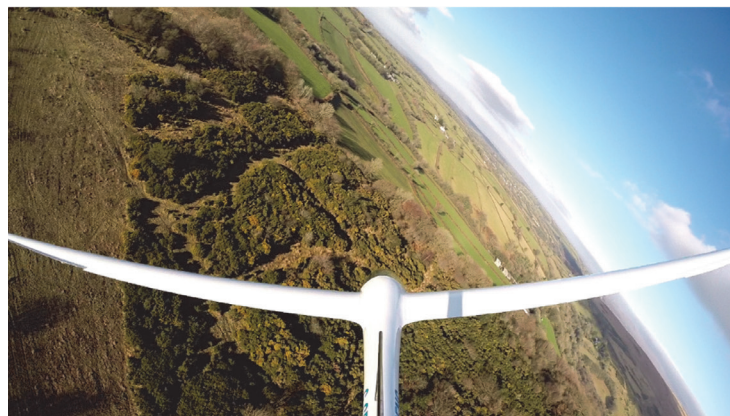
**Figure 4**

Eleven seconds after the launch failure, the glider was in a sustained 60° left turn at 51 KIAS (Figure 4) and had turned through approximately 90° from the launch heading. The nose of the glider then dropped well below the horizon and the airspeed and the descent rate increased, with the glider rolling rapidly left through 80°, with the airspeed reaching 70 KIAS before it hit the ground 14 seconds after the launch failure.

11 seconds after launch failure, with significant left aileron input

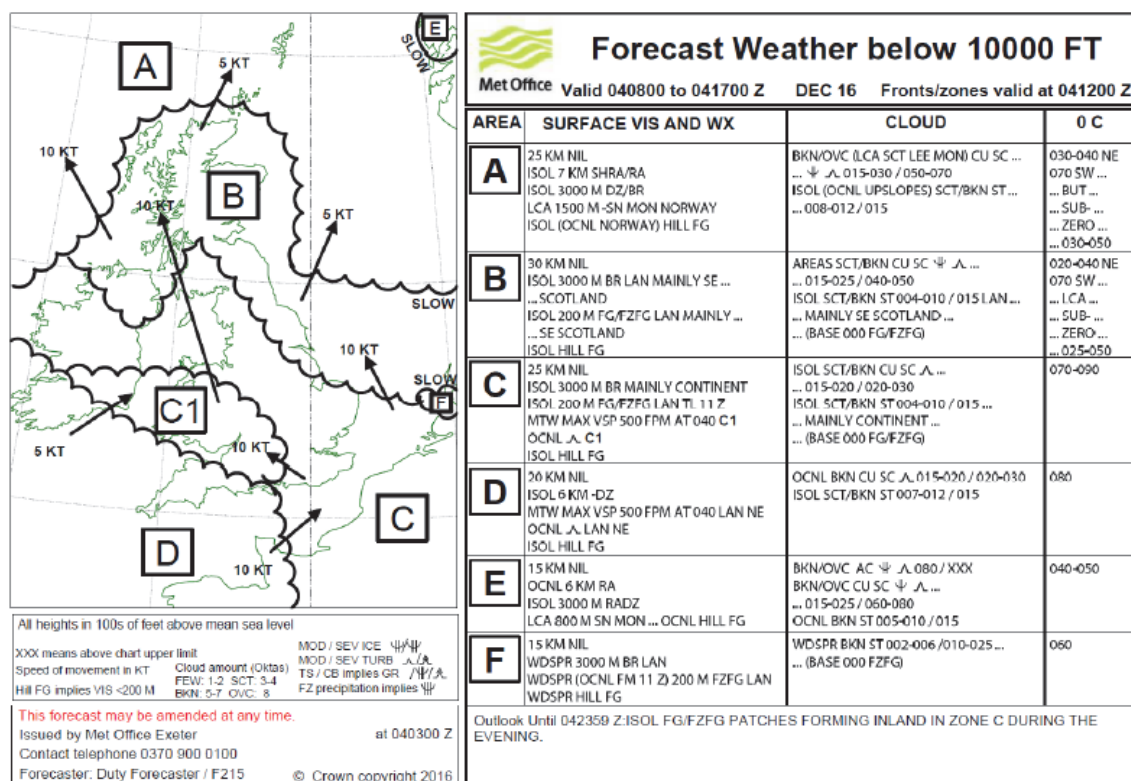
**Figure 5**

The forecast Metform 215 for the time of the accident (Figure 5) highlights at Area D the risk of mountain waves (MTW) and occasional moderate low-level turbulence near the accident site. In particular, it noted that mountain waves of 500 feet per minute were expected at around 4,000 ft.

Forecast low-level weather, 4 December 2016

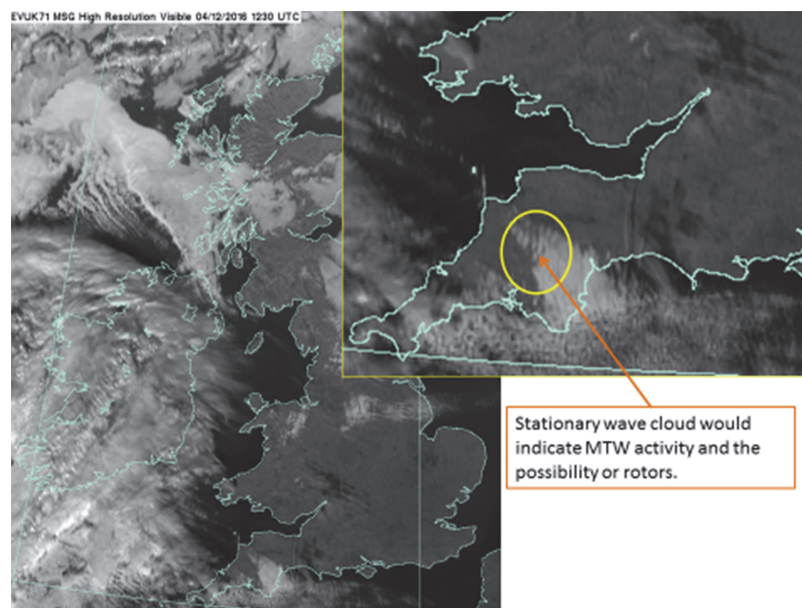
**Figure 6**  
Satellite image

Satellite imagery of the area at the time of the incident confirms the presence of mountain wave activity in the Dartmoor area and therefore a high probability of significant turbulence at low levels (Figure 6).

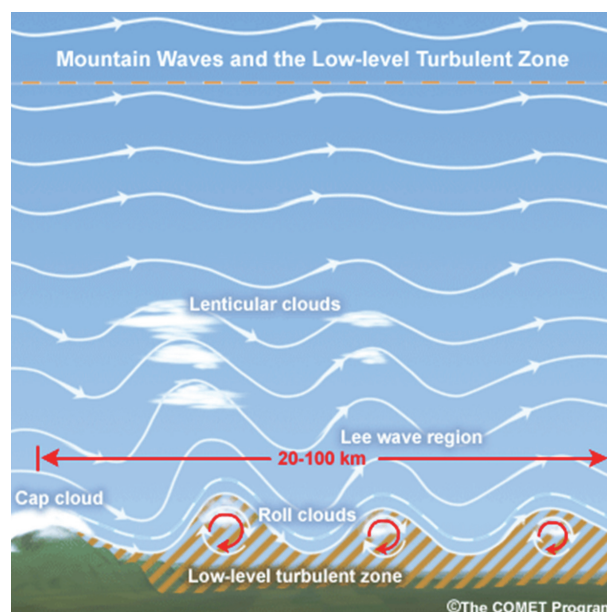
**Figure 7**  
'Mountain Wave' diagram

In areas of mountain wave activity a low-level turbulent zone can extend many kilometres downwind from the high ground inducing the phenomena. Brentor Airfield would have been within this zone on the day of the accident (Figure 7).
