ACCIDENT

Aircraft Type and Registration:	Cessna F150L, G-BABC
No & Type of Engines:	1 Continental Motors Corp O-200-A piston engine
Year of Manufacture:	1972 (Serial no: 831)
Date & Time (UTC):	14 November 2017 at 1330 hrs
Location:	RAF Henlow, Bedfordshire
Type of Flight:	Training
Persons on Board:	Crew - 2 Passengers - None
Injuries:	Crew - None Passengers - N/A
Nature of Damage:	Nose leg detached and propeller, engine, forward lower fuselage and right wing damaged
Commander's Licence:	Airline Transport Pilot's Licence
Commander's Age:	71 years
Commander's Flying Experience:	16,288 hours (of which 1,125 were on type) Last 90 days - 23 hours Last 28 days - 12 hours
Information Source:	Aircraft Accident Report Form submitted by the pilot

Synopsis

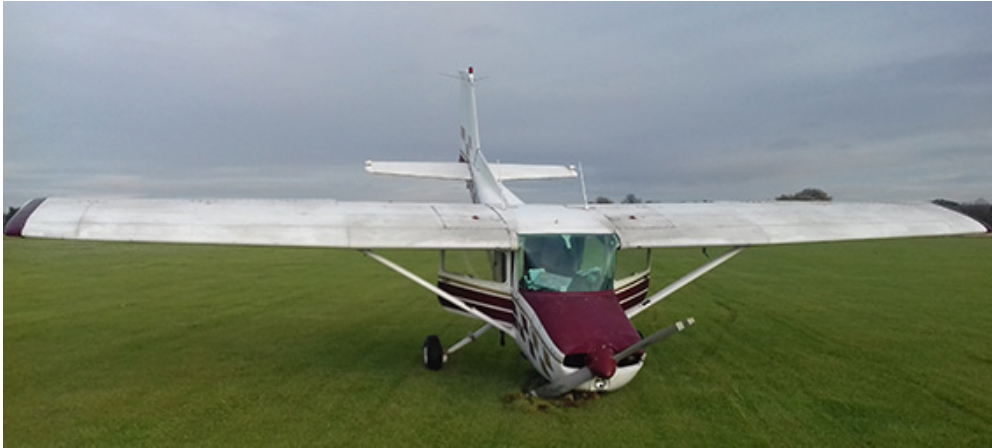
Figure 1

A high rate of descent developed when landing with flaps set to 30° and, despite intervention from the instructor, the aircraft struck the ground in a nose-down attitude. The nose leg detached and the propeller sustained damaged, but the aircraft bounced and landed heavily on its mainwheels before coming to rest in a nose-down attitude.

was not available. The instructor was therefore unable to prevent the aircraft descending but he held the control column fully back, to prevent the aircraft diving towards the ground and to try to cushion the subsequent touchdown. It landed heavily on both mainwheels but the nose leg had already detached and it pitched forward and both the nose and the right wing tip contacted the ground. The tail rose until the fuselage was inclined almost vertically, for a few seconds, before the aircraft toppled back onto its mainwheels (Figure 1). The occupants then switched off the fuel and electrics before opening their doors and vacating without difficulty.

G-BABC resting on its lower engine cowling

In previous training the student had only landed with the flaps set to 20° and had not appreciated the effects of selecting idle power with the flaps set to 30°. The instructor resolved to give future students more landing practice with the flaps set to 30° before trying to teach them short field techniques.
