ACCIDENT

Aircraft Type and Registration:	Jodel DR1050-M Excellence, G-JODL	
No & Type of Engines:	1 Continental Motors Corp O-200-A piston engine	
Year of Manufacture:	1960 (Serial no: 99)	
Date & Time (UTC):	24 September 2017 at 1730 hrs	
Location:	Lashenden (Headcorn) Airfield, Kent	
Type of Flight:	Private	
Persons on Board:	Crew - 1	Passengers - None
Injuries:	Crew - None	Passengers - N/A
Nature of Damage:	Wing, stabilator, main and tail landing gear and propeller damaged. Probable shock-loading of engine	
Commander's Licence:	Private Pilot's Licence	
Commander's Age:	48 years	
Commander's Flying Experience:	144 hours (of which 19 were on type) Last 90 days - 25 hours Last 28 days - 5 hours	
Information Source:	Aircraft Accident Report Form submitted by the pilot and enquiries made by the AAIB

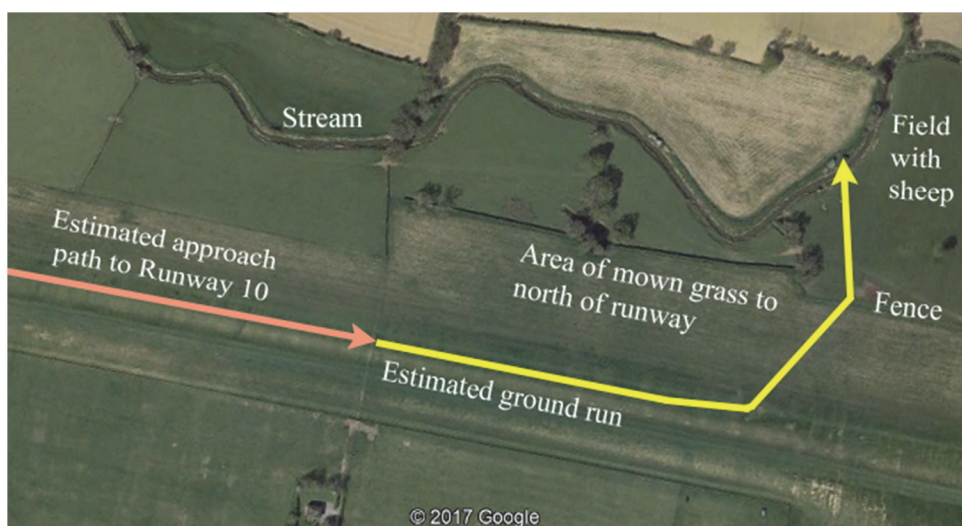
Figure 1

Aerial view of the eastern portion of Lashenden airfield with G-JODL's estimated track
©2017Google, Image © DigitalGlobe
