ACCIDENT

Aircraft Type and Registration:	Titan T-51B Mustang, G-CIXK	
No & Type of Engines:	1 Suzuki V6 Mini Merlin piston engine	
Year of Manufacture:	2016 (Serial no: LAA 355-15207)	
Date & Time (UTC):	24 November 2017 at 1240 hrs	
Location:	Shacklewell Airfield, Lincolnshire	
Type of Flight:	Private	
Persons on Board:	Crew - 1	Passengers - None
Injuries:	Crew - None	Passengers - N/A
Nature of Damage:	Damaged beyond economic repair	
Commander's Licence:	Light Aircraft Pilot's Licence	
Commander's Age:	53 years	
Commander's Flying Experience:	646 hours (of which 26 were on type) Last 90 days - 12 hours Last 28 days - 4 hours	
Information Source:	Aircraft Accident Report Form submitted by the pilot

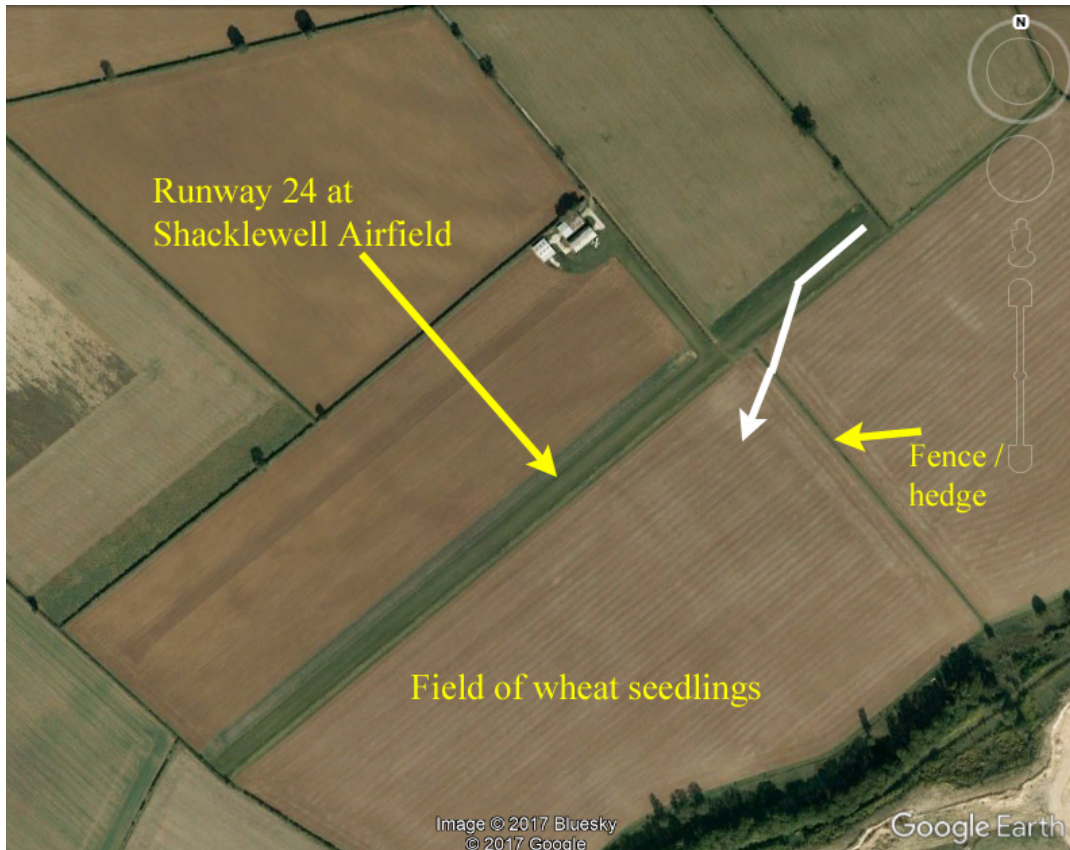
Figure 1

During the takeoff roll, and after the tailwheel had lifted, the aircraft swung left and headed towards a fence/hedge in an adjacent field. The pilot was unable to correct the swing using right rudder pedal and there was insufficient space to abandon the takeoff, so he attempted to lift the aircraft off the ground and clear the fence/hedge. However, the main landing gear struck the fence/hedge, and the aircraft fell into the next field (Figure 1) where it came to rest with its nose and left wing resting on the ground.

White line indicates aircraft's approximate path
