# Rail Accident Report

**Child nearly falling through a missing toilet floor, South Devon Railway  
22 June 2017**

Report 02/2018  
January 2018

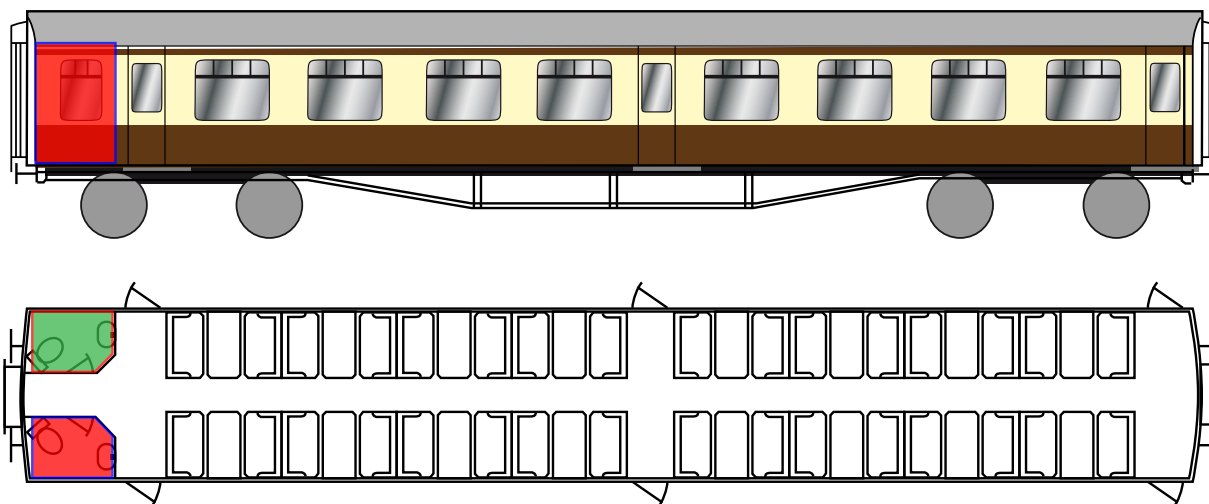
- 9 The train was formed of former Great Western Railway steam locomotive 5526 and a combination of ex-British Railways (BR) Mark One Second Open (SO) carriages (figure 3) and ex-Great Western Railway coaches. Carriage 4805 was the fourth of the five coaches. On the day of the accident, only three of the six toilets on the five carriages of the train were operational.

Figure 3: Side elevation and plan of the carriage showing the location of the toilet cubicle with the floor missing (green box). The toilet opposite (red box) was also out of use.

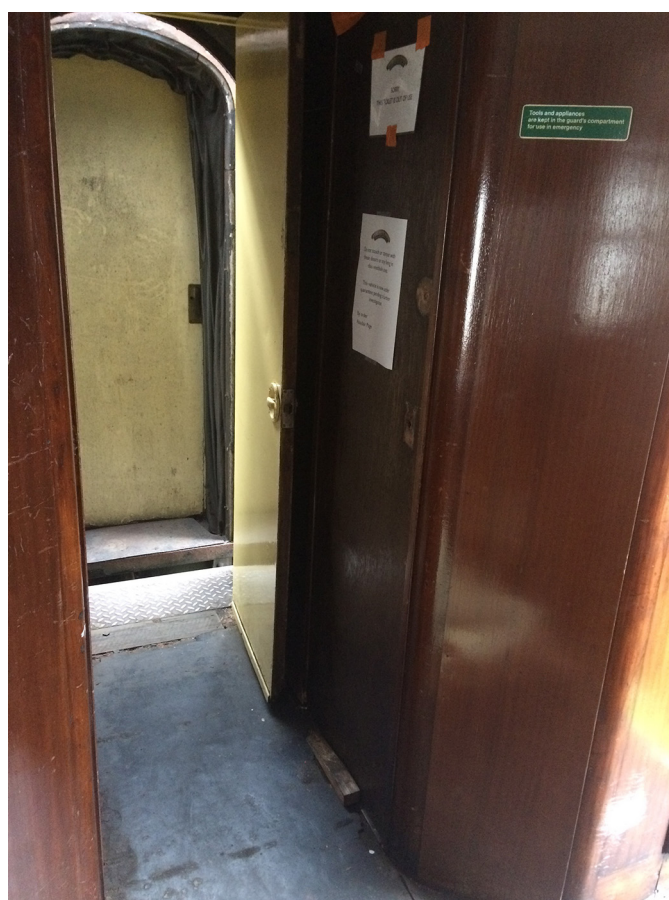
- 15 The mother and child boarded the train at Buckfastleigh station (for the 12:17 hrs departure) and travelled to Totnes. Soon after arriving at Totnes, they decided to return on the same train, which departed from Totnes at 13:00 hrs, and from Staverton at 13:15 hrs.
- 16 A few minutes after leaving Staverton station, the child, who had travelled on the train before and was aware that the toilets were located at the end of each carriage, decided to go to look at a toilet. The mother, who was aware that some of the toilets were out of use ('out of use' signs were on several toilet cubicle doors) followed a short distance behind the child (figure 4).

*Figure 4: The outside of the toilet cubicle involved in the accident*

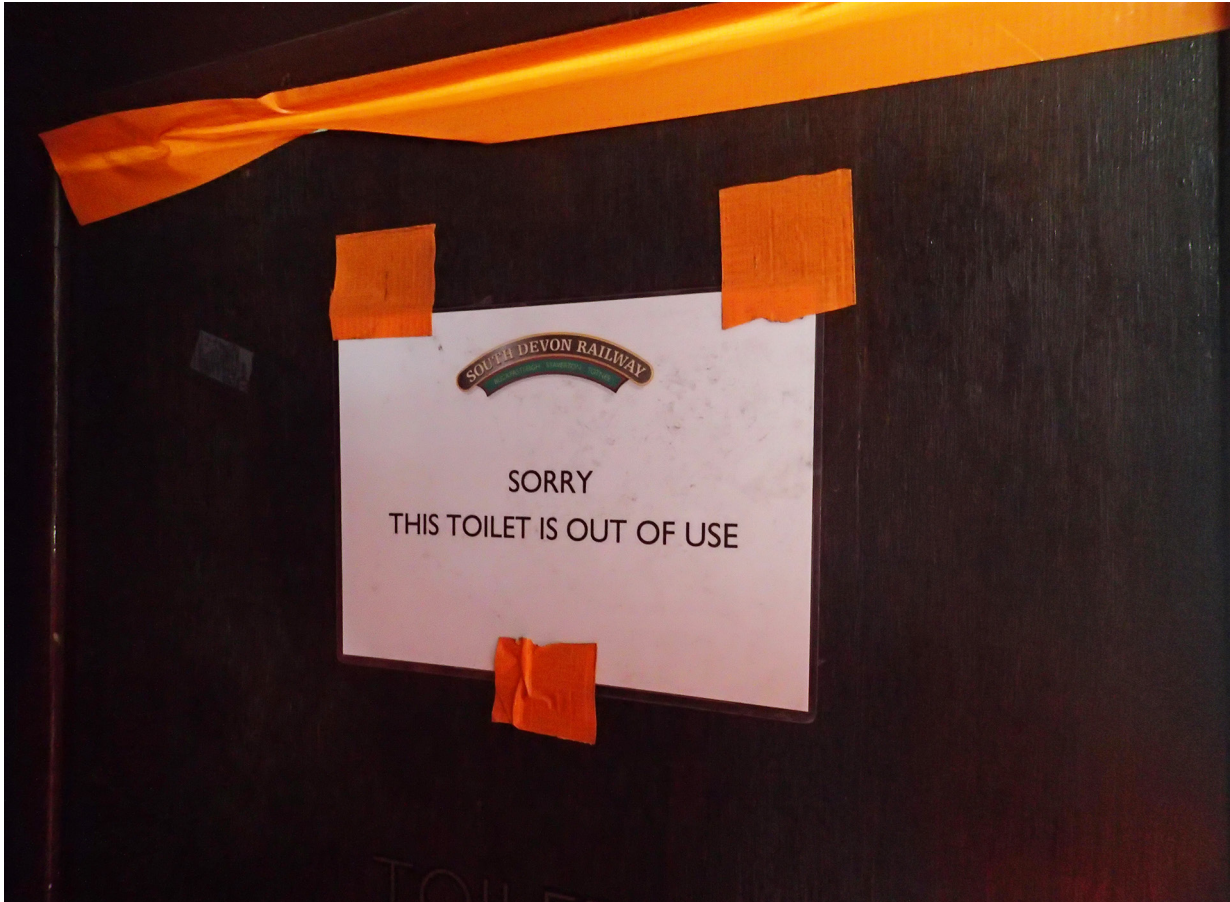
Figure 5: The 'out of use' sign and orange tape placed on the toilet cubicle door

- 21 One of the fitters stated that when he arrived at the carriage to carry out repairs, he found the toilet door was open, part of the wooden door frame had broken off and the screws that were supposed to be holding the door closed were missing. The screws holding the vacant / engaged sign to the door frame and door were also loose (figures 6 and 7). The 'out of use' sign on the door was still present, but the orange tape which was said to have been stuck all round the door frame was only present on the top part of the frame above the door (figure 5).

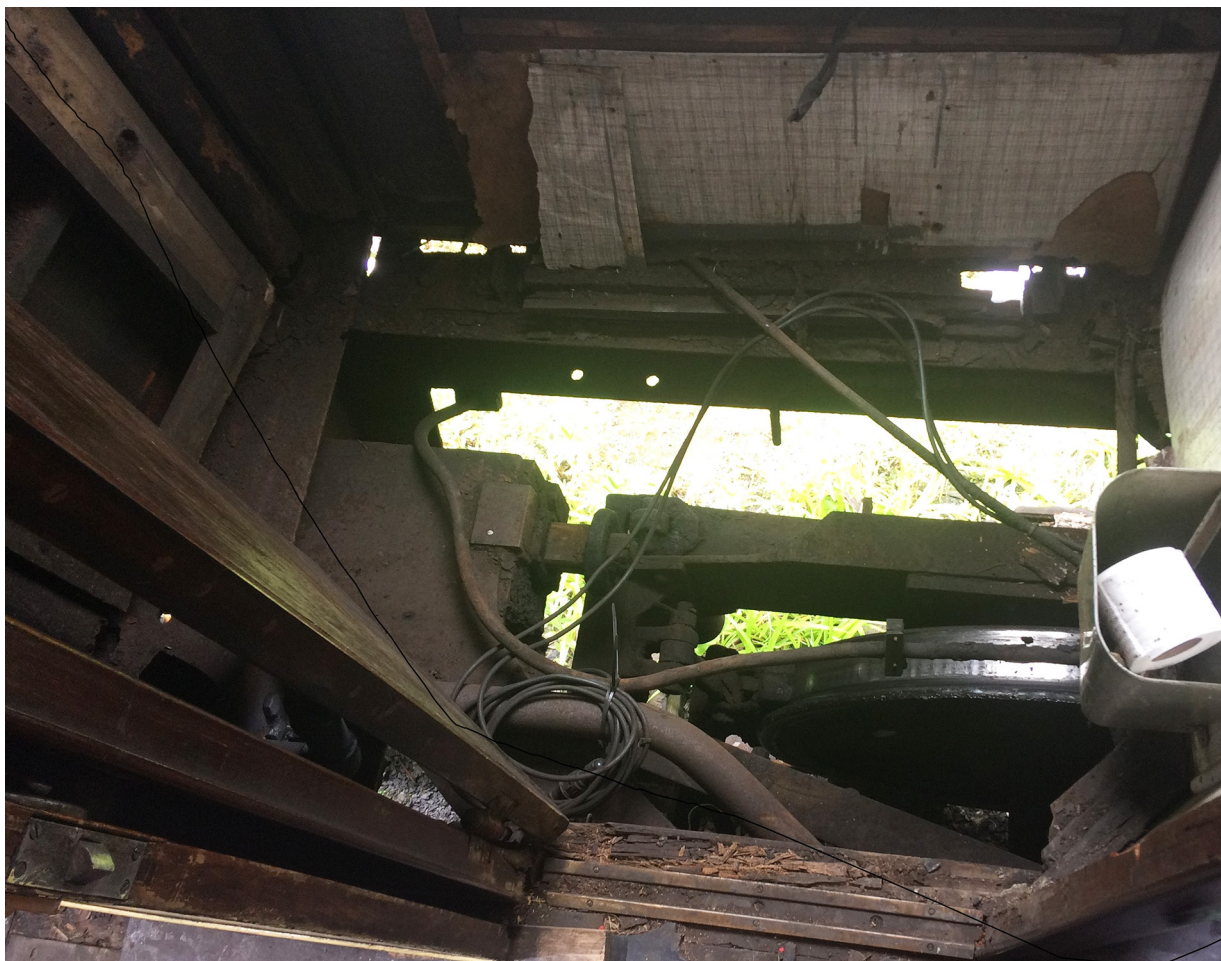
- 18 Although the toilet cubicle door was supposed to have been secured closed (see paragraphs 30 to 37), the child was able to enter the cubicle (it is not known whether he used the door knob or simply pushed the door). The door of the toilet cubicle opened inwards. The mother stated that the child fell forward towards the track, breaking his fall on the brake pipe. The mother reacted quickly and grabbed the child's arm, preventing him from falling onto the track (figure 8).

Figure 8: The interior of the toilet cubicle on carriage 4805

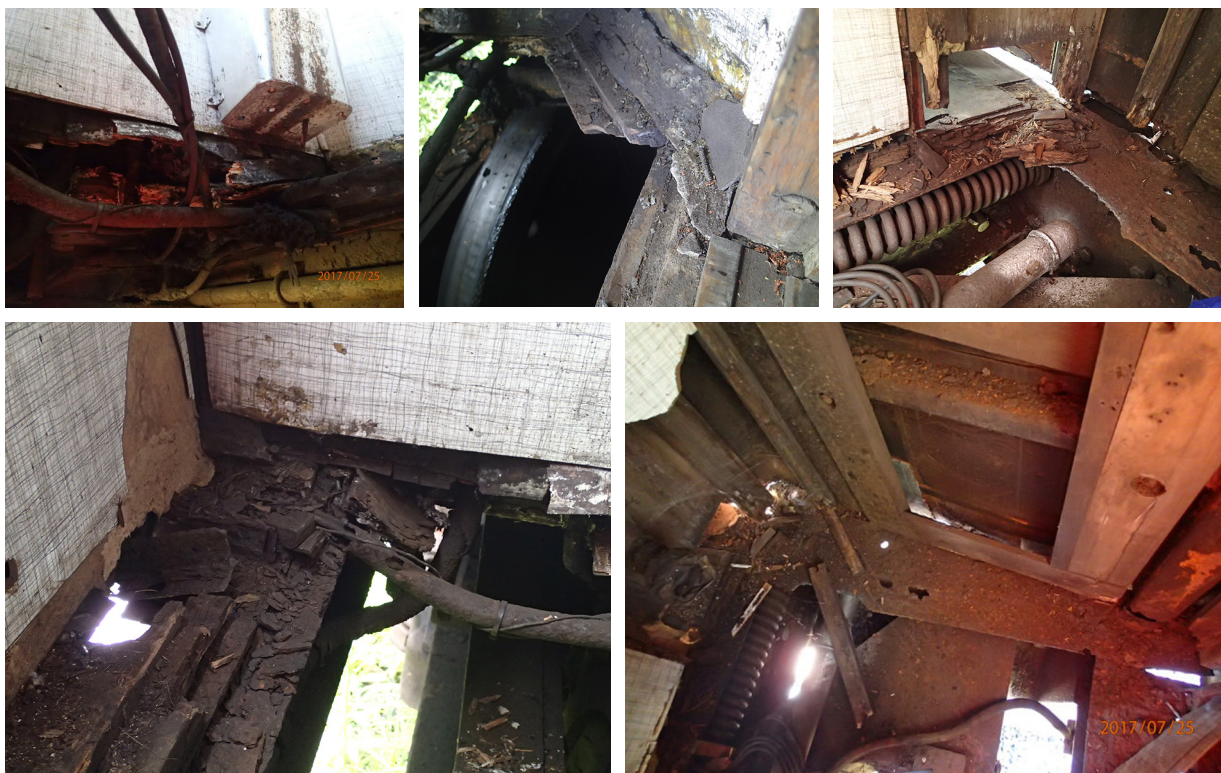
Figures 9 to 13: Details of the condition of the toilet cubicle on carriage 4805

- 32 The position of the fault in the brake pipe (between the toilet floor and structural member) meant the maintenance staff could not see the fault nor could they gain access to repair it. As, at the time, the SDR had no resources available to lift the carriage, the engineering manager and carriage and wagon superintendent decided the most effective method of gaining access to undertake the repair, was to remove the toilet cubicle floor. This was done on 2 April. Removal of the floor revealed a previously unsuspected level of corrosion of the underframe and wood rot in the toilet floor and partition walls (figures 9 to 13).

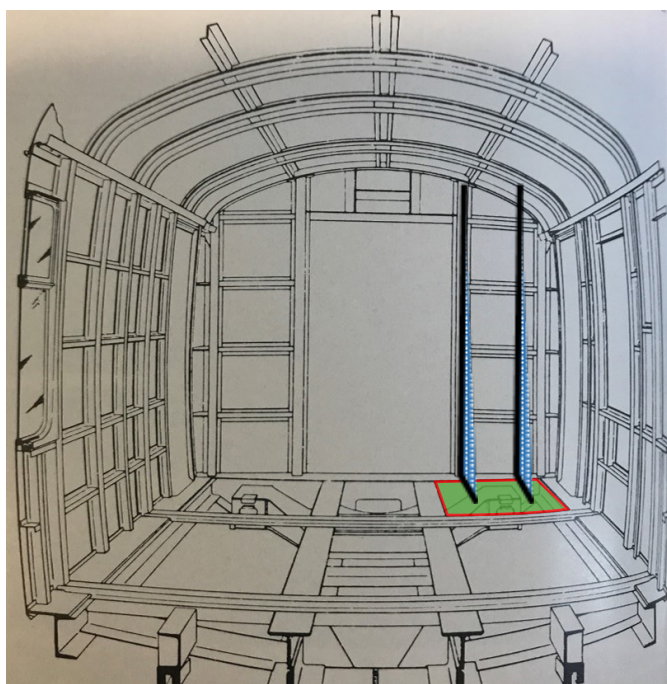
- 27 The area of the vehicle around the ends and the toilet compartments is prone to damage and deterioration caused by ingress of water through joints in the roof, via door and window openings, and spillage from the lavatory equipment, and from substances used to clean the toilet areas. These penetrate the floor and, if not dealt with effectively, may result in wet rot affecting the toilet floor and the partition wall bases, and corrosion of the underframe cross-members and bracing (figure 14).

Figure 14: Diagram showing the structure of the Mark 1 carriage. Probable areas where water may enter the carriage panelling are shown in blue. The green shaded area shows the location of the toilet floor (see figure 7). (Image courtesy of the Institute of Locomotive Engineers).

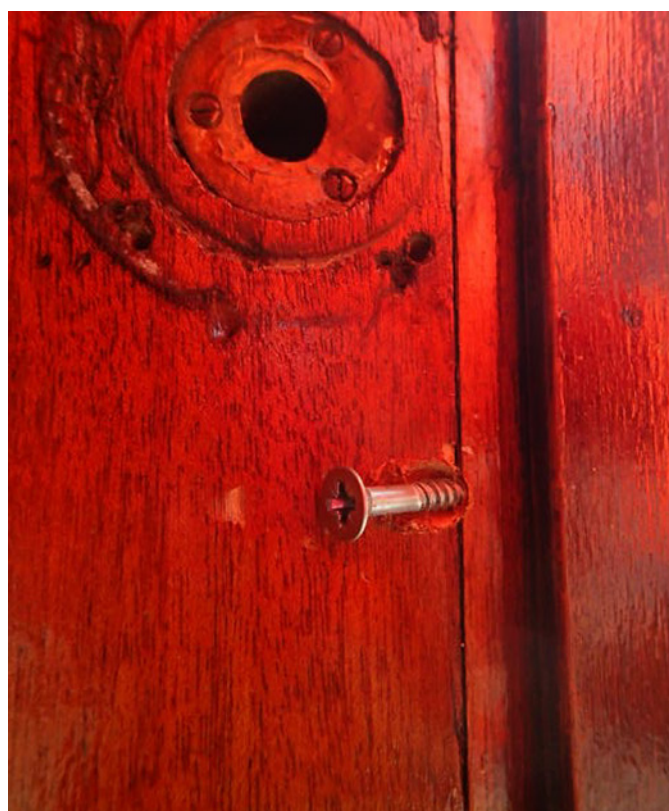
36 The method of securing the toilet door, with screws through the door into the frame (figure 15), had been previously used on another vehicle without incident in 2016. As a result, the engineering manager and carriage and wagon superintendent believed that this method was adequate as a temporary measure. An 'out of use' sign was placed on the door and orange tape was attached to the door frame surround. The toilet cubicle door was inspected by the carriage and wagon superintendent and the engineering manager, and the railway manager was advised that the carriage could be put back into service.

*Figure 15: The method of securing a toilet cubicle door using screws through the door and frame*

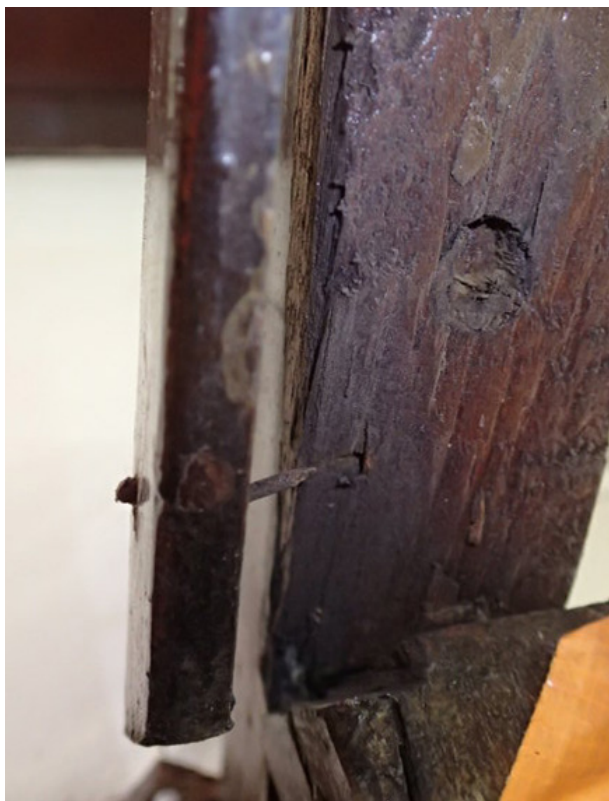
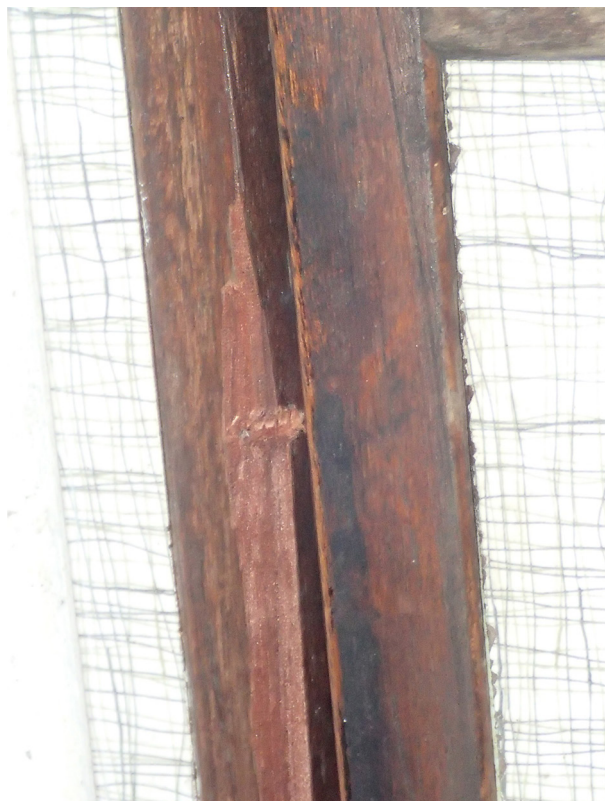
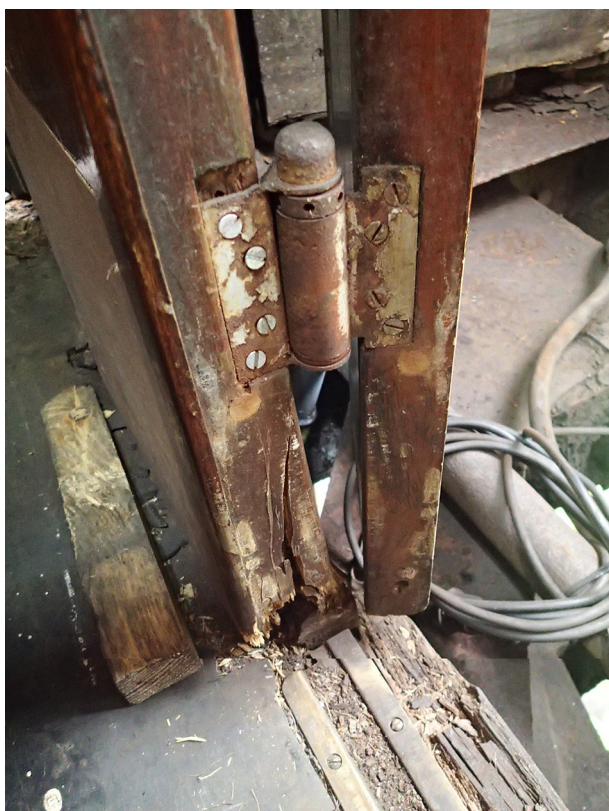
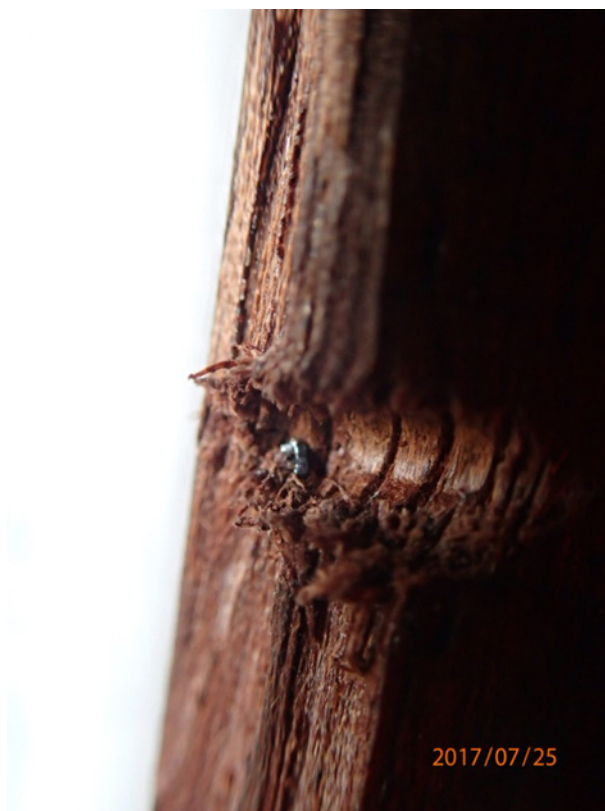
- 37 The RAIB's examination of the toilet cubicle and the damage to the door and the frame, after the accident and the subsequent repairs, found that the screws were inserted through the door frame and door at an angle (figures 16 to 19). Although the physical evidence is not conclusive, the RAIB considers that the screws could have become ineffective as a result of one or a combination of the following factors:

- a. The door was accidentally or intentionally forced open, resulting in damage to the door frame, allowing the screws to become loose or fall out.
  - b. The removal of the toilet floor and the decay at the base of the partitions resulted in a loss of integrity of the structure of the toilet cubicle, because the floor was no longer tying the partition walls together. This meant the structure was no longer rigid, and the movement of the train may have resulted in the door frame and the door moving relative to each other. This movement caused the screws securing the door to become loose, fracture or fall out.

Figures 16 to 19: The damage to the toilet cubicle frame and door of carriage 4805
