## CONTENTS

### COMMERCIAL AIR TRANSPORT

**(ALL TIMES IN THIS BULLETIN ARE UTC)**

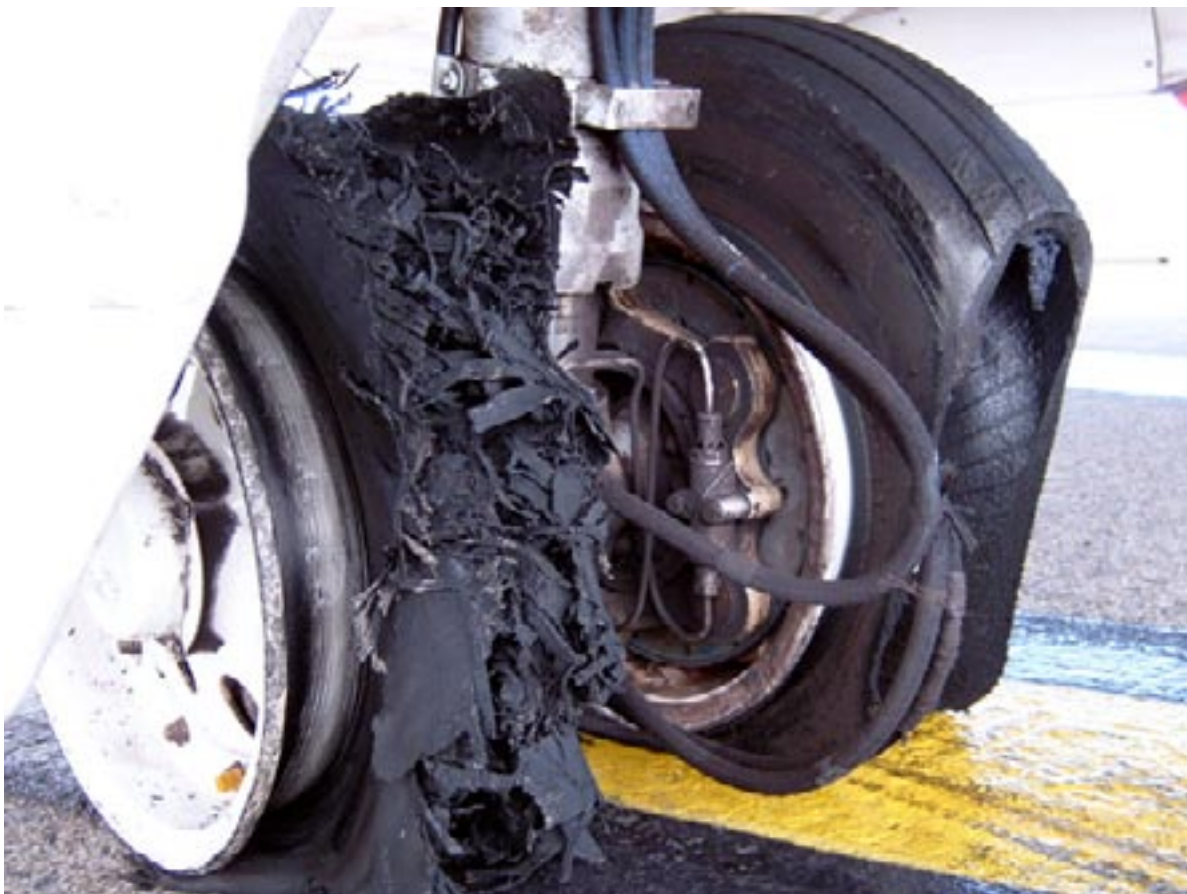
**Figure 1**

pattern of damage to the wheel rim showed that, following the tyre burst, this wheel had been rotating for at least part of the time that the aircraft rolled along and clear of the runway and this damage was not inconsistent with a tyre burst at, or very shortly after, touch-down. By contrast, there was no visible damage to wheel No 2 and its tyre was intact over some 180° of its circumference. The remaining circumference of the tyre showed two very large and distinct areas of 'chamfer' and local heating, where the tyre had slid along the runway surface without rotation. (See Figure 1.)

The only other damage to the aircraft was secondary, the failure of the linkage retaining the landing gear door. This appeared to have occurred because the No 1 tyre burst.

View looking aft and inboard on the Nos 1 & 2 tyres after landing

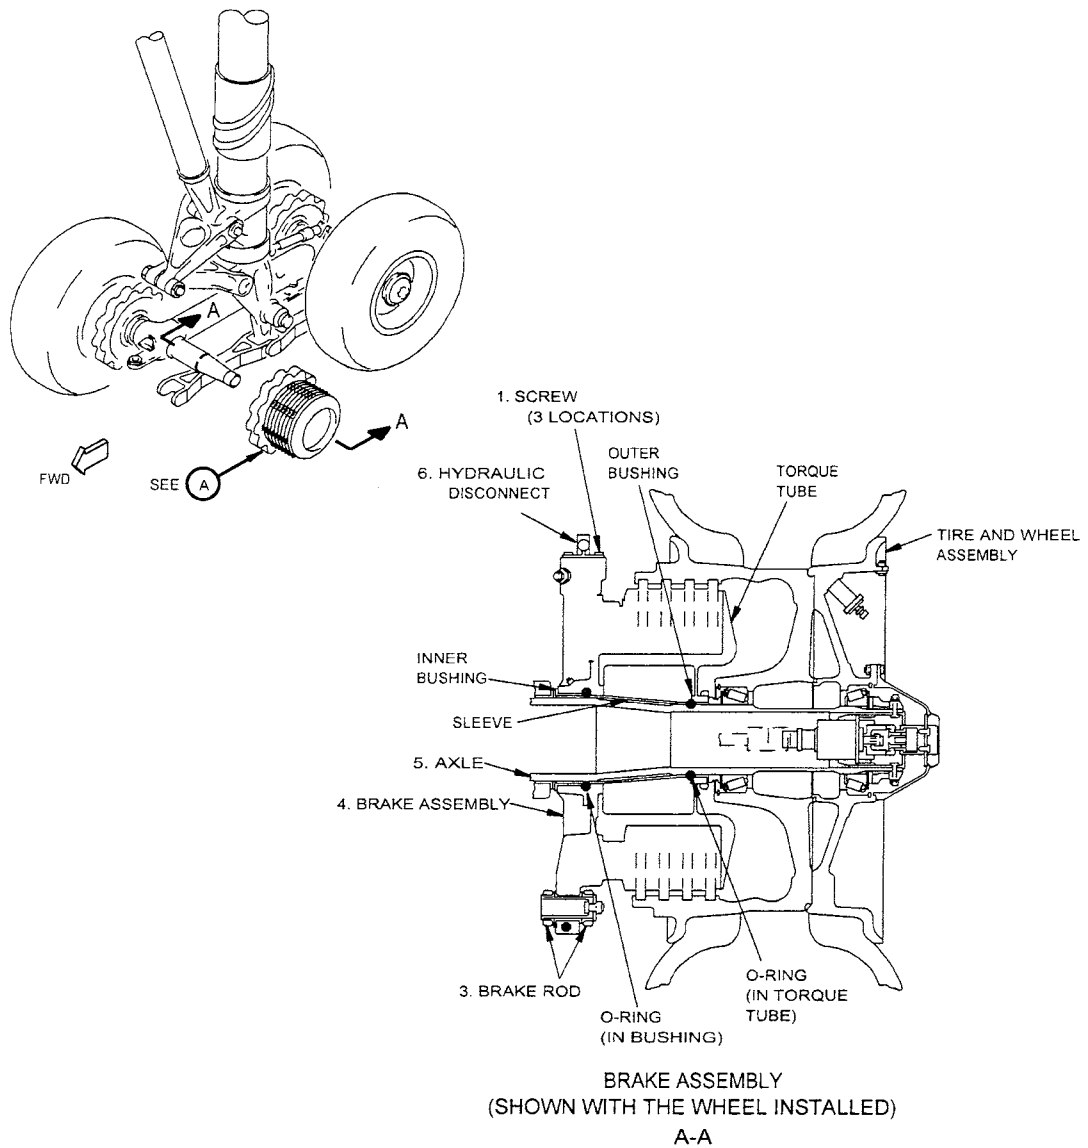
Main Gear Wheel Brake Installation  
Figure 401 (Sheet 1)

It was established that the brake rod pin end cap had not been fitted, which resulted in a situation in which the pin worked its way free from the brake assembly. This allowed the brake rod to hang vertically downwards and impact the ground during a landing, and the brake assembly to rotate and sever hydraulic and electrical lines. This sequence of events is corroborated by the operator's report in which it was stated that:

- 1 TIGHTEN TO 100-200 POUND-INCHES
- 2 INSTALL THE PIN WITH THE HEAD ON THE TRUCK SIDE AS SHOWN (PREFERRED)  
INSTALL THE PIN WITH THE HEAD ON THE BRAKE SIDE (OPTIONAL, NOT SHOWN)

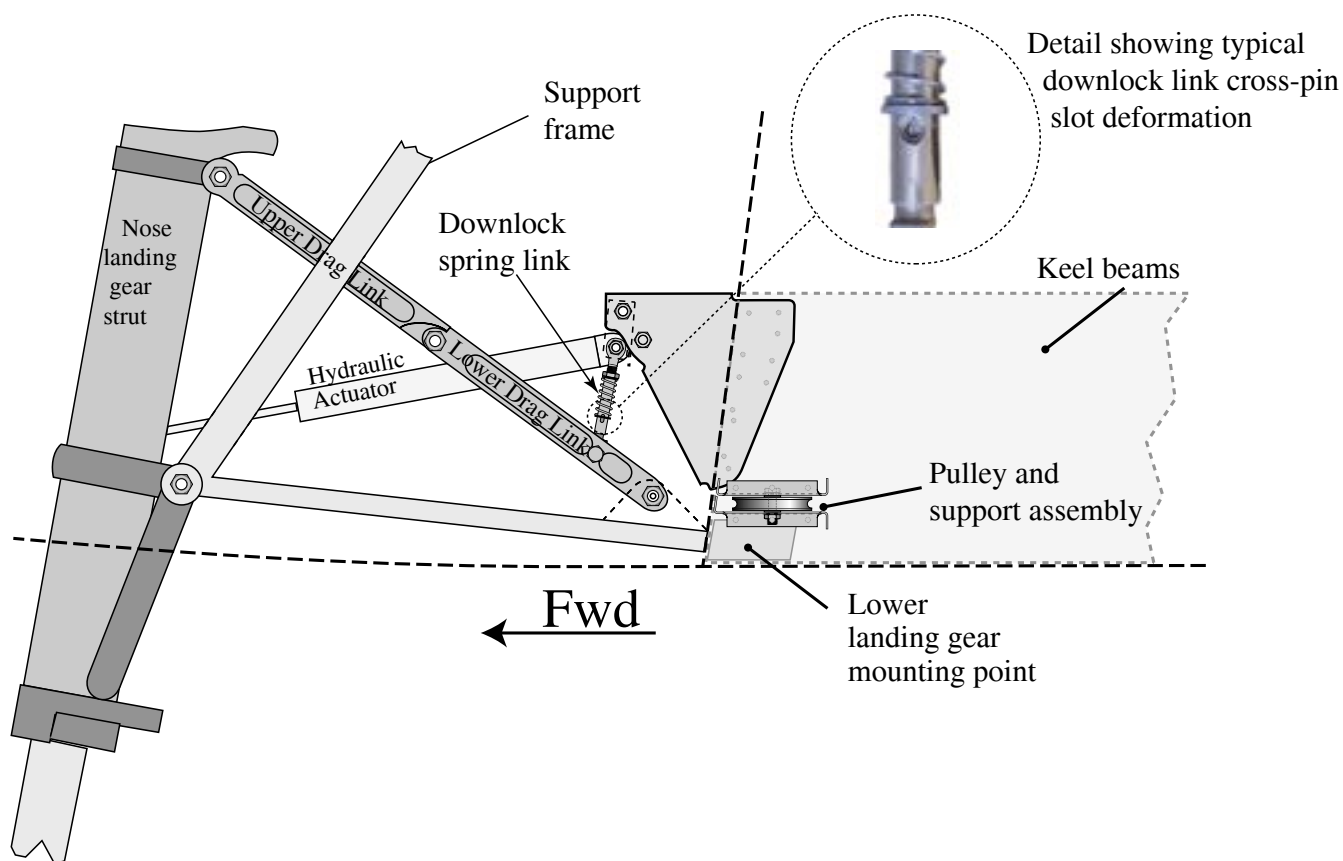
The nose landing gear upper and lower drag links together with the landing gear support frame, Figure 1, showed no signs of deformation or damage although the downlock link showed some deformation of its cross-pin

**Figure 1**  
Side view showing general arrangement of the nose landing gear and its support structure in the forward fuselage

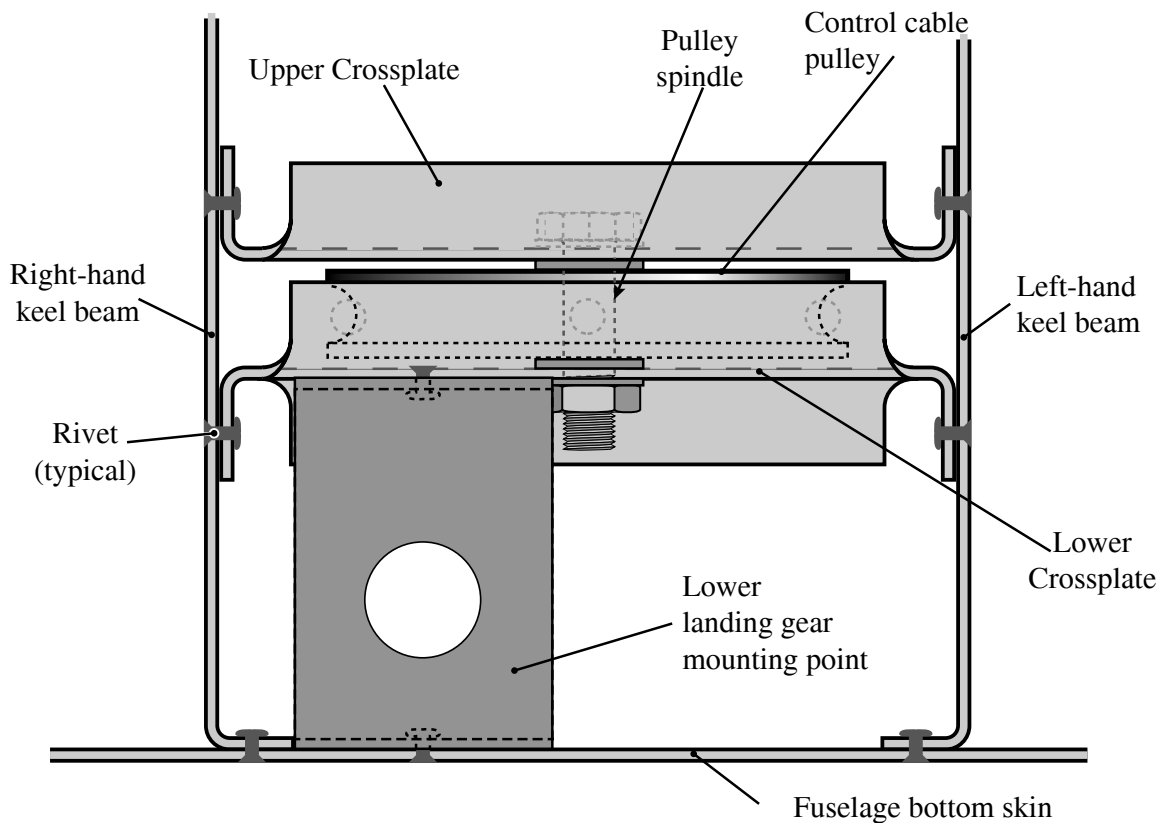
**Figure 2**

View of keel assembly - looking aft from fuselage front bulkhead

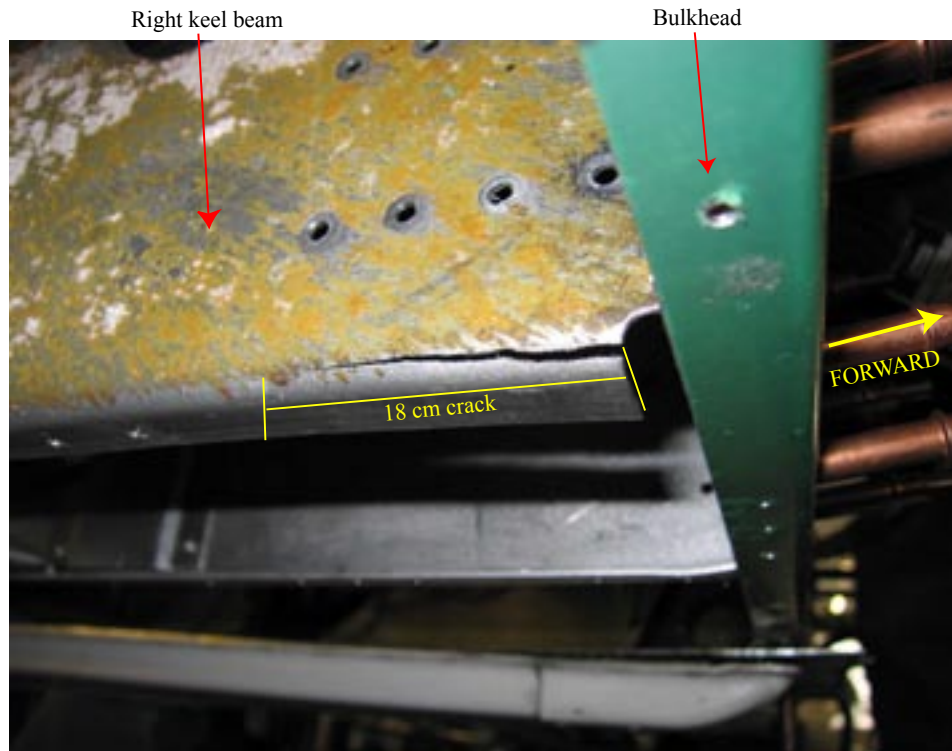
**Figure 3**  
Right keel beam crack

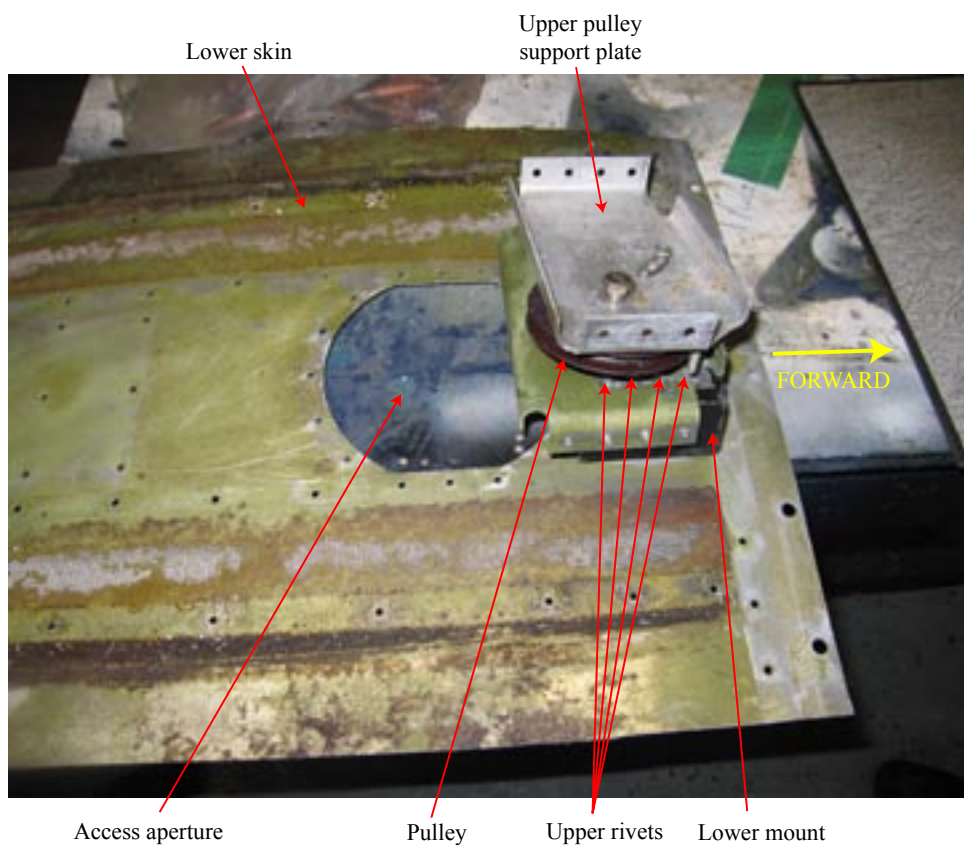
crossplate, support the pulley spindle, (see Figure 4). A 12 cm diameter access panel, located immediately aft of the pulley and mount assembly, provides access to this area. In order to determine if it would be possible to carry out a visual inspection of the lower mount and its fasteners in an assembled condition, tests were carried out on another aircraft using both standard and specialist inspection equipment. The results of these tests showed that, whilst the conditions of the mount's lower fasteners could be assessed, the upper fasteners could not be readily viewed through the access panel and, therefore, an assessment of their condition could not be made.

**Figure 4**  
Lower mount with control pulley and support plates in position

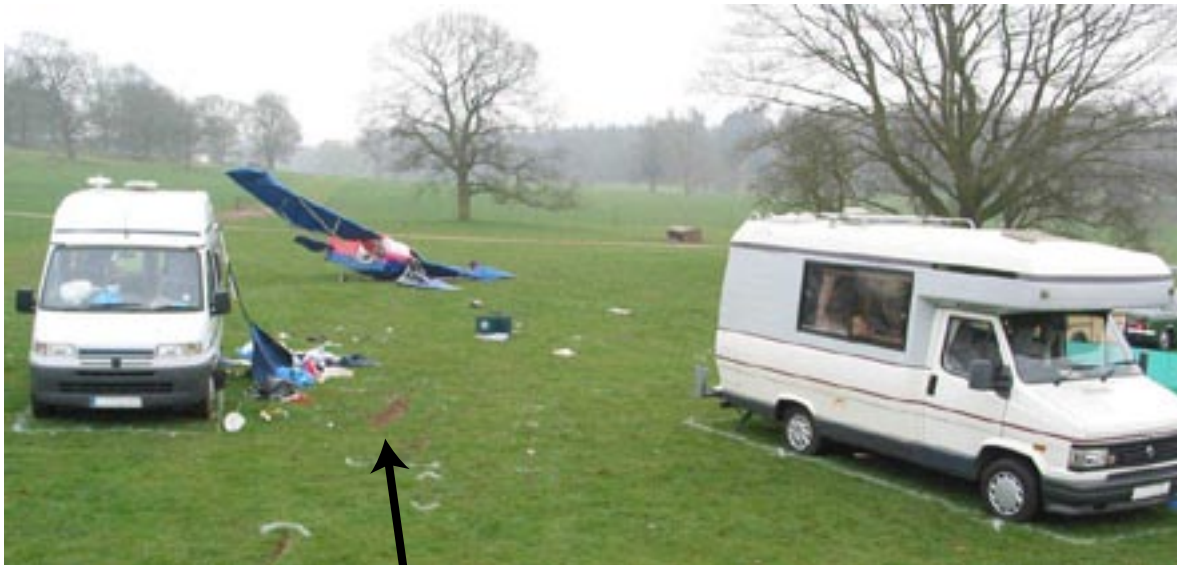
**Figure 2**  
Crash Site

The accident site shown in Figure 2 was to the east of the north-eastern end of the landing area. From the ground impact marks it was deduced that the aircraft contacted the ground out of control, in a slightly nose-down pitch attitude. It passed between two motor caravans, parked approximately 19 ft apart, colliding with an awning attached to the left vehicle and striking the owner of the vehicle. The nose and left main landing gear were torn off during the ground slide.

The aircraft's left wing struck and damaged the bumper of the motor caravan on its left. Smear marks of black plastic from the bumper were visible on the leading edge of the left wing and the wing leading edge tube was deformed over a spanwise distance of about 6 ft, approximating to the width of the vehicle. The roof of the right motor caravan exhibited damage consistent with it having been struck by the right wing. From

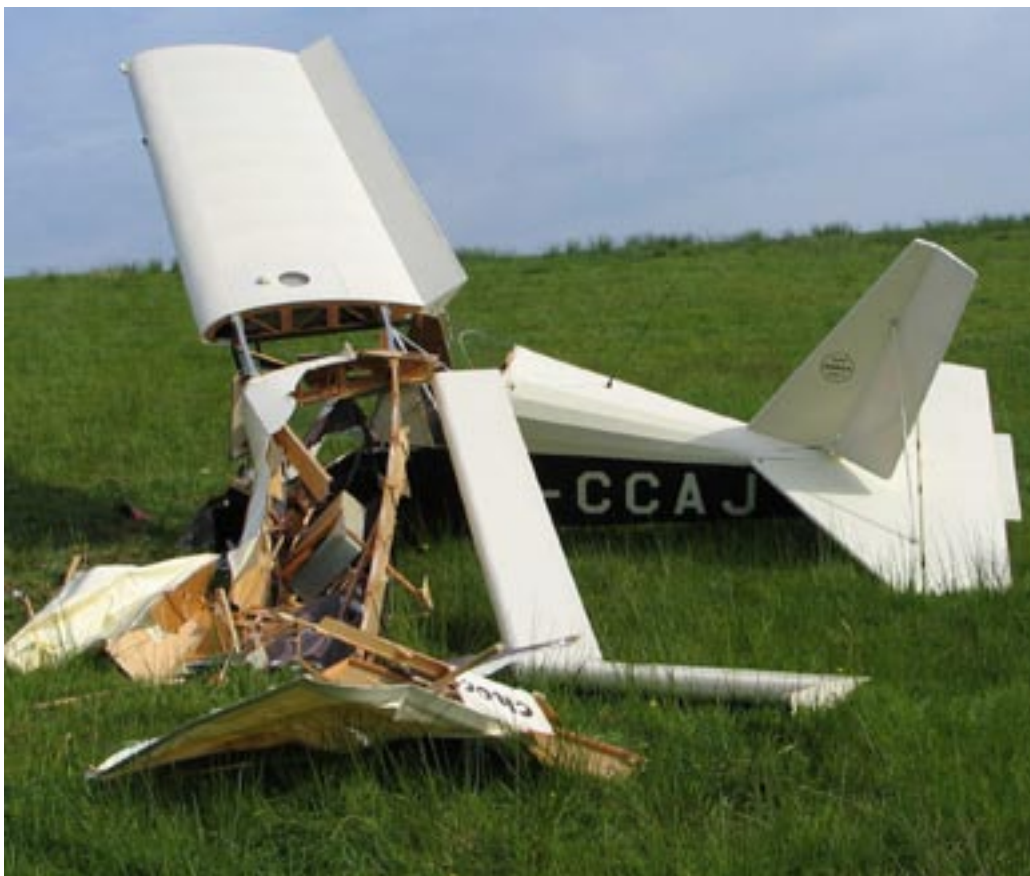
From the wreckage and ground marks it was established that the aircraft crashed within the airfield boundary approximately 42 m south of Runway 07 on a heading of 231°. Ground marks from the left wing tip, which broke off on impact, and broken fragments from the

cockpit floor indicated that the aircraft struck the ground left wing first at a nose-down angle of between 60° and 80°. The left wing, the fuselage forward of the cockpit and the left side of the cockpit were totally destroyed. There was minor damage to the leading edge of the right wing; however the landing gear and structure aft of the cockpit were undamaged. The fuel tanks, which were  $\frac{2}{3}$  full, were intact. One of the propeller blades had broken off close to the hub and fragments of the blade were discovered in a hole approximately 0.6 m wide and 0.12 m deep. The aircraft was equipped with a four-point harness of which the shoulder harness securing cable had failed at its anchor point. There were no ground marks beyond the immediate vicinity of the aircraft. See Figure 1.

**Figure 1**  
Crash site

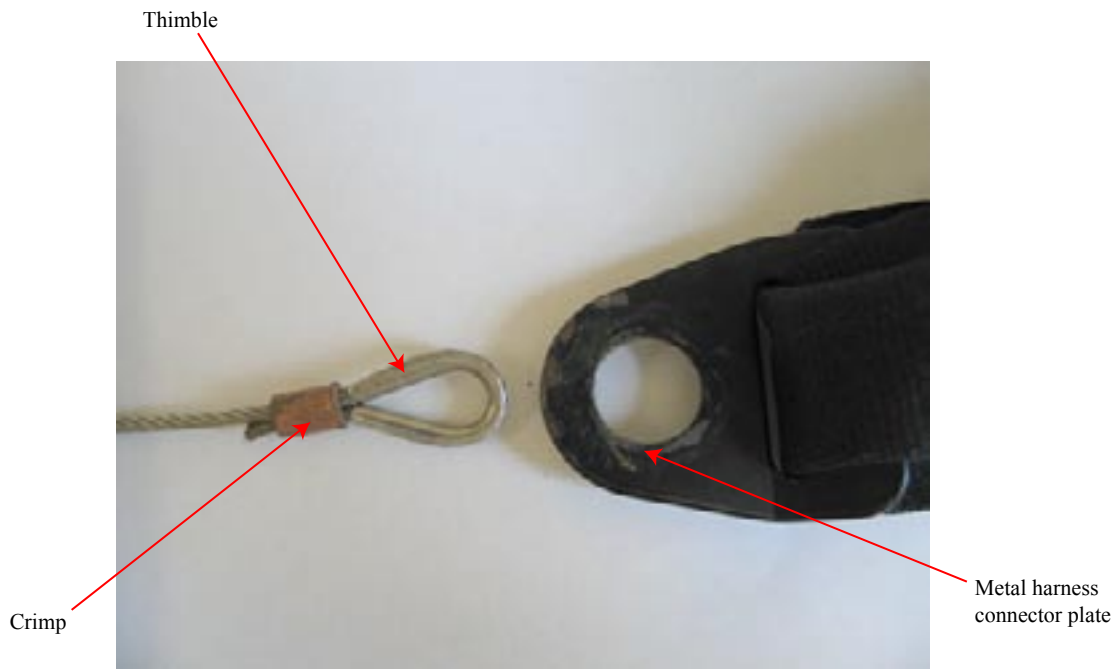
**Figure 3**

The aircraft was equipped with a four-point harness consisting of a lap strap and two shoulder straps. The shoulder straps should have been connected to a galvanised steel cable which looped back through the elevator control support bracket fitted at the rear of the fuselage. The design drawings showed that one shoulder strap should have been attached to each end of the cable

Connection of harness to cable (Note the thimble should be fitted over the lug of the harness connector, joining the cable directly to the connector plate)

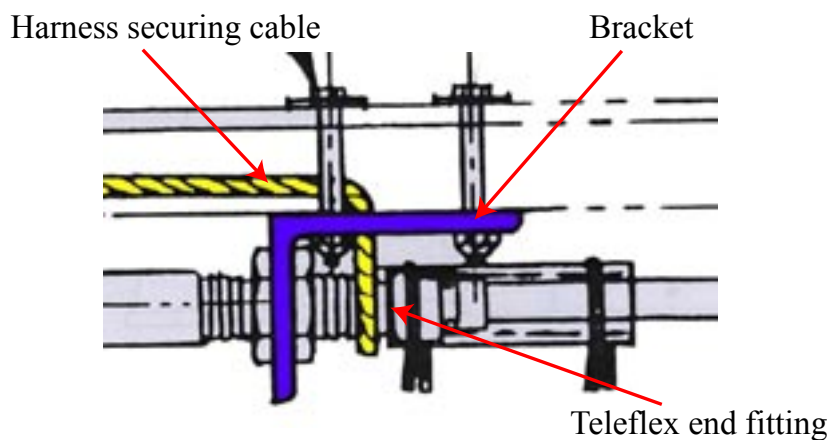
**Figure 4**

flange of the bracket which supported the aft ends of the two elevator Teleflex cables. The harness cable then was looped underneath the Teleflex outer sheath end fittings before passing up through another hole in the horizontal flange and, with another tight 90° bend, forward again to the pilot's shoulder harness. (Fig. 4)

Routing of shoulder harness securing cable in rear fuselage

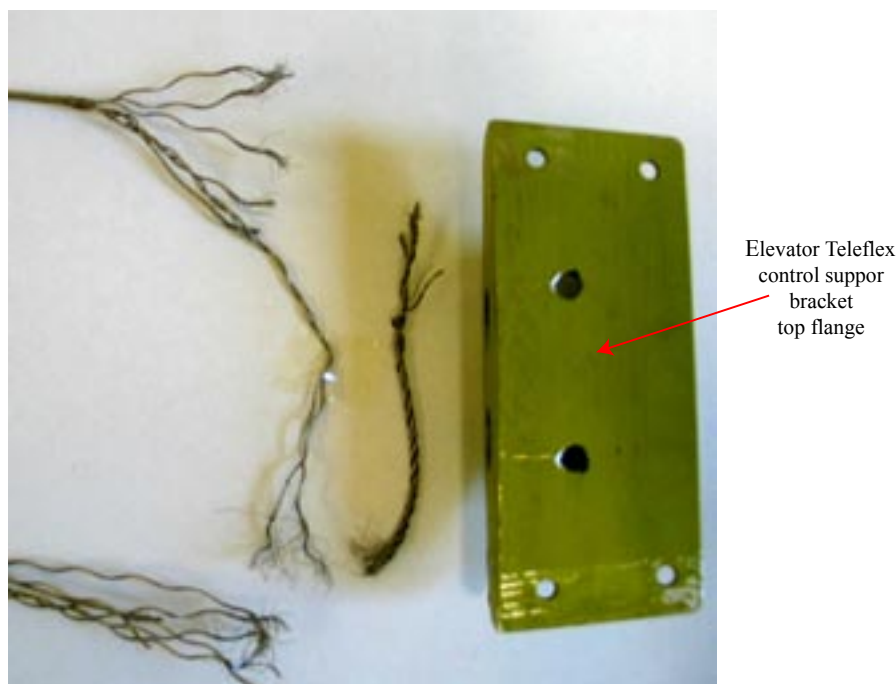
**Figure 5**

Shoulder harness cable and elevator Teleflex cable mounting bracket
