CONTENTS

Summary of:	Aircraft Accident Report No: 5/2008	49
	Report on the accident to Boeing 737-300, OO-TND at Nottingham East Midlands Airport on 15 June 2006

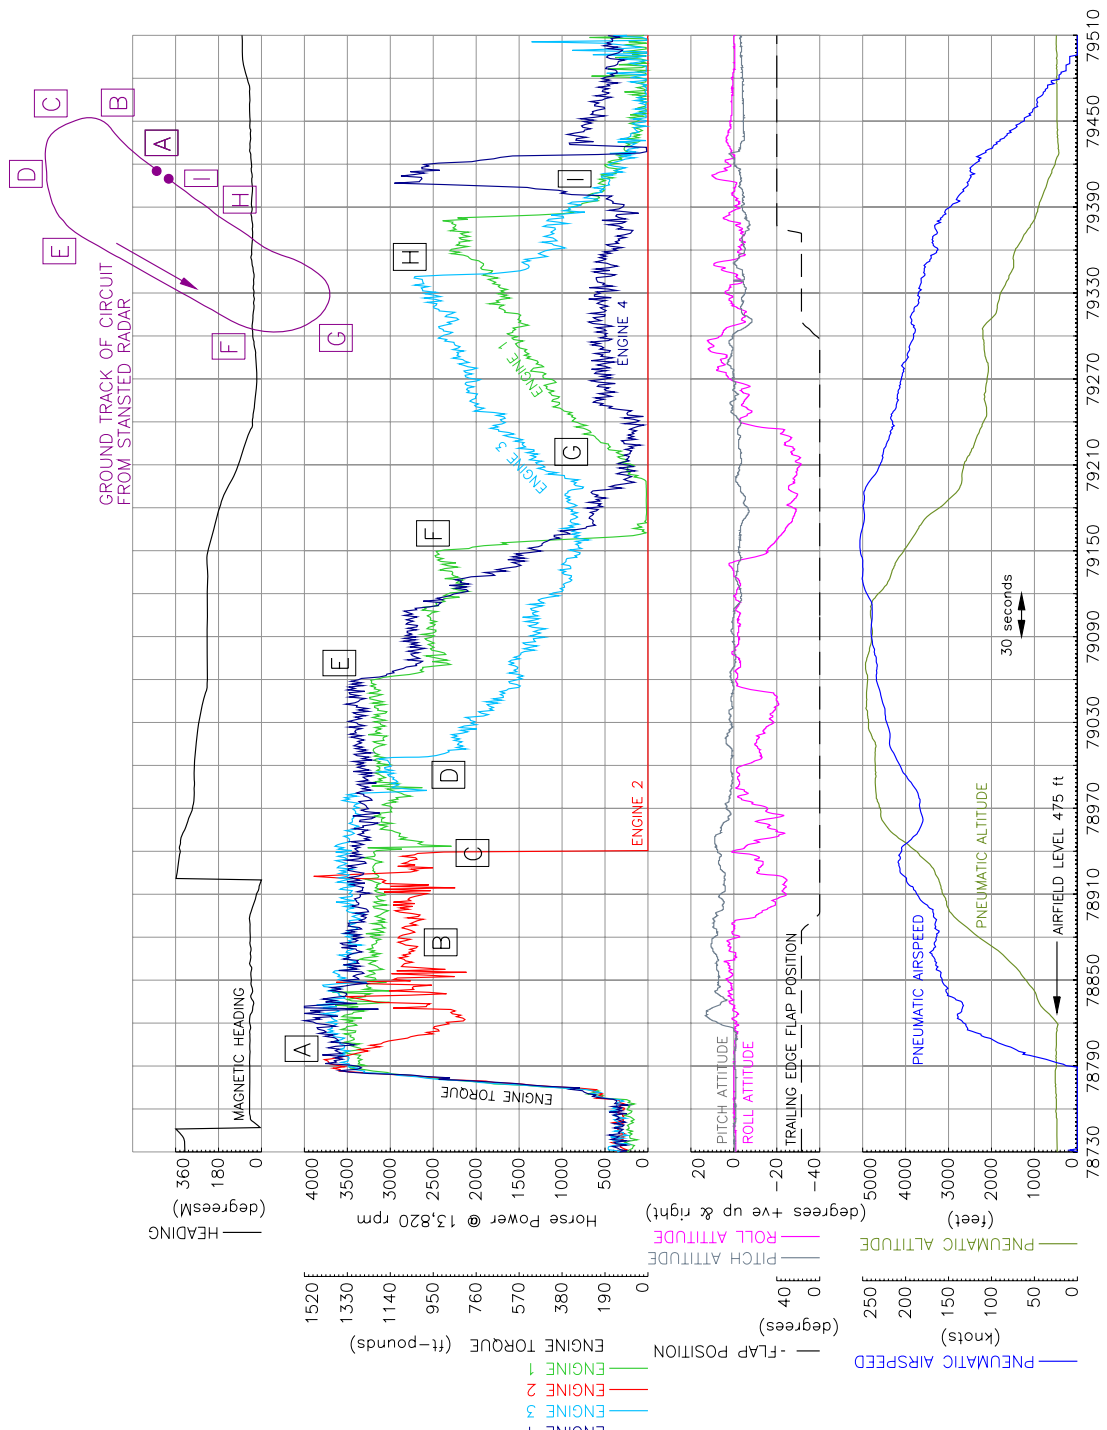
Figure 3
FDR Parameters

Only a limited number of parameters was recorded and a time history of these parameters during the incident flight is shown at Figure 3. The only parameter relating to the engines is torque, measured between the power section of the engine and the reduction gearbox, the values of which are also displayed to the crew via digital indicators but converted to horsepower (HP). The horsepower is calibrated to indicate the power output of the engine

at the constant on-speed condition of 13,820 rpm¹. This horsepower is also illustrated on Figure 3 with the equivalent horsepower at 13,820 rpm scale shown alongside the torque. Each of the engine torques appears to have a certain amount of noise (± 30 lb ft or ± 80 HP @ 13,820 rpm) which is also evident on all previous flights recorded on the UFDR.

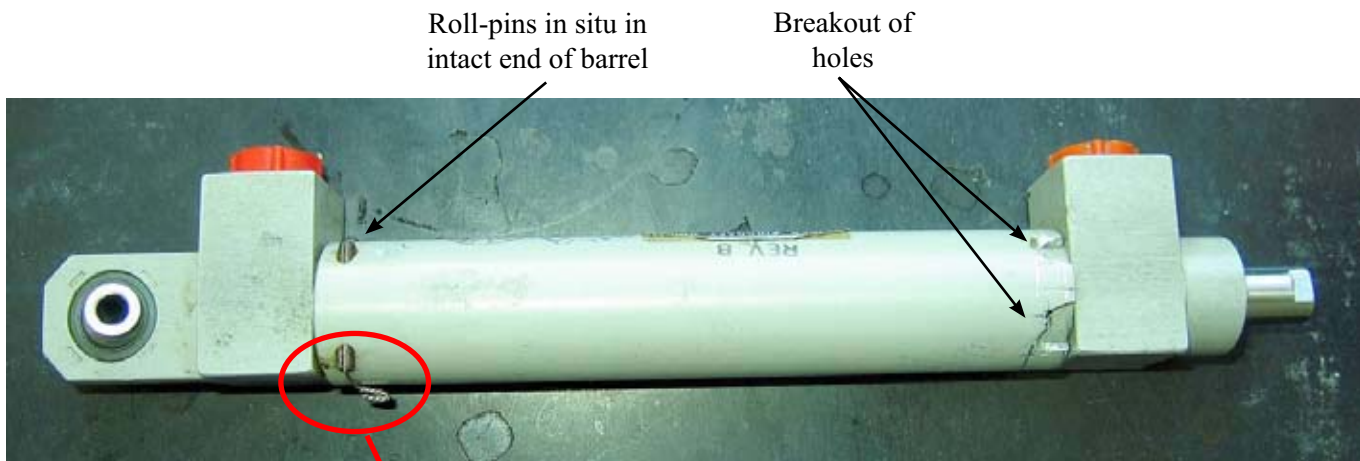
Figure 1 (above)

Examination of the actuator revealed the presence of pre-existing stress corrosion and critical cracking, in the actuator body. It was concluded that the failure was associated with the maritime environment in which the aircraft had operated, possibly exacerbated by very thin anodic coating.

Examination of the aircraft after the accident revealed that the barrel of the right main landing gear door actuator had failed in such a manner as to allow the end-cap of the cylinder to detach. This caused a total loss of hydraulic fluid and consequent failure of the retraction actuating system. The AAIB examined the failed actuator and it was apparent that the end-cap had separated because of a 'breakout' of material around holes in the barrel of the cylinder. These holes provided location for a pair of roll pins that passed tangentially through the barrel and the cylinder end plug, on opposing sides of the cylinder housing, fixing the former to the latter (Figure 1).

The failed unit was subjected to detailed metallurgical examination, which included scanning electron microscopy. It was established that the cracks were indeed intergranular, probably caused by corrosion, which was widely apparent. Corrosion products had fully penetrated the grain boundaries, consistent with exposure to a marine environment. Cracks appeared to have been initiated by intergranular fissures in the surface of the barrel during manufacture, prior to the component being anodised, resulting in penetration of these fissures by anodic products (oxides). Additionally, the anodic coating of the barrel was unusually thin, being no more than 3 microns. This appeared to be not thick enough to prevent exploitation of these fissures subsequently by corrosion in service. The final overload fractures were ductile, suggesting that the material itself was not particularly embrittled, but Energy Dispersive X-Ray (EDX) analysis suggested the material was a copper/aluminium alloy, a type that generally offers poor resistance to corrosion.

Failed actuator, showing broken-out roll-pin holes (end plug re-inserted in barrel)

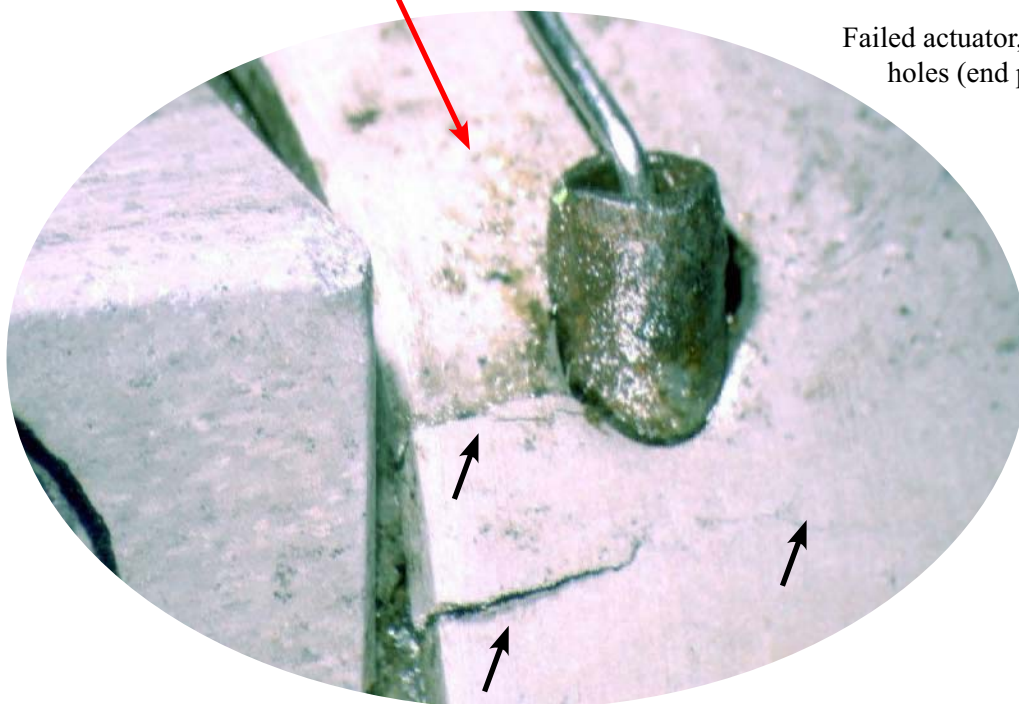
Figure 2

each of the roll-pin holes in the barrel. This occurred both at the end which had failed and also around similar roll-pin holes in the opposite end of the barrel, which had not failed (Figure 2). It was evident that the breakout which had allowed the end plug to detach, resulted from exploitation of these pre-existing cracks, which gave the appearance of having been caused by stress-corrosion or a related mechanism.

Typical cracks at hole in *intact* end of barrel

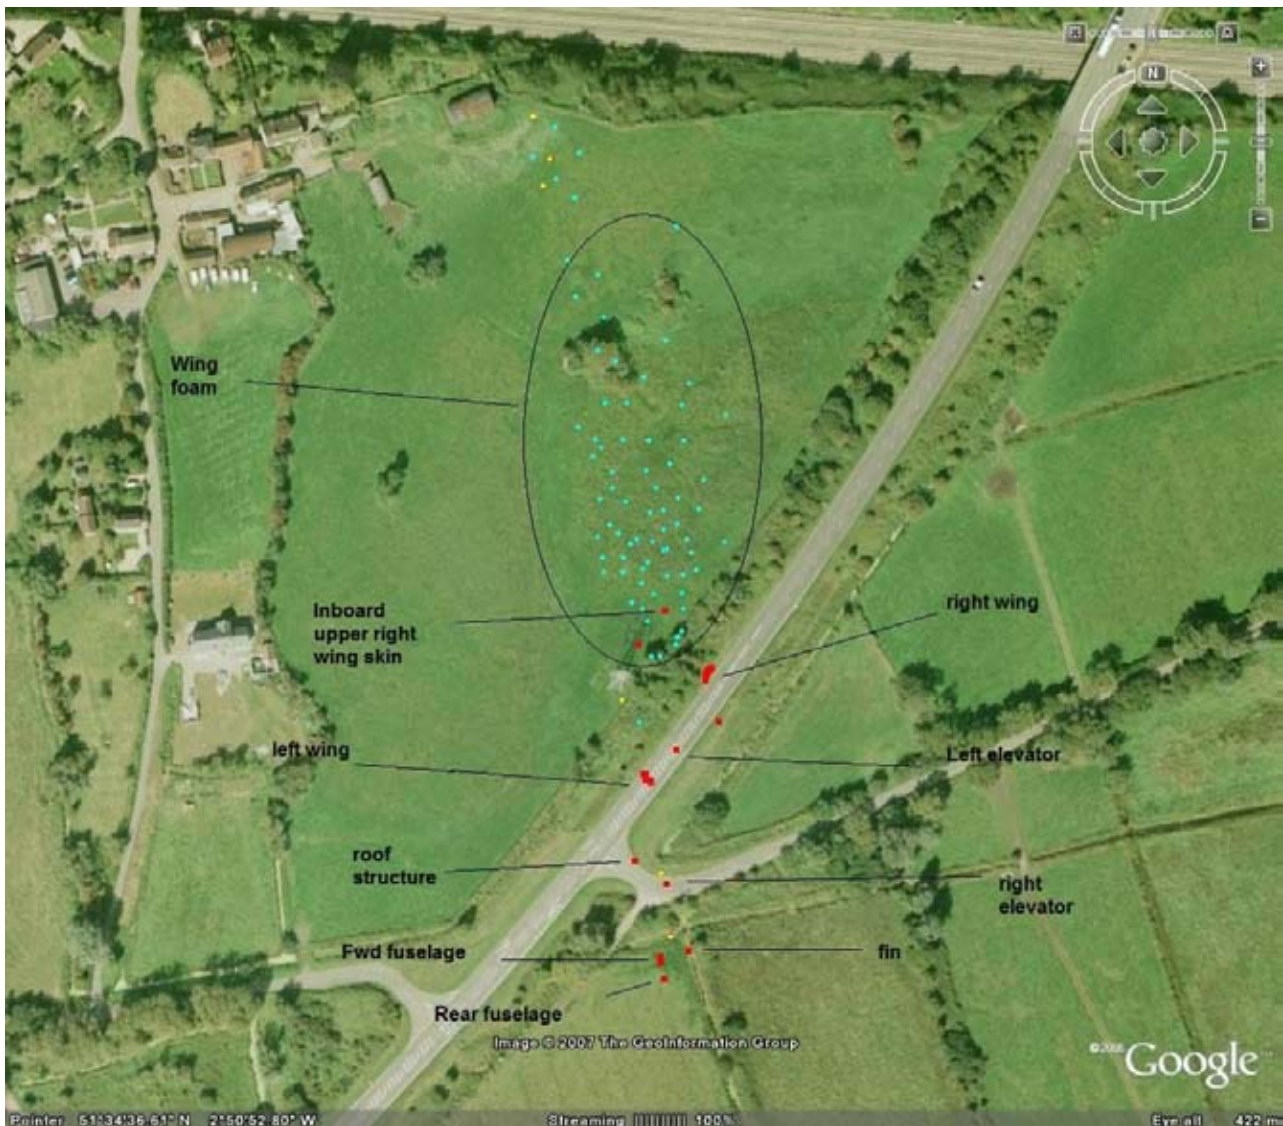
Figure 2

The wreckage trail continued for 430 metres on an approximate heading of 170° immediately to the south of a railway line, see Figure 2. The first items recovered were flight documentation and some personal effects. Approximately 35 metres south of the railway

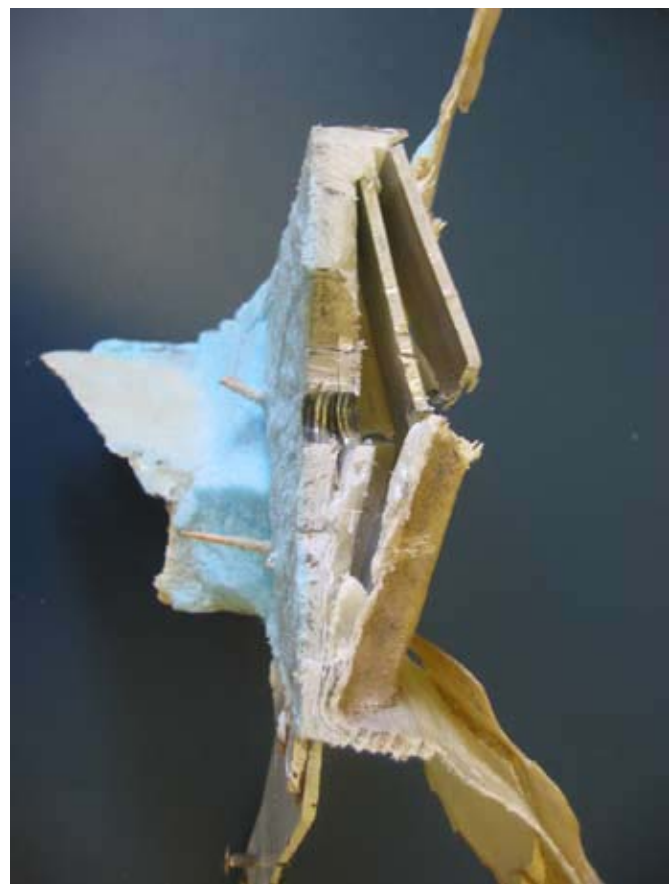
Figure 6

Both the left and right wing lift pins had failed together with the drag pin of the left wing. The mountings for these pins, together with the threaded portion of the pins, remained in place in their respective wing ribs. Examination of the fracture surfaces of the pins showed that they had all failed due to the application of large cyclic bending loads. A section of the right wing inboard rib which contained the right drag pin mounting was recovered from the accident site some distance from the remains of the right wing. The mounting structure of the pin, which consists of several aluminium plates laminated together (including the one which hinges the flap), appeared to have failed due to the application of a tensile load. The innermost (closest to the wing rib) plate and flap plate remained in situ, but the outer two plates (closest to the fuselage) had been deformed and pulled away from the structure, see Figure 6. The outermost plate together with the right drag pin remained attached to its mounting point on the fuselage. The corresponding mount was removed from the left wing for comparison. This showed that whilst the left wing mount had been constructed in accordance with the Europa Build Manual, the right mount had not. The laminated plates of the right drag pin mount had become staggered during the lay-up, so that the forward edge of the outermost plate (closest to the fuselage) had been placed 5.5 mm ahead of the edge of the plate immediately below it, and that plate was 3 mm further forward of the innermost (closest to the rib) plate. The forward edge of the innermost

plate was aligned with the forward edge of the flap hinge plate. The hole had also been drilled 2.5 mm forward of the vertical centreline of the outermost plate. This had reduced the edge clearance of the hole in that plate from 7.5 mm to 5 mm.

Due to the staggered lay-up of the mount, the edges of all of the subsequent laminations had been breached. The edges of the innermost plate and flap hinge plate had been breached to the extent that the hole consisted of little more than a semi-circular cut-out of the forward edge. The description of how to assemble the lift and drag pin mounts, given in the Europa Build Manual issued at the time of the aircraft's construction, requires that all three plates are laid up at the same time and does not show any method of maintaining the alignment of the assembly while it cures. It does however provide the following advice:

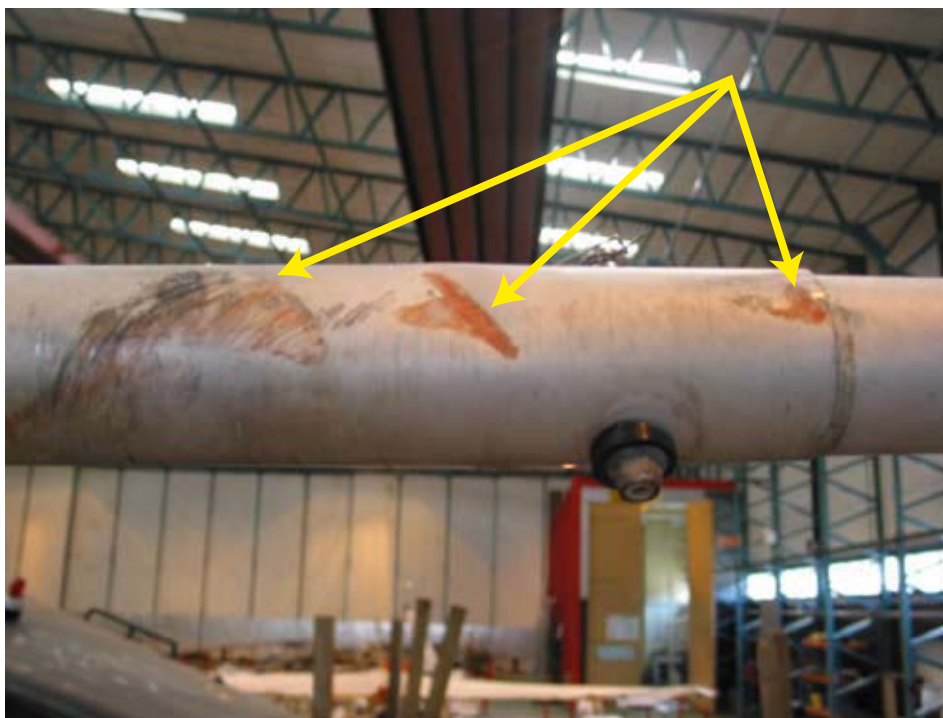
Figure 2

The front strut had failed, with the upper and lower portions remaining attached to the wing and the trike, respectively. The pilot had sustained a wound to the front of his head, consistent with having struck the fractured end of the upper portion of the strut. The monopole had failed at the locking clamp location, leaving an approximately 150 cm long section of it attached to the wing; the rest of the monopole was still attached to the trike. Multiple paint transfer marks, indentations on the rear of the wing keel tube and cuts in the fabric of the fin were indicative of the propeller blades having struck the rear of the wing whilst the propeller was turning (Figure 2).

Propeller strike marks on wing keel tube

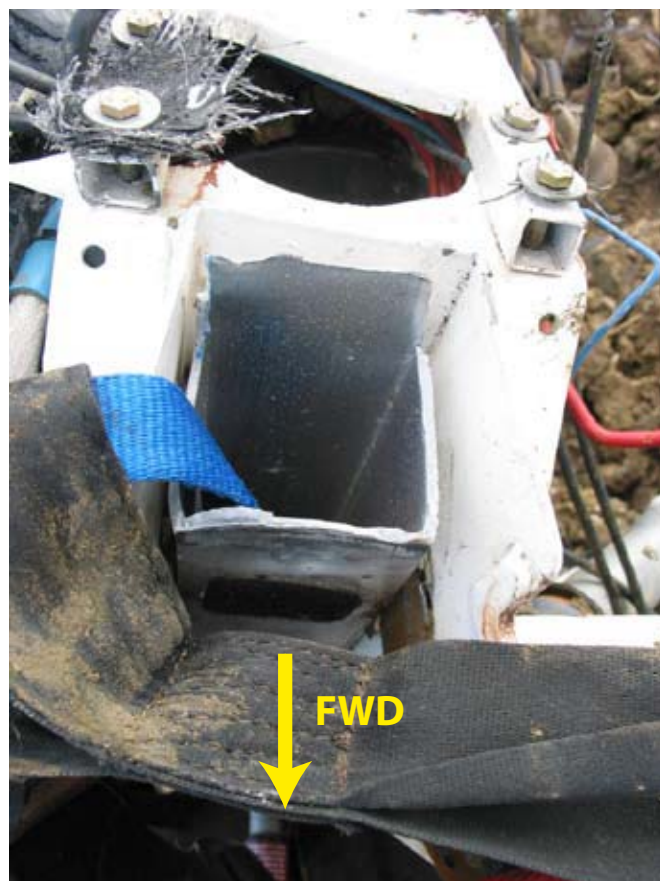
Figure 3
Monopole failure

Distortion and fractures of the noseplate fitting indicated that the wing folded upwards following the failure of the basebar. It was also apparent that the wing had been exposed to very high negative (ie downward) loading at some point in the break-up sequence. This was indicated by downward distortion of the tip washout rods and 'kinking' of the luff line cables where they passed through
